# **NOT ALL THOSE WHO WANDER ARE LOST:**

## **Reconstructing the Post-Medieval Phase of Stonegrave Minster using a Buildings Archaeology Approach**

**MA in the Archaeology of Buildings**

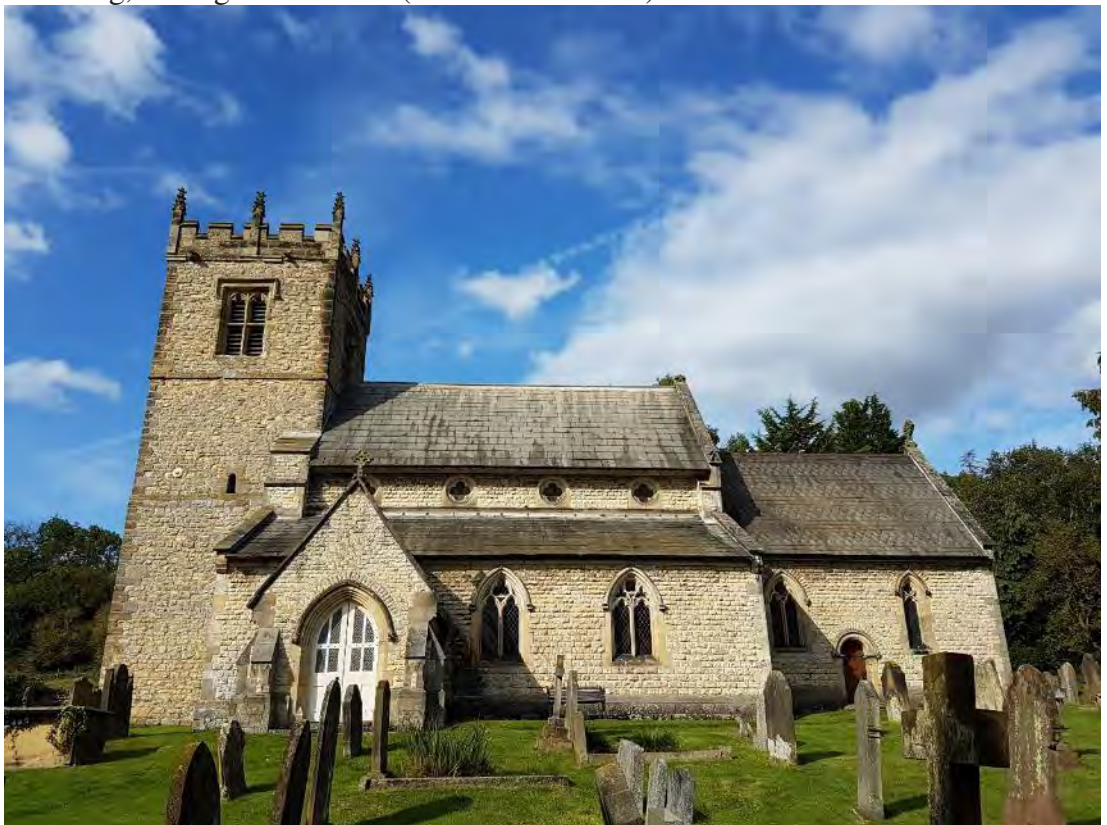
Figure 5: The southern elevation of Stonegrave Minster (Source: Author 2019).

The nave, chancel, vestry and southern porch have steeply-pitched single-gabled roofs, while the north and south aisles have skillion roofs. The tower roof was not accessible (Figure 5-Figure 9). Victorian Westmorland slate tiles cover the roof (HE 2019a), with a standard uniform pattern (Figure 5-Figure 8) aside from the chancel, which displays alternating bands of chamfered and rectangular slates in groups of three courses (Figure 5). Decorative Victorian cross finials are located on raised copings on the end gables of the chancel and porch. The nave finial is missing (Figure 5).

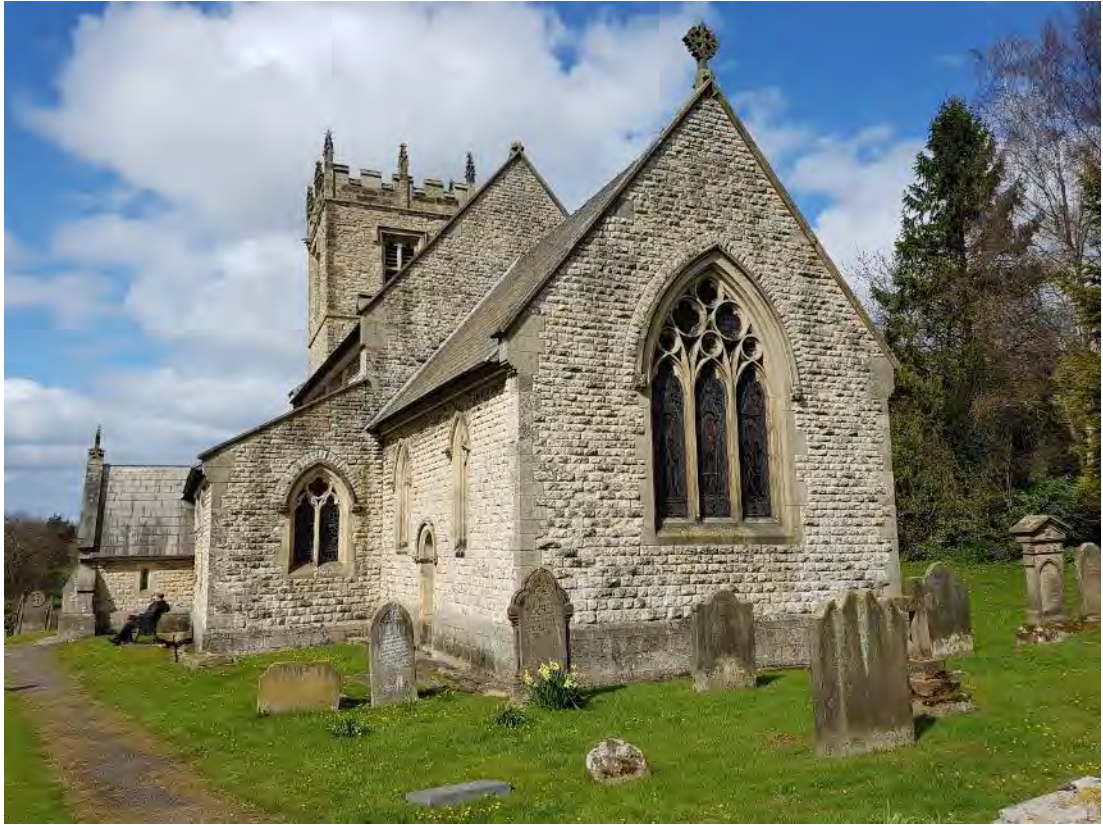
Figure 6: The eastern elevation of Stonegrave Minster from the south-east (Source: Author 2019).

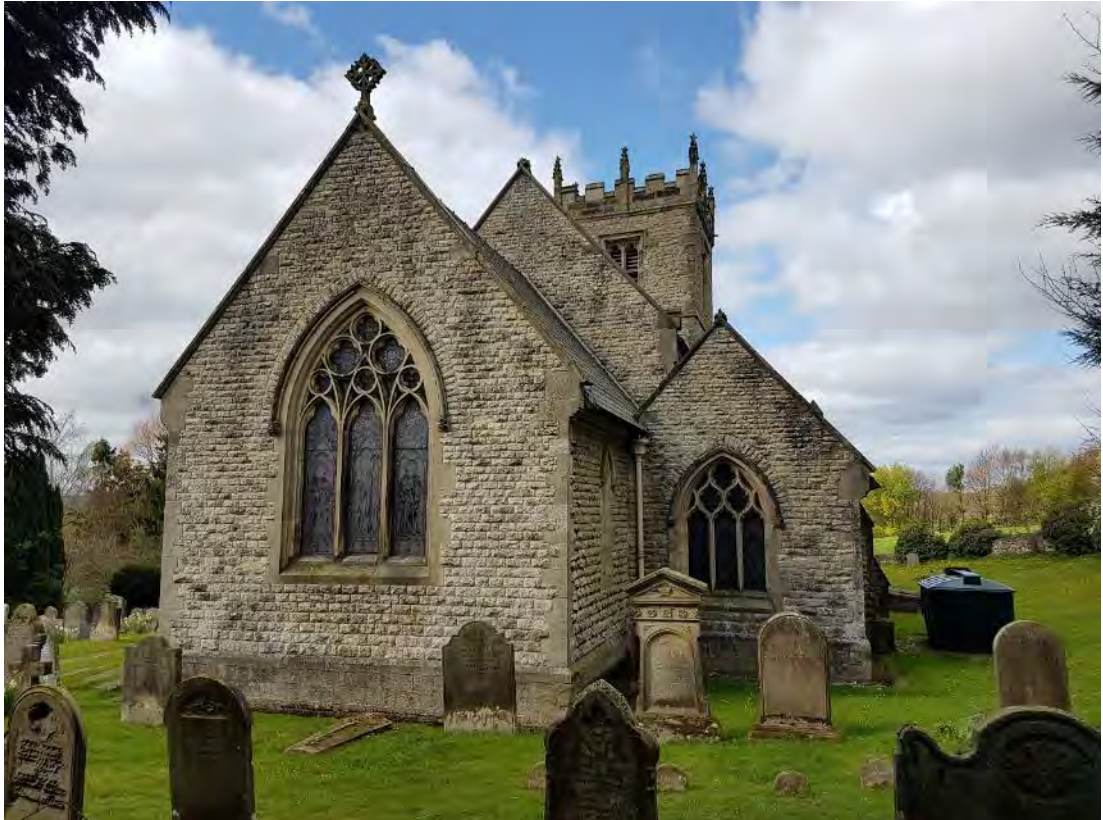
Figure 7: The eastern elevation of Stonegrave Minster, from the north-east (Source: Author 2019).

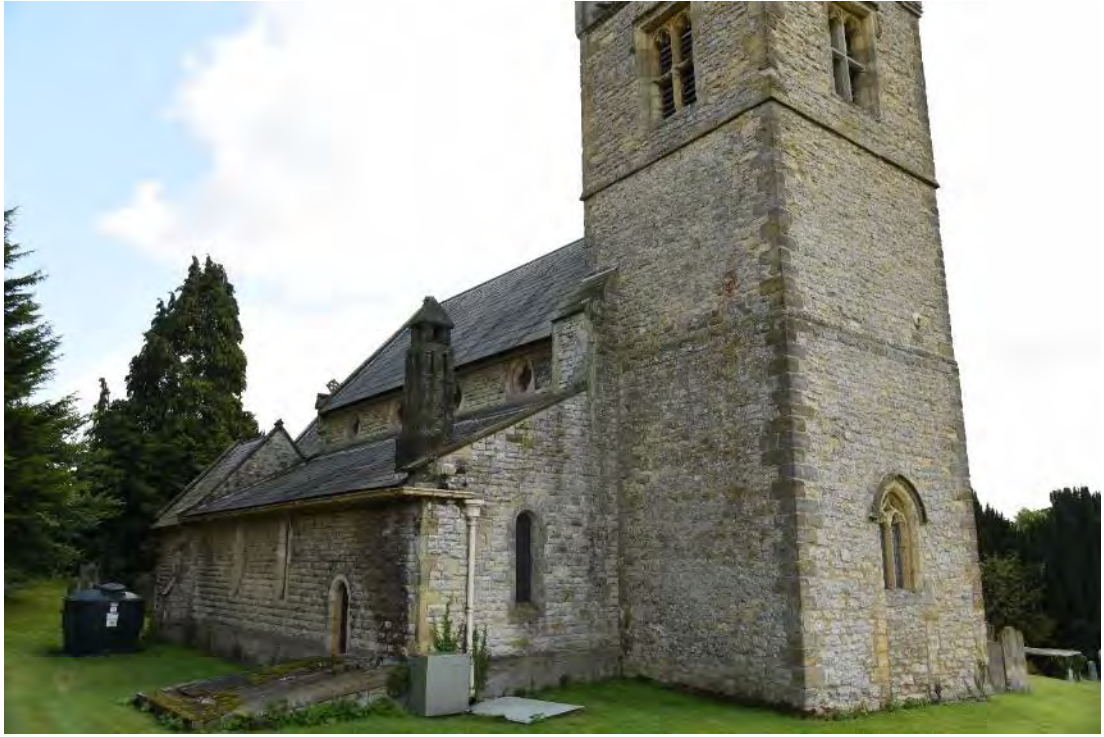
Figure 8: The northern and western elevation of Stonegrave Minster from the north-west (Source: Author 2019).

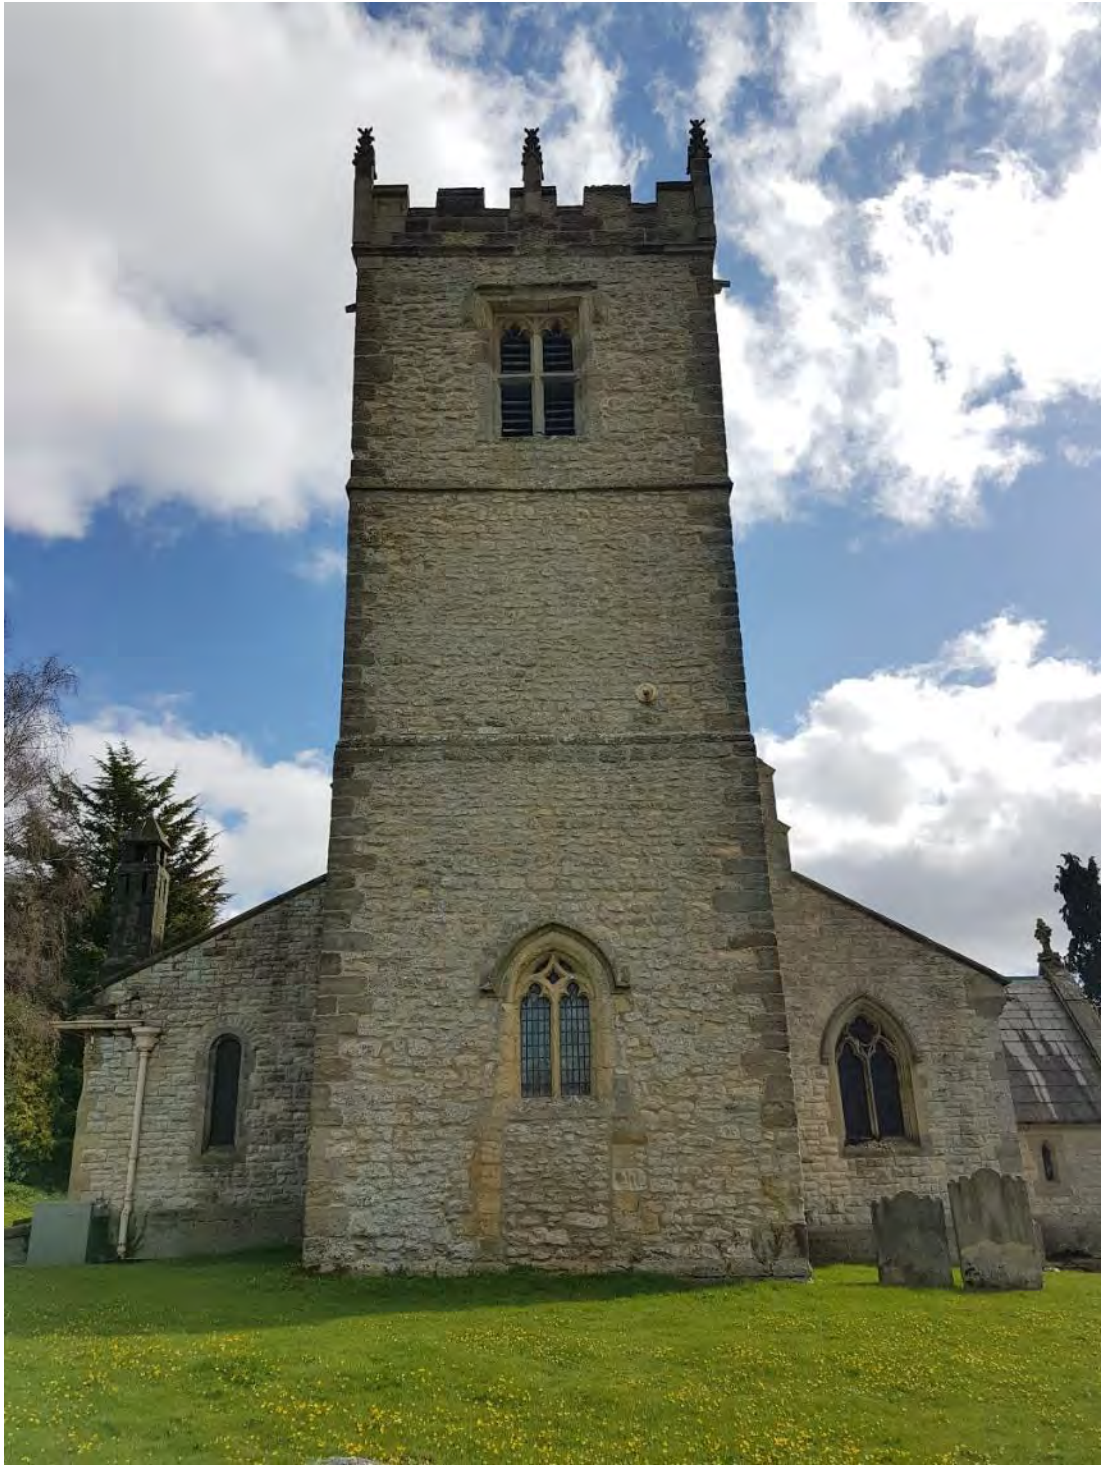
Figure 9: The western elevation of Stonegrave Minster from the west (Source: Author 2019).

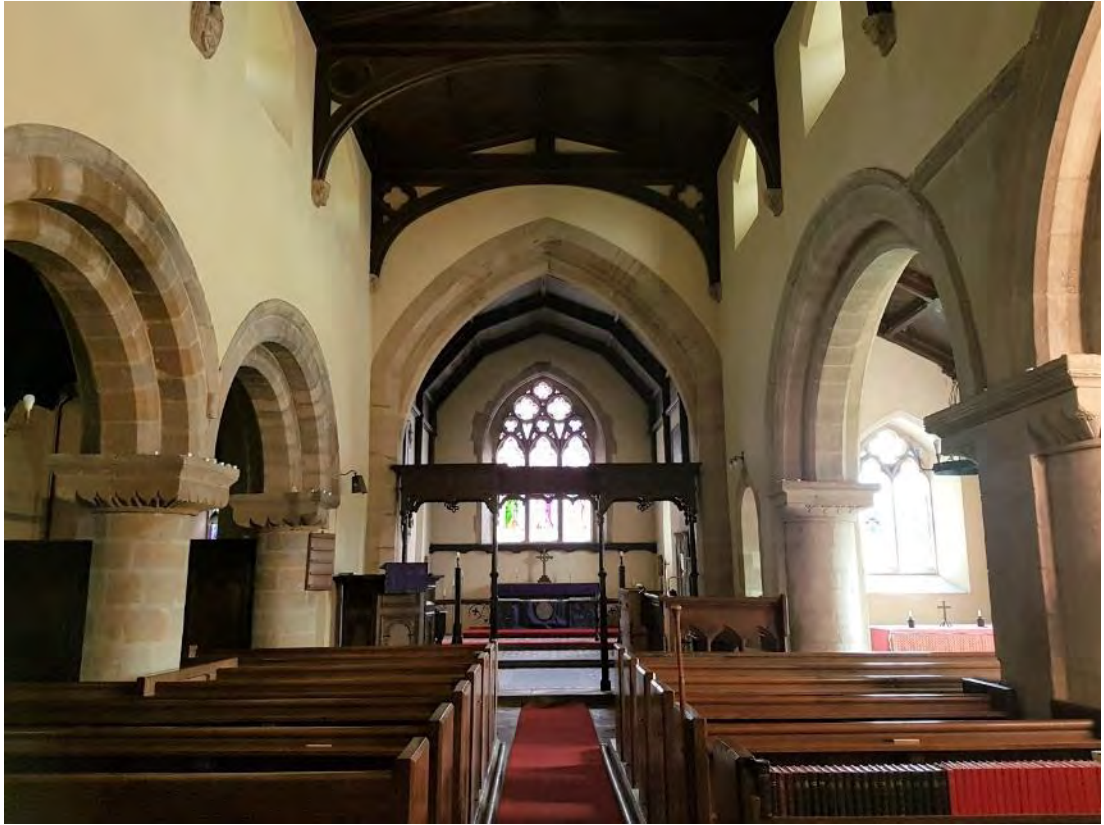
Figure 12: The interior of Stonegrave Minster, taken from the entrance to the western tower and showing the retained medieval fabric of the arcades in the nave, as well as some of the retained Post-Medieval fixtures and fittings including the chancel screen (Source: Author 2019).

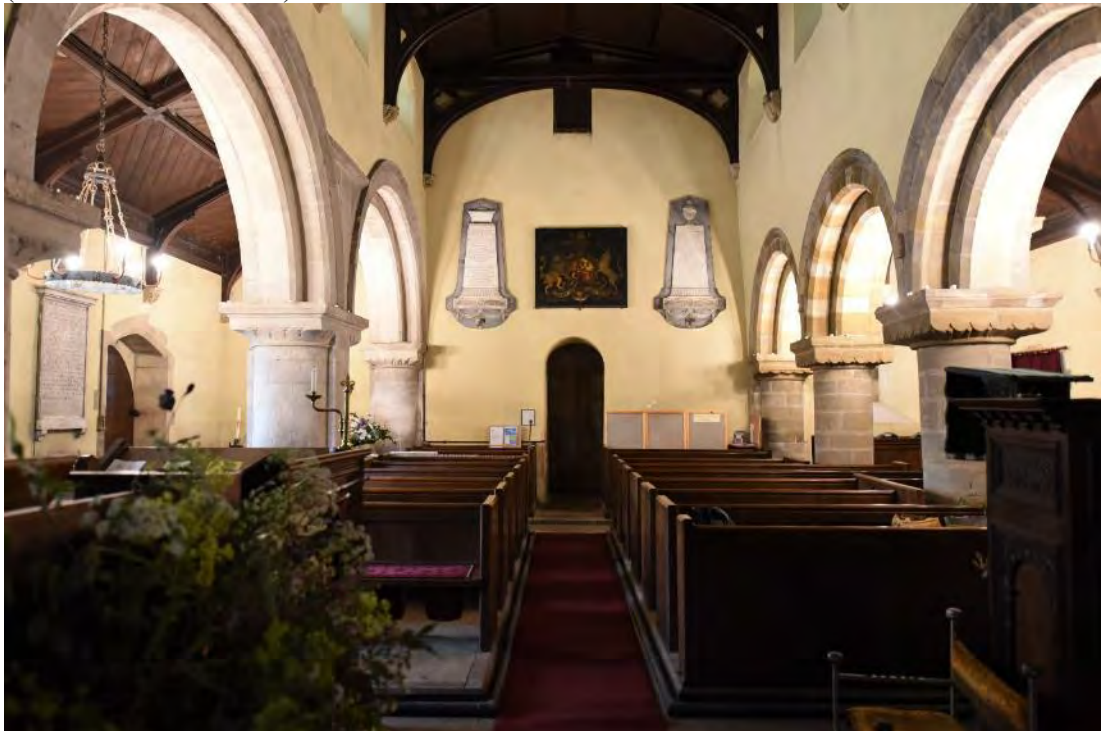
Figure 13: The interior of Stonegrave Minster, taken from the entrance to the chancel and showing the retained medieval fabric of the arcades in the nave and the entrance to the tower (Source: Author 2019).

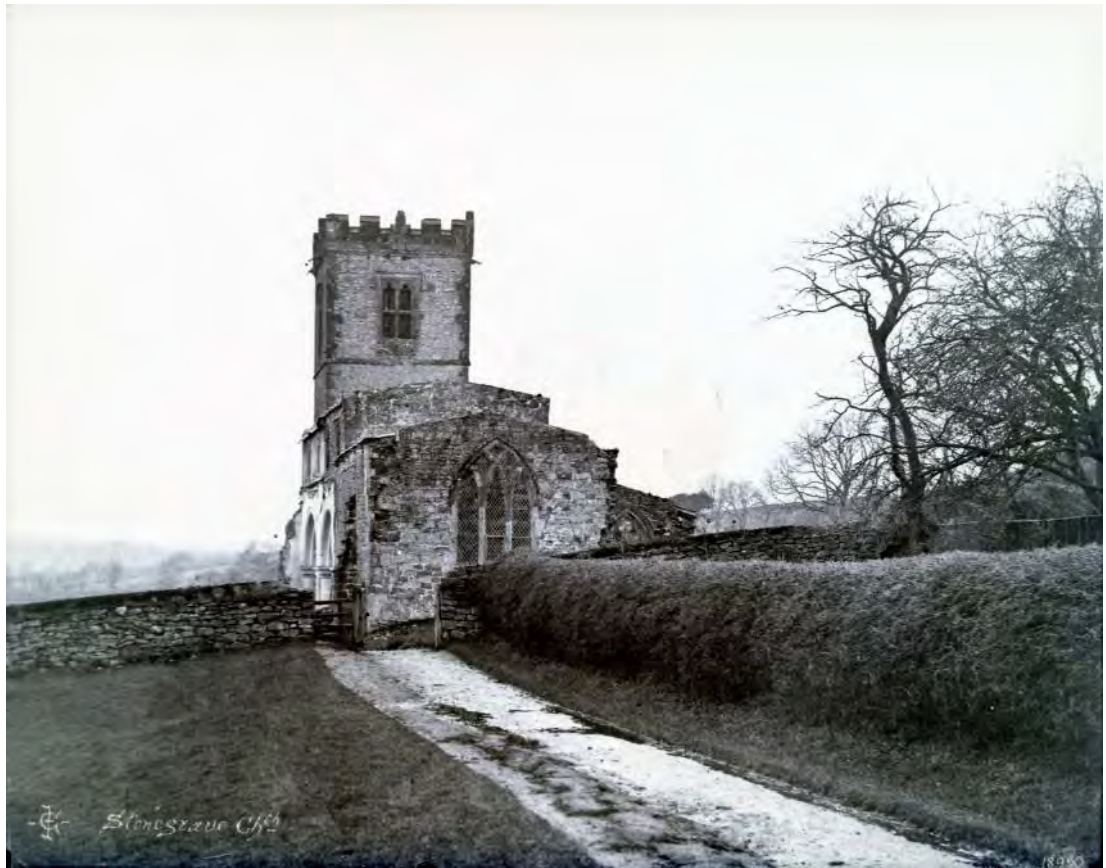
Figure 14: Photograph by George Fowler Jones during the 1862-3 restoration, showing the C15 roof structure of the chancel and nave, looking west. It also shows that the southern aisle was fully demolished (Source: NSM RPS 18950).

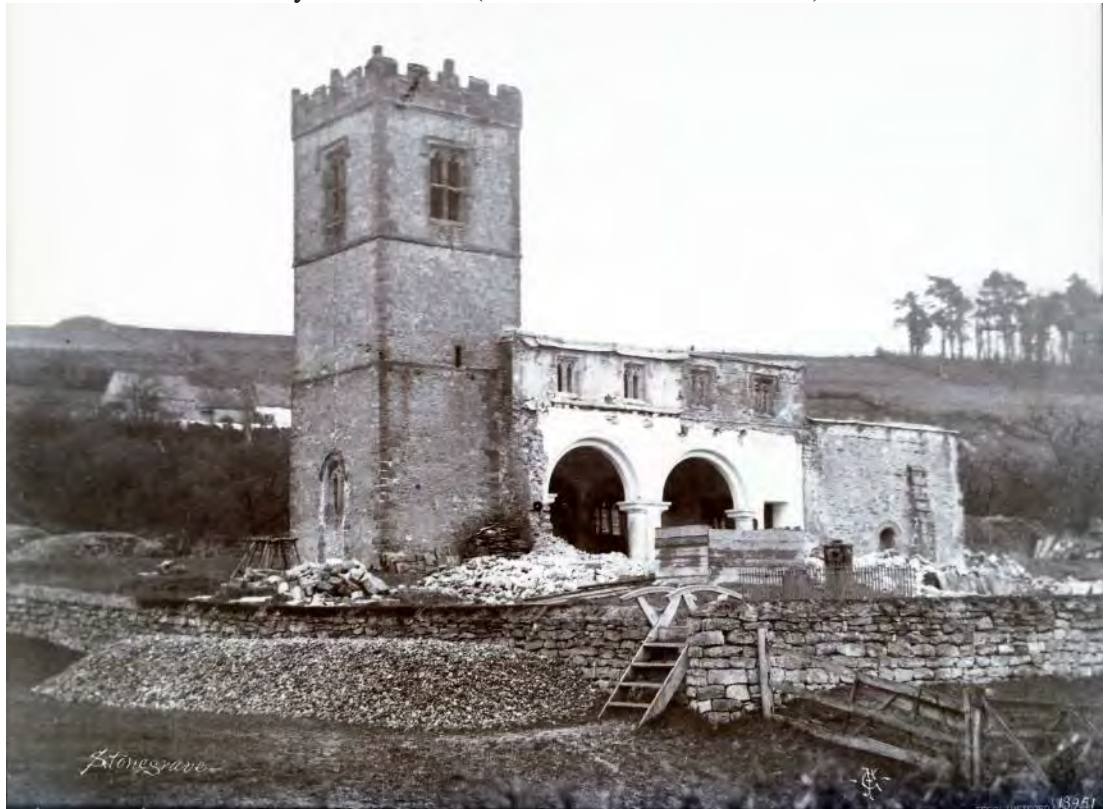
Figure 15: Photograph by George Fowler Jones during the 1862-3 restoration, showing the exterior of the church from the south-west. It shows the demolition of the southern aisle and evidence of the previous roofing in of the western end of the clerestory (Source: NSM RPS 18951).

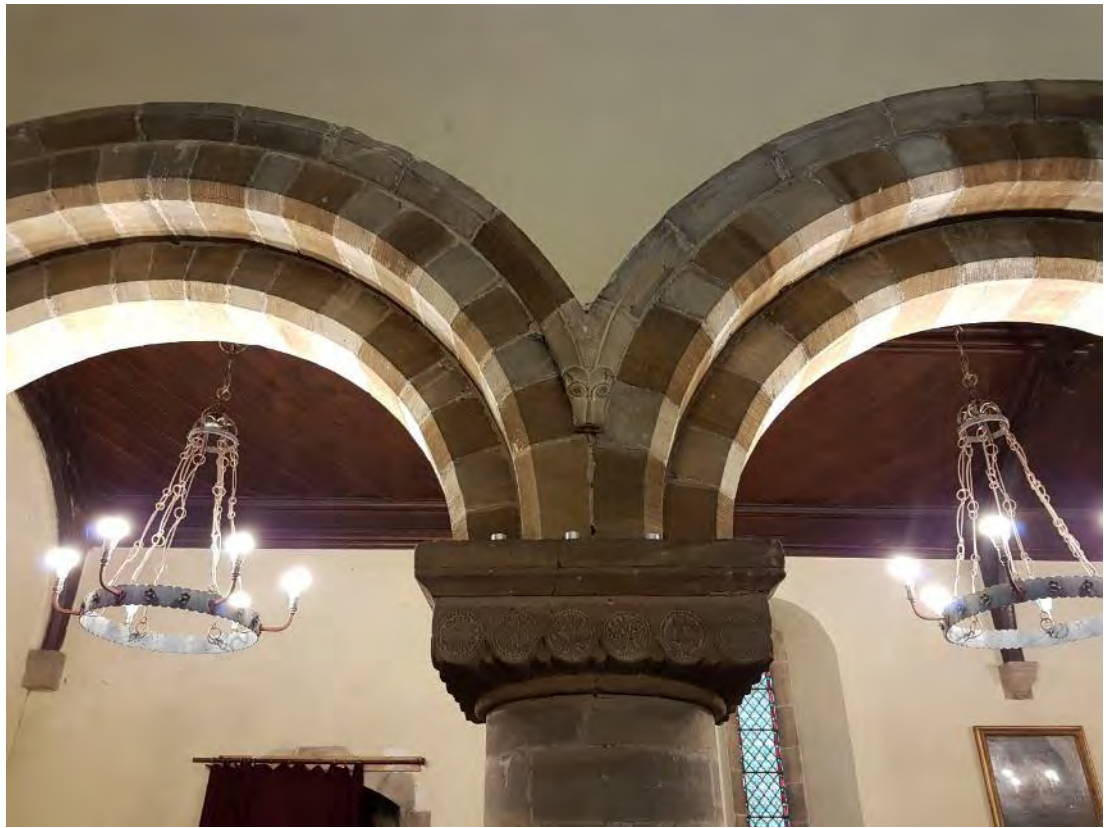
Figure 19: The head of the beast/animal above the eastern pillar of the western arch of the northern arcade (Source: Author 2019).

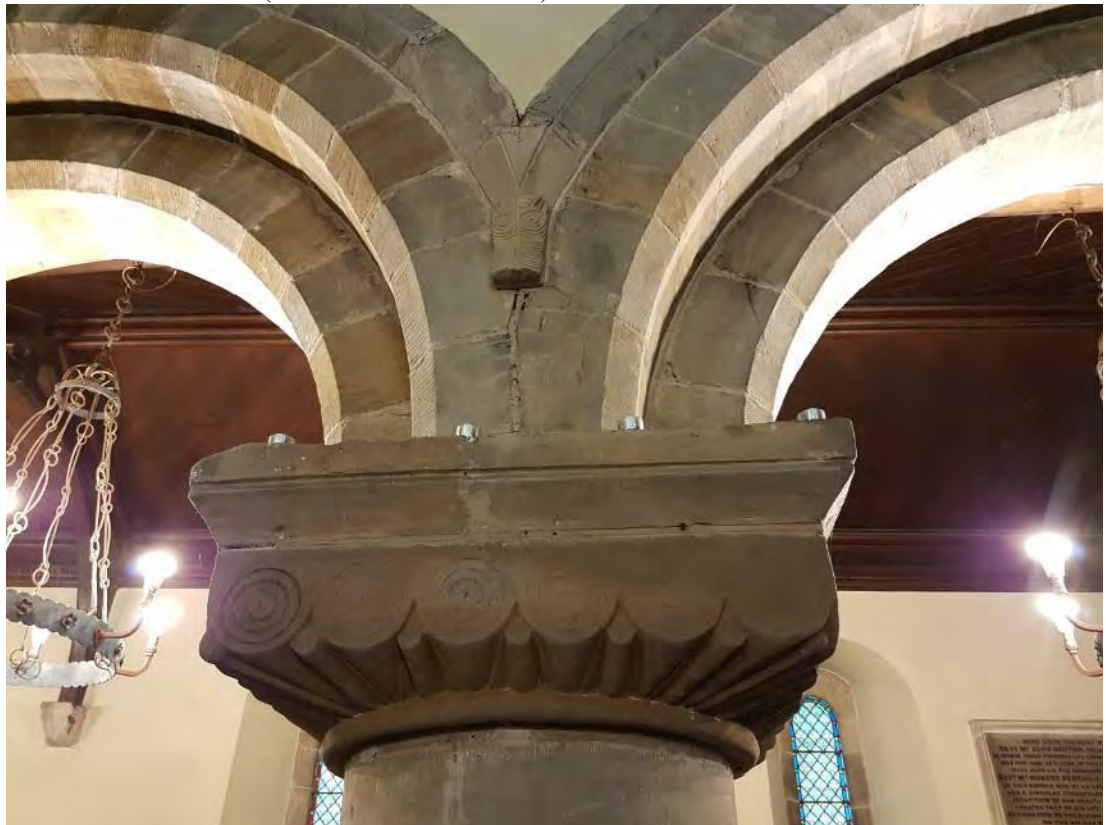
Figure 20: The head of the beast/animal above the eastern pillar of the eastern arch of the northern arcade (Source: Author 2019).

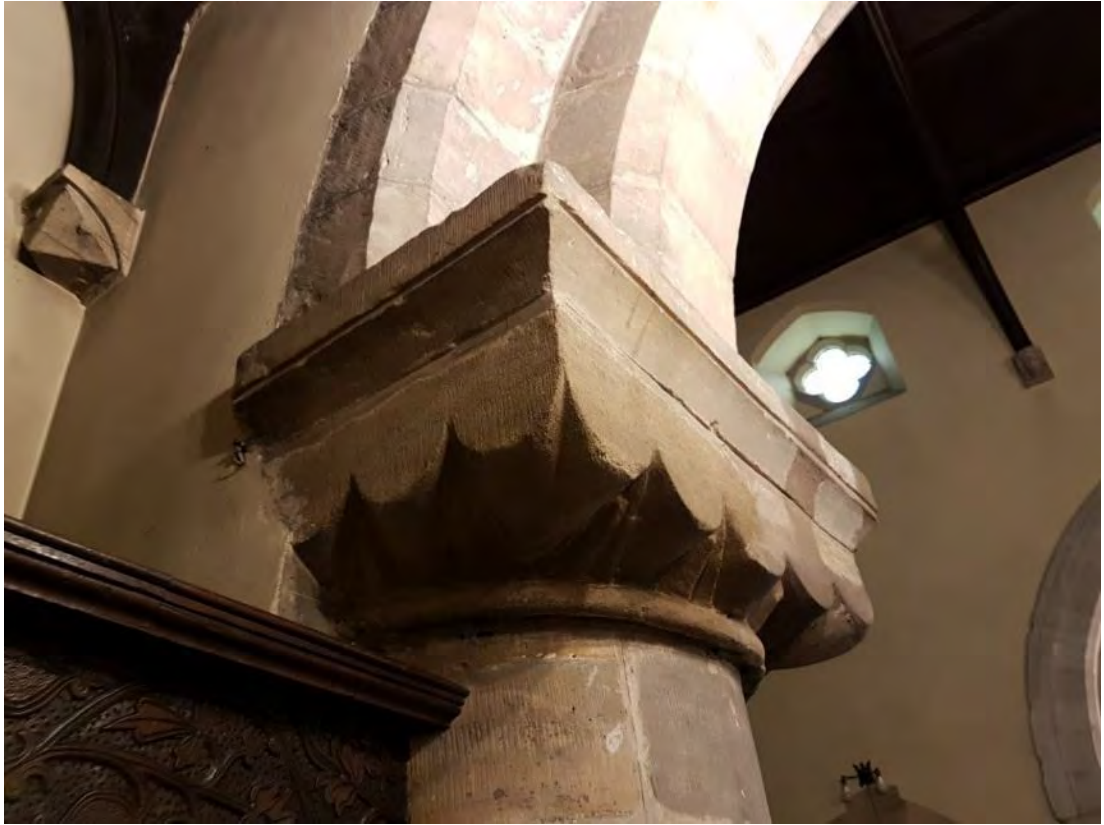
Figure 21: The capital of the eastern pillar of the eastern bay of the northern arcade, showing scalloped trumpets with no floral medallions (Source: Author 2019).

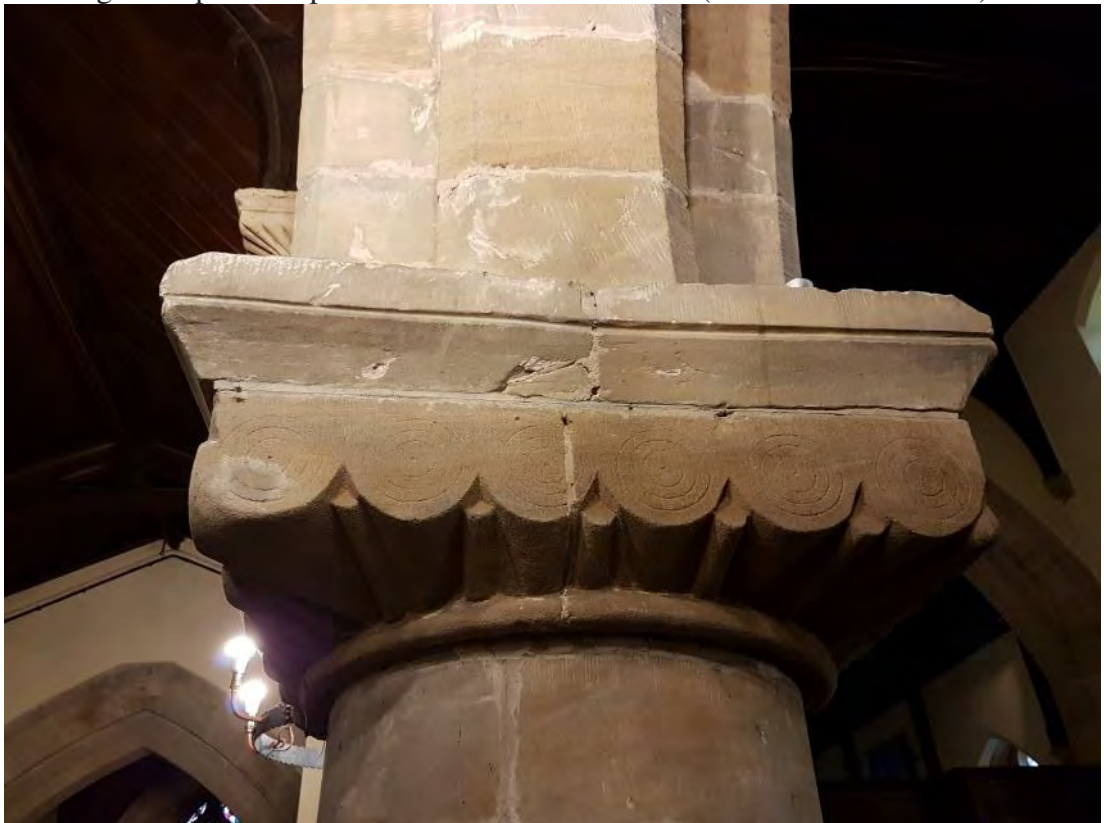
Figure 22: The capital of the eastern pillar of the central bay of the northern arcade, showing scalloped trumpets with incised medallions ready for decoration (Source: Author 2019).

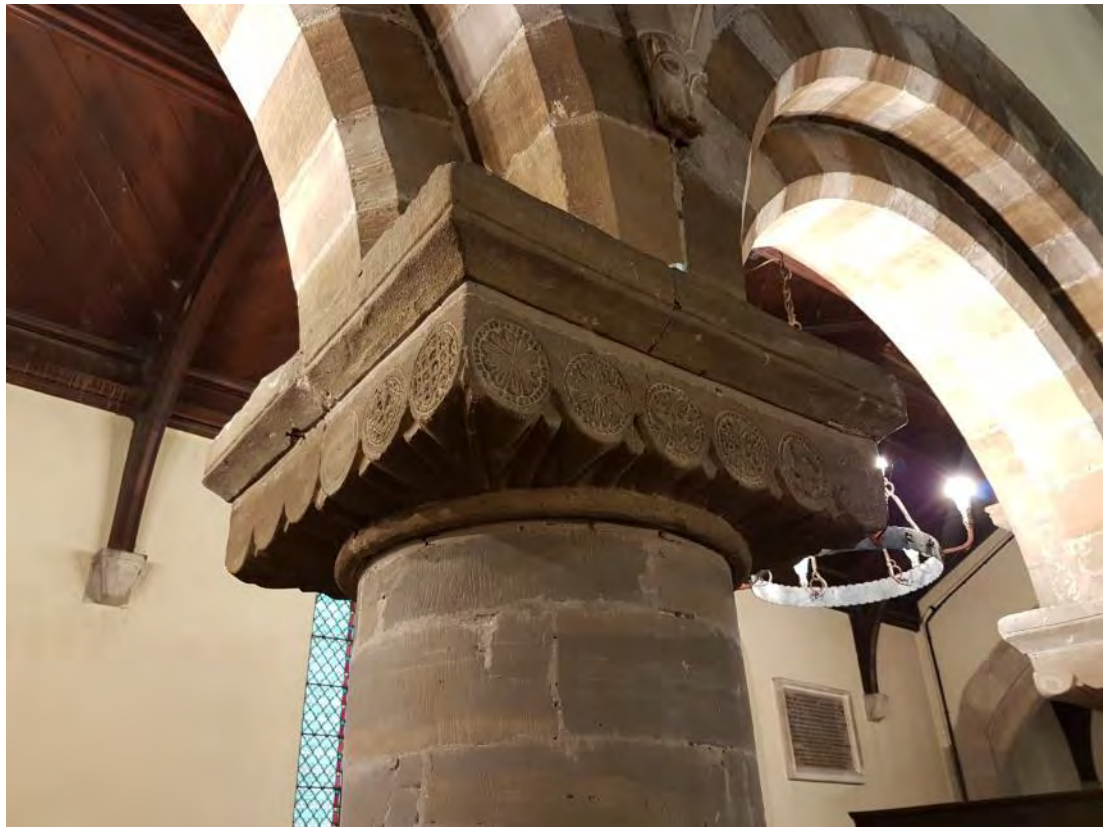
Figure 23: The capital of the western pillar of the central bay of the northern arcade, showing scalloped trumpets with incomplete floral medallions (Source: Author 2019).

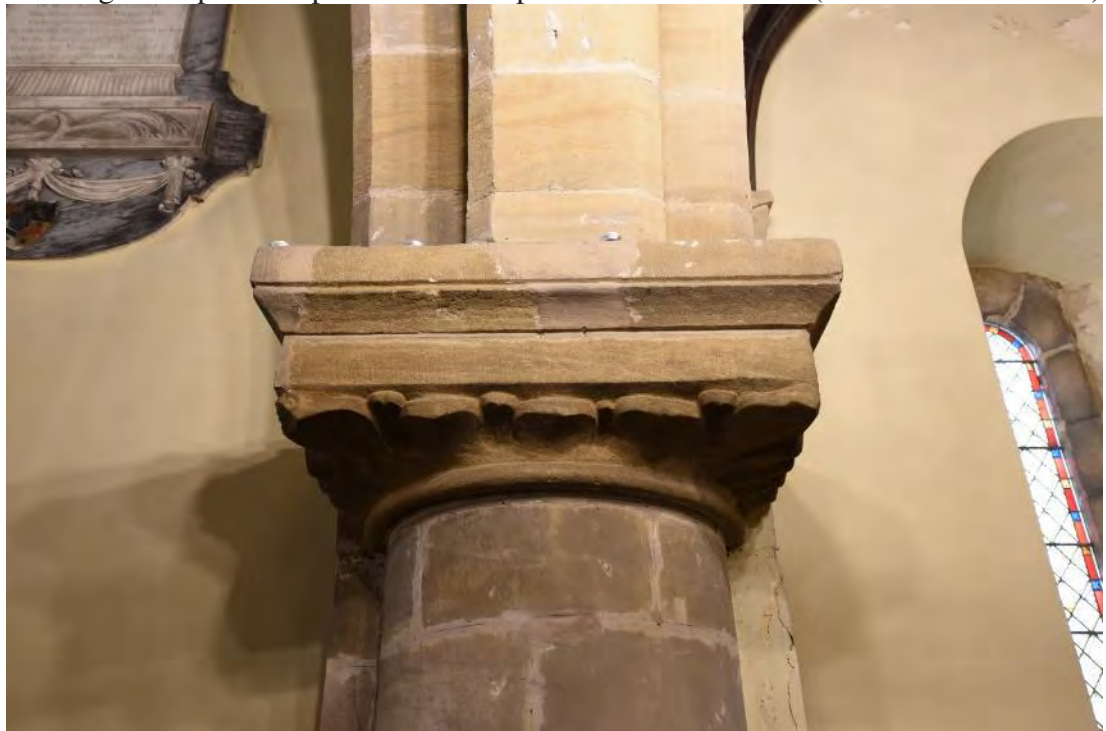
Figure 24: The capital of the western pillar of the western bay of the north arcade, between the western nave wall and the northern aisle, showing the use of two orders in the one capital: scalloped trumpets on the northern and eastern edges; and, a waterleaf capital on the eastern edge (Source: Author 2019).

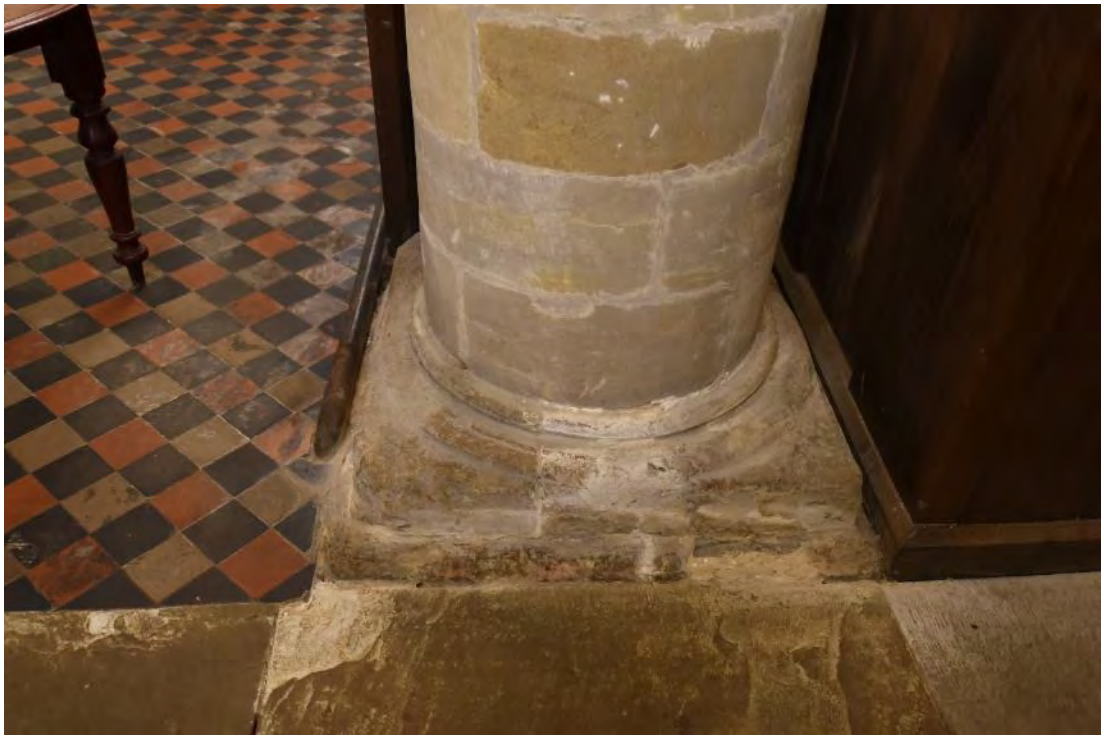
Figure 25: The base of a typical column along the northern arcade, comprising a circular torus on top of a scotia, circular chamfered torus and a square base, on top of a square plinth (Source: Author 2019).

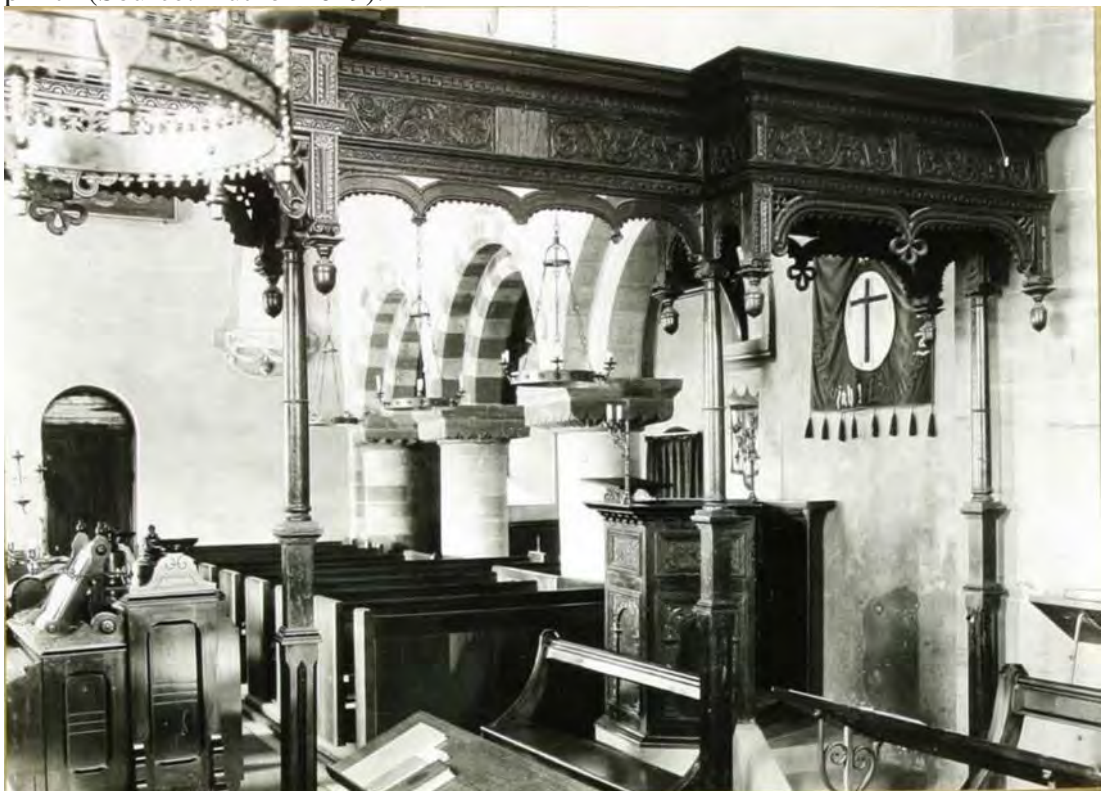
Figure 26: The chancel screen of Stonegrave Minster from the nave, showing the now missing choir stalls in 1949 and the Victorian organ in the foreground (Source: HEA 6433\_080).

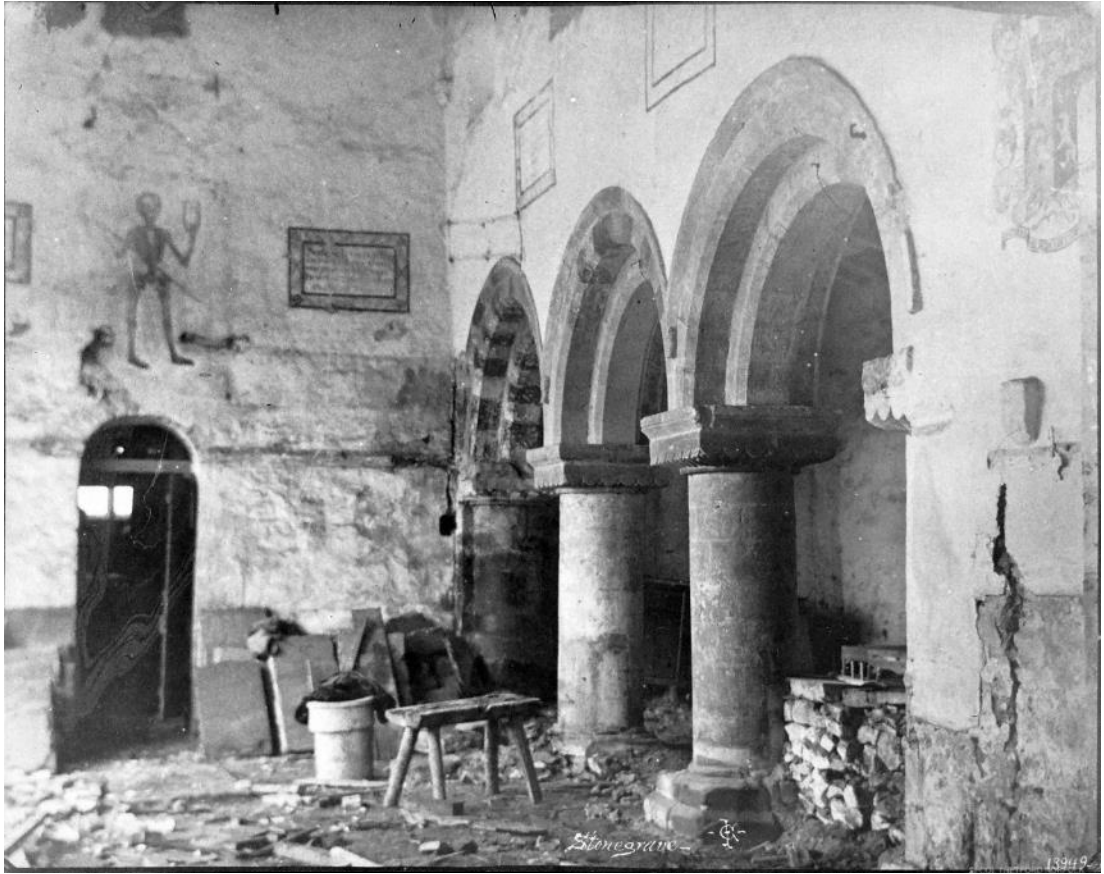
Figure 27: Photograph of the nave, showing the northern arcade and western wall of the nave, as well as the north aisle, taken by George Fowler Jones during the 1862-3 restoration (Source: NSM RPS 18949).

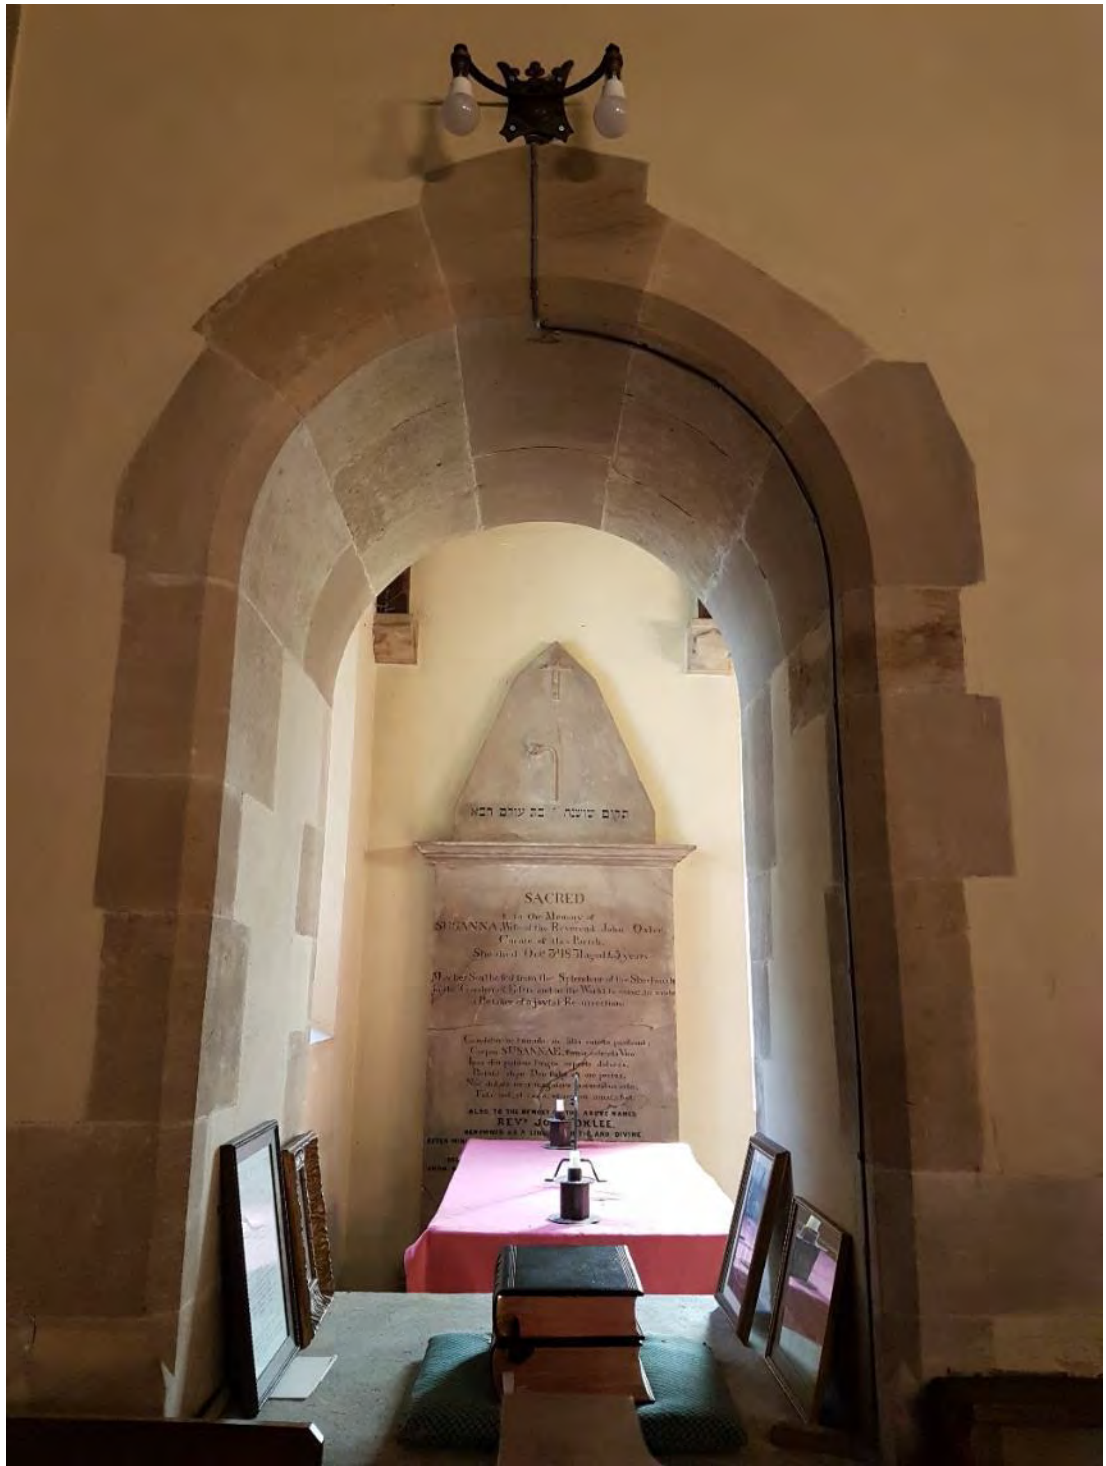
Figure 28: The eastern opening the southern wall of the nave, looking through to the altar in the south aisle, comprising a chamfered round-headed window using smooth-faced stone quoining and a solid stone block sill (Source: Author 2019).

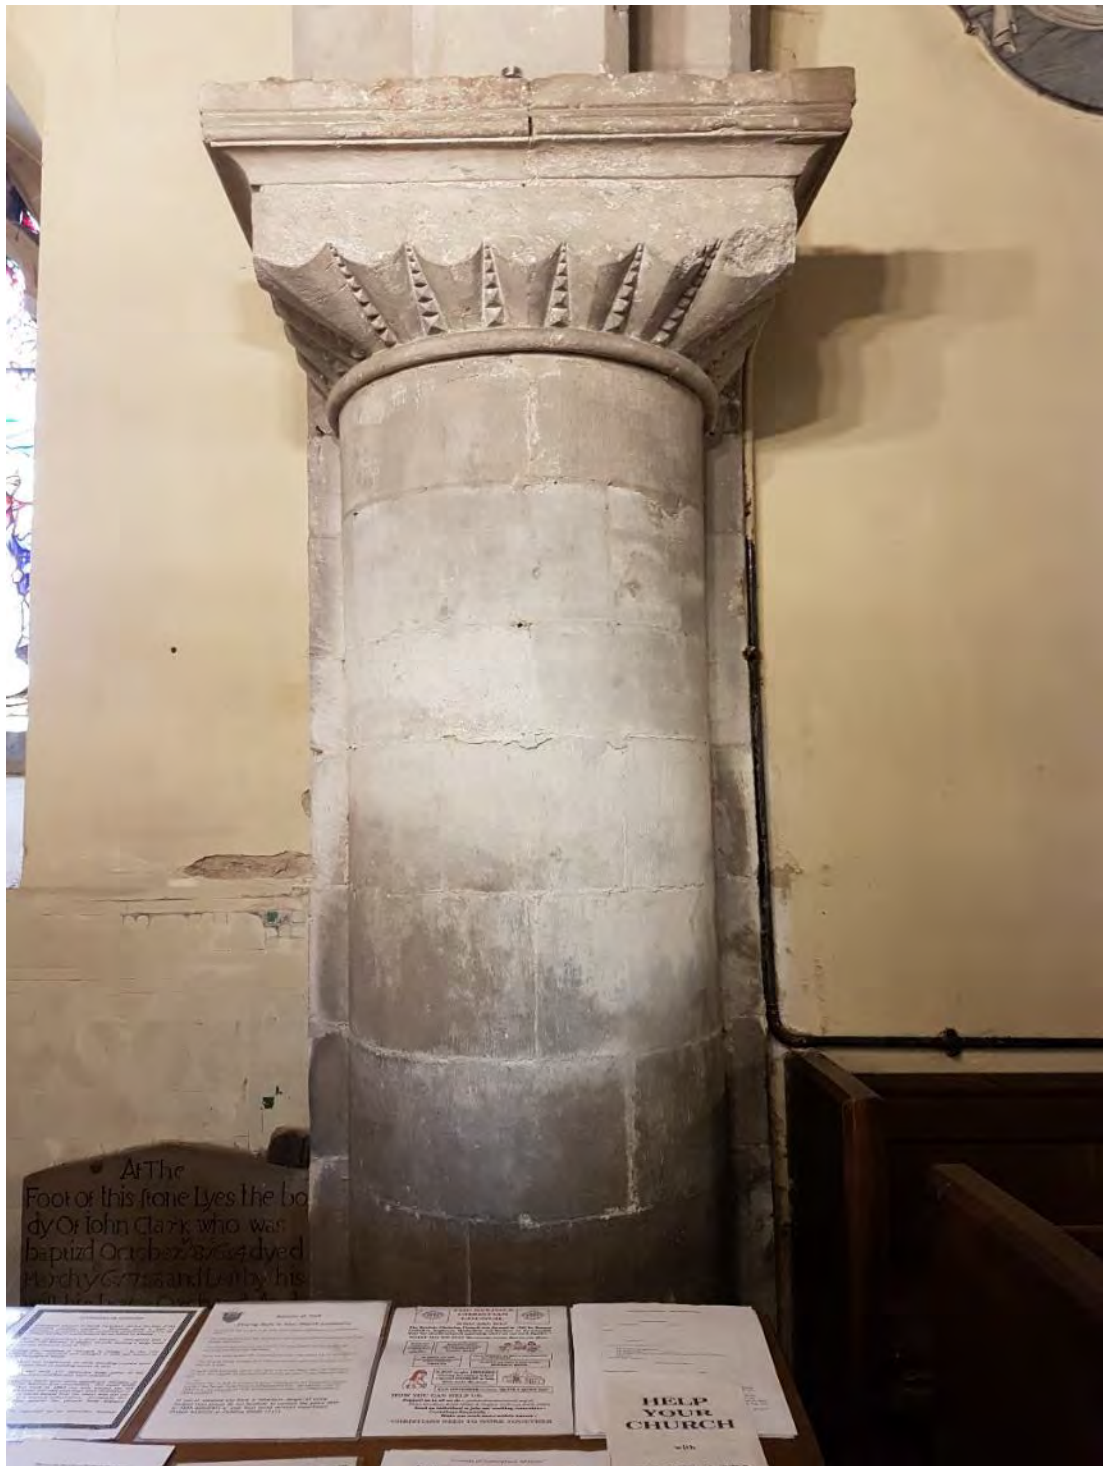
Figure 29: The western column of the western bay of the arcade, showing the scalloped trumpet capital with nailhead decoration between the scallops (Source: Author 2019).

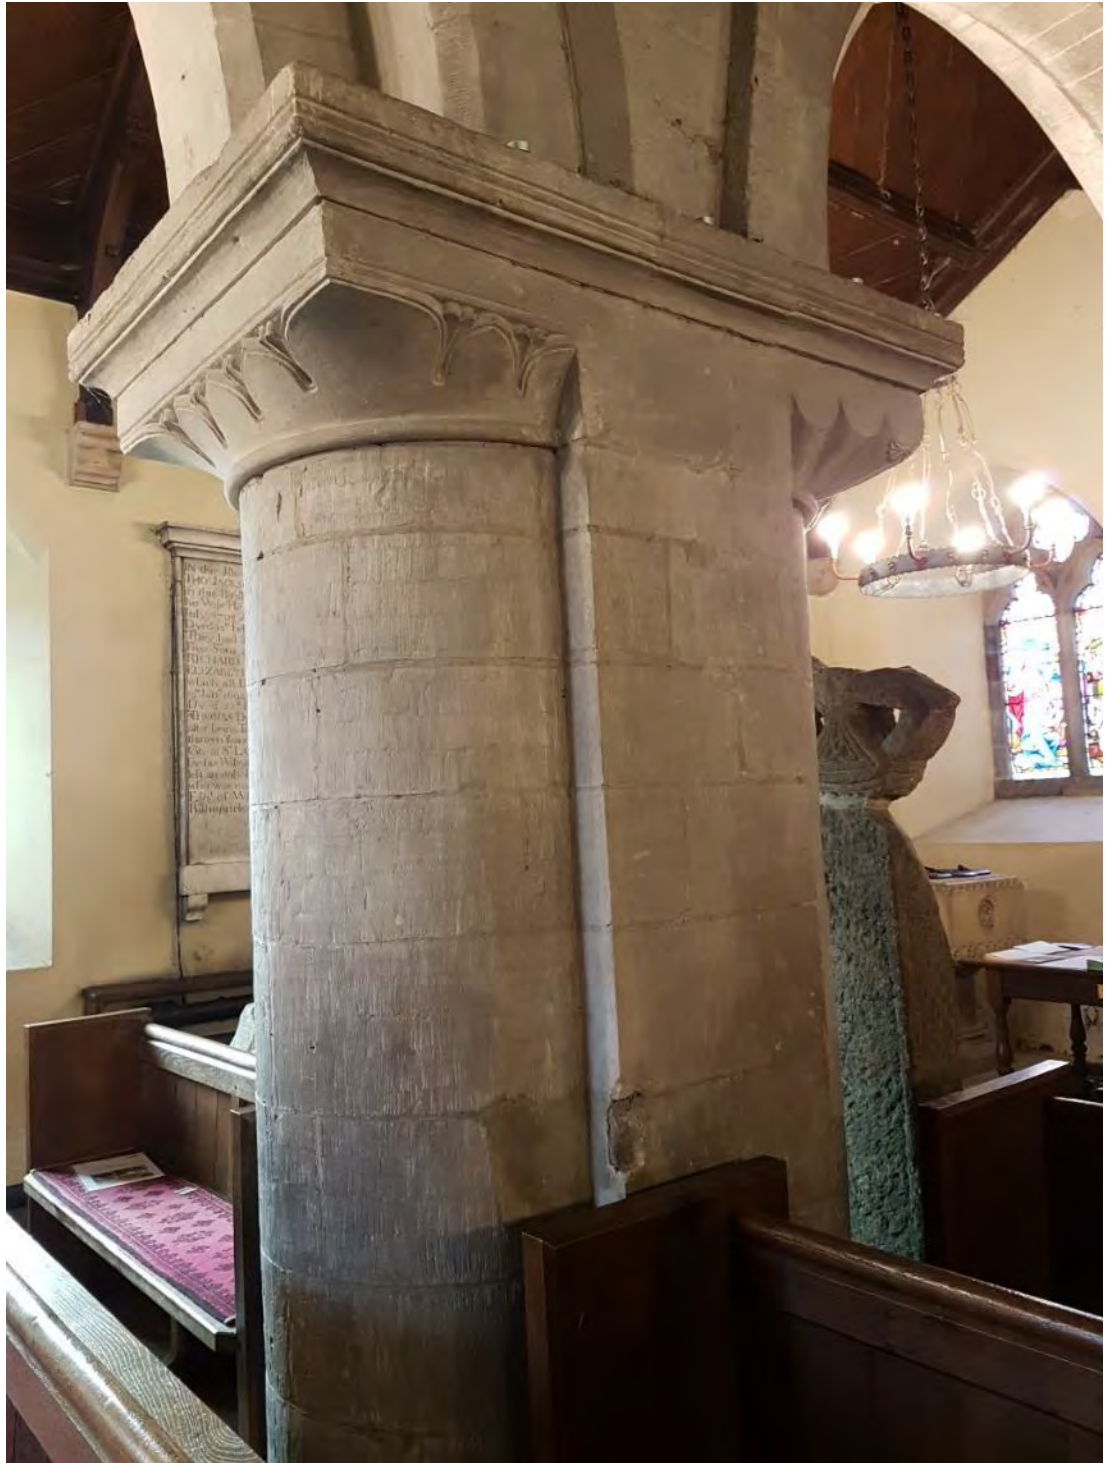
Figure 30: The central pier between the western and eastern bays of the southern arcade, showing the scalloped trumpet capital with nailhead decoration on the western column and waterleaf capitals on the eastern capital (Source: Author 2019).
