# **NOT ALL THOSE WHO WANDER ARE LOST:**

## **Reconstructing the Post-Medieval Phase of Stonegrave Minster using a Buildings Archaeology Approach**

**MA in the Archaeology of Buildings**

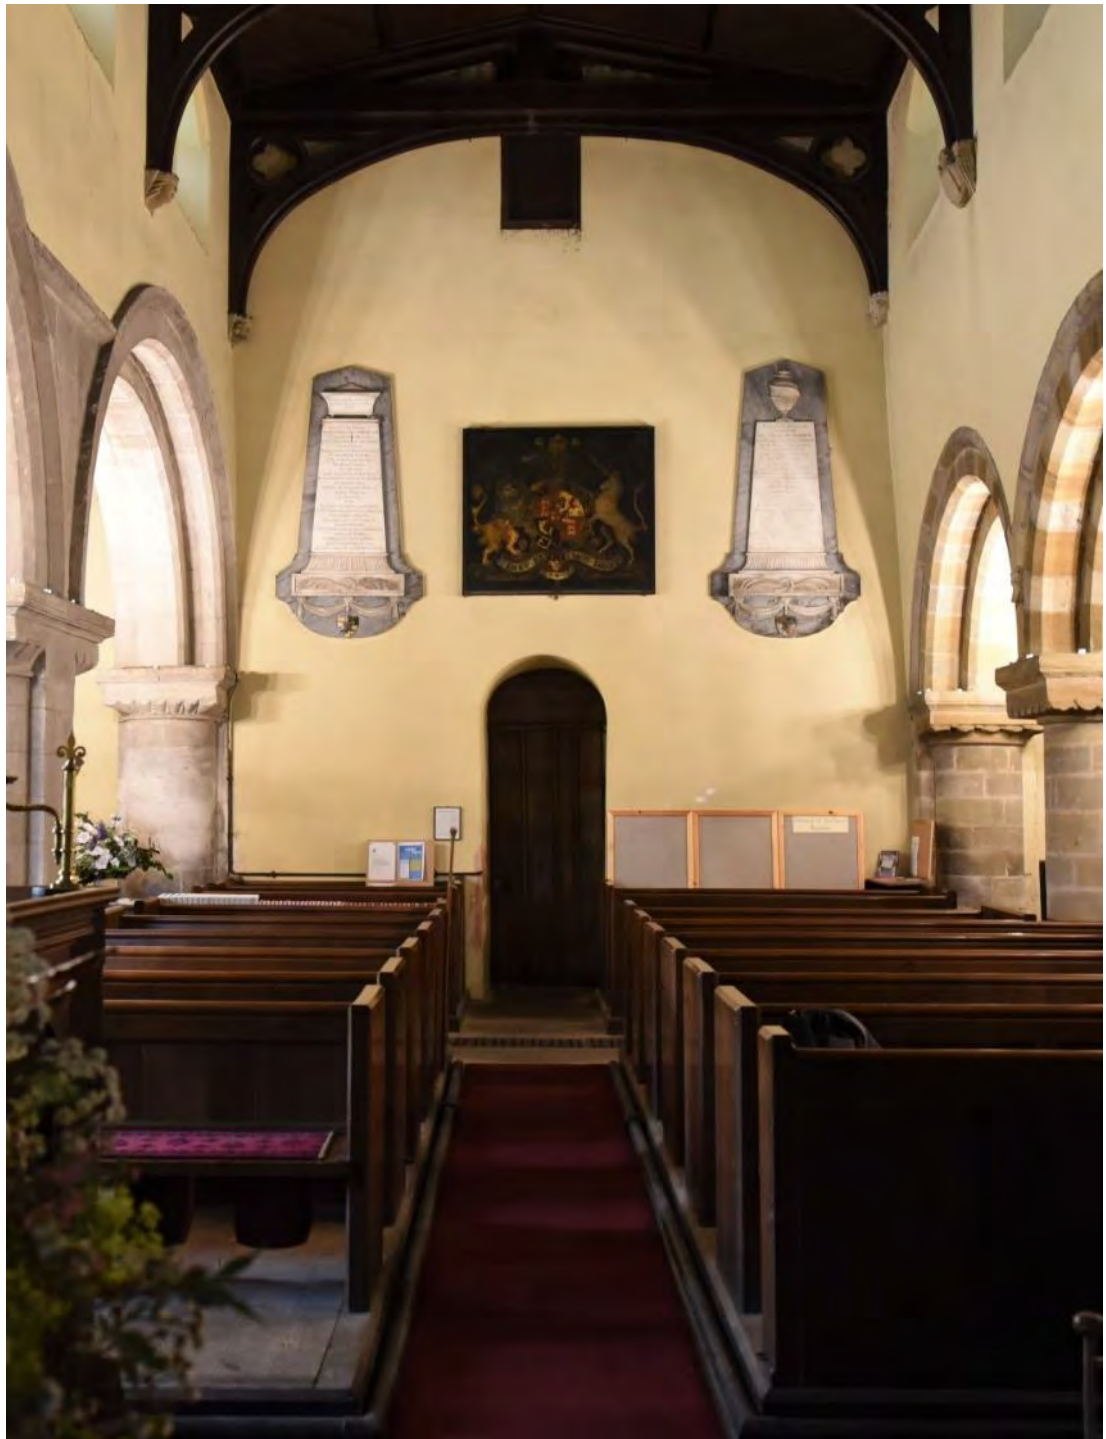
Figure 36: The eastern wall of the tower (the western wall of the nave) from the eastern end of the nave (Source: Author 2019).

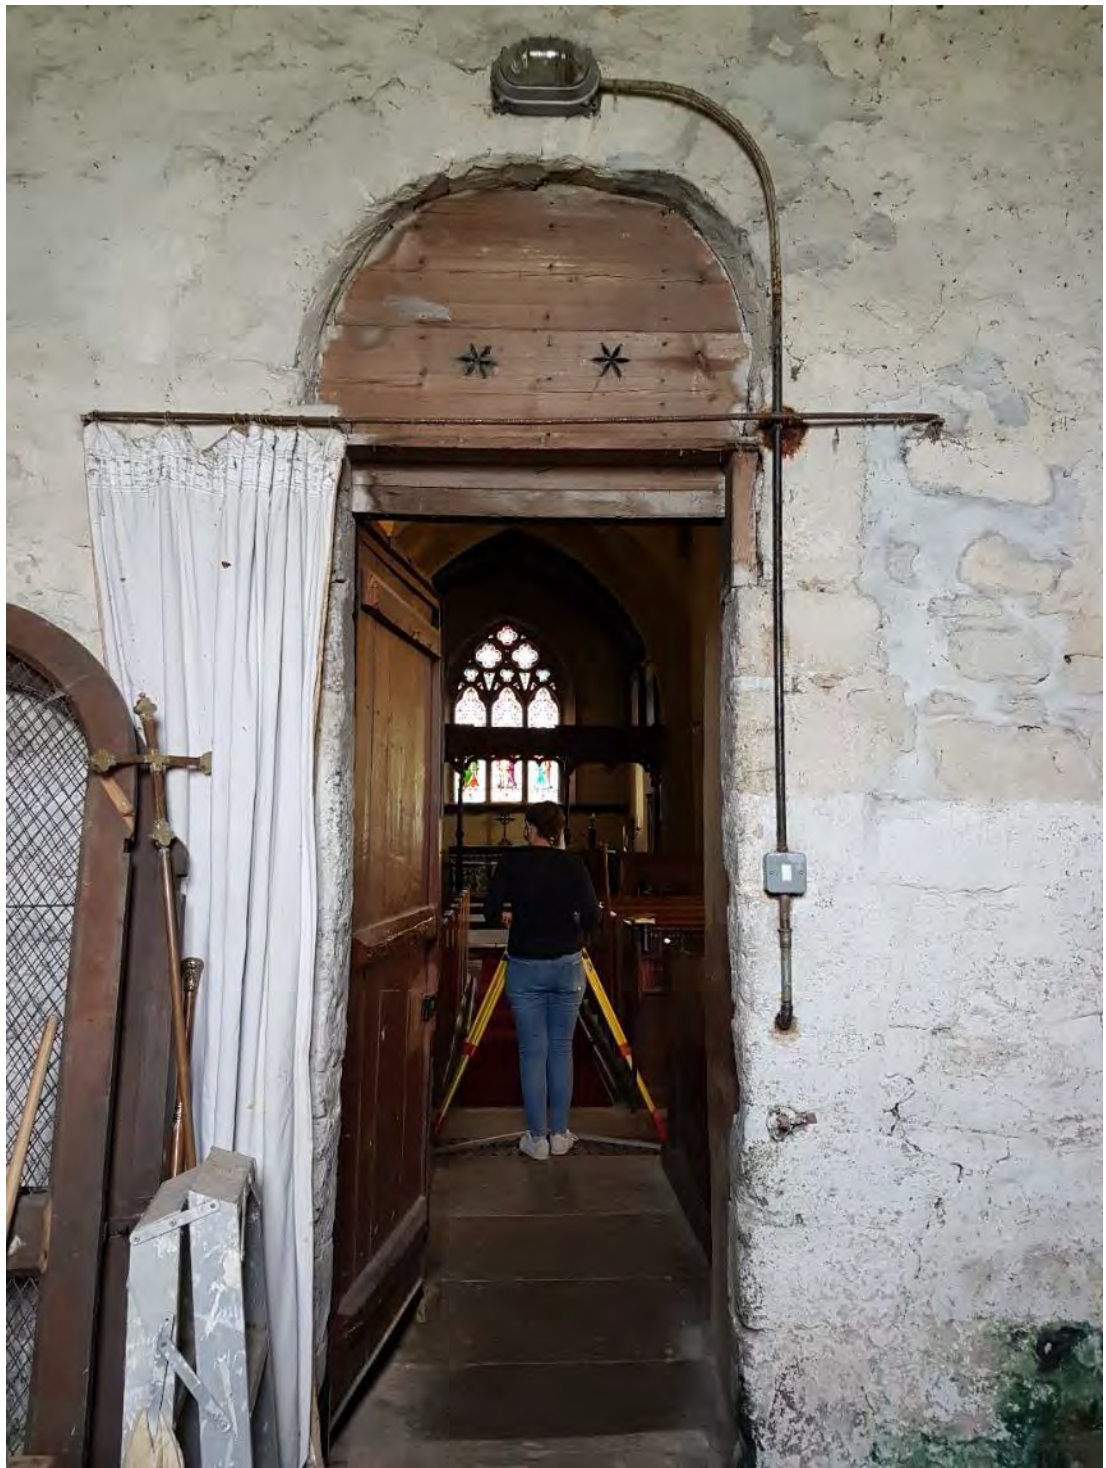
Figure 37: The western side of the Saxo-Norman door from inside the tower, looking east (Source: Author 2019).

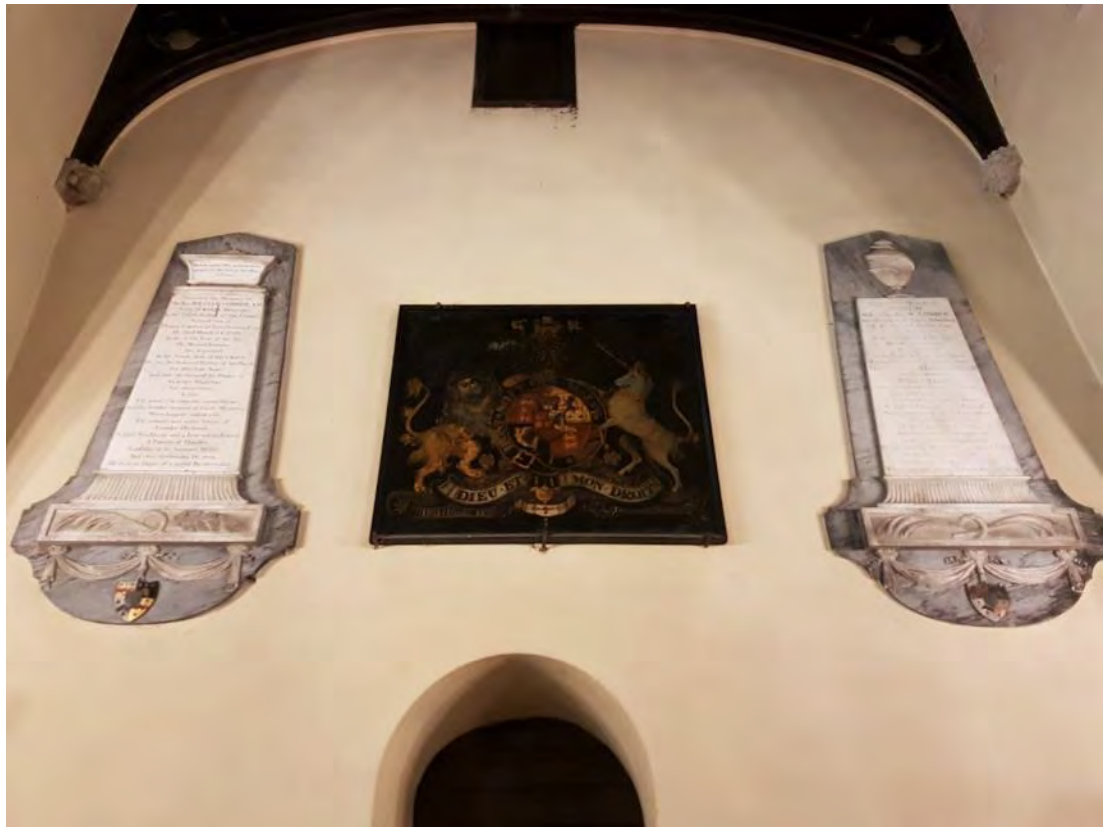
Figure 38: The western wall of the nave and eastern side of the eastern wall of the tower, showing the top of the arched doorway, the two early C19 mural tablets flanking the coat of arms, the reused C15 corbels and the western side of the upper door in the tower (Source: Author 2019).

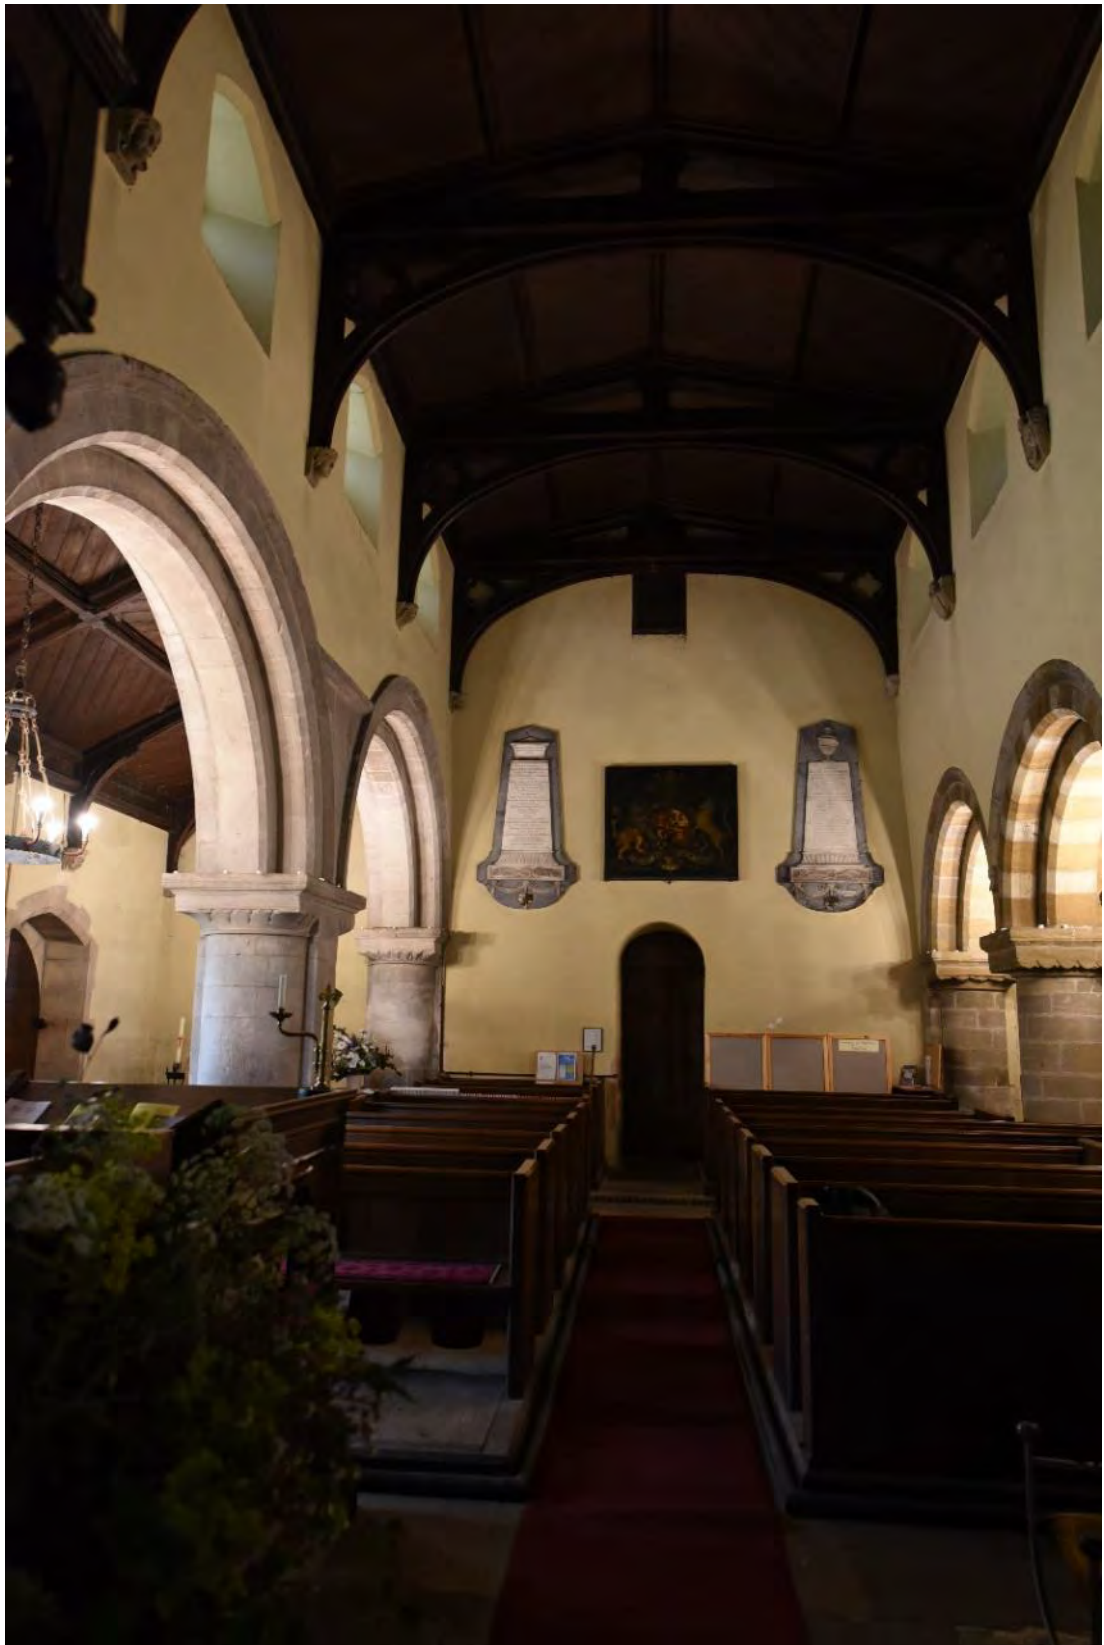
Figure 39: The roof of the nave, showing timber beams resting on corbels, supporting a timber-boarded low-pitched ceiling (Source: Author 2019).

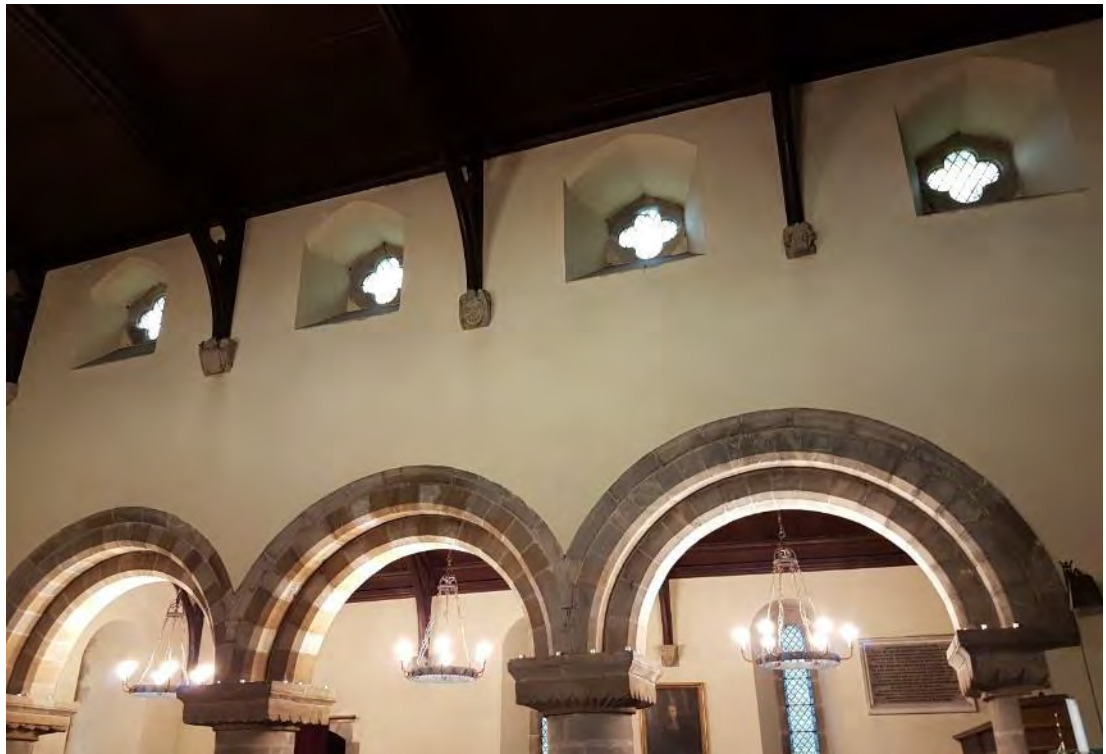
Figure 40: The C15 corbels along the north wall of the clerestory, decorated with family crests and human heads. The corbels are interspersed between clerestory windows of quatrefoil tracery set inside a chamfered segmental pointed arched surround and chamfered sill (Source: Author 2019).

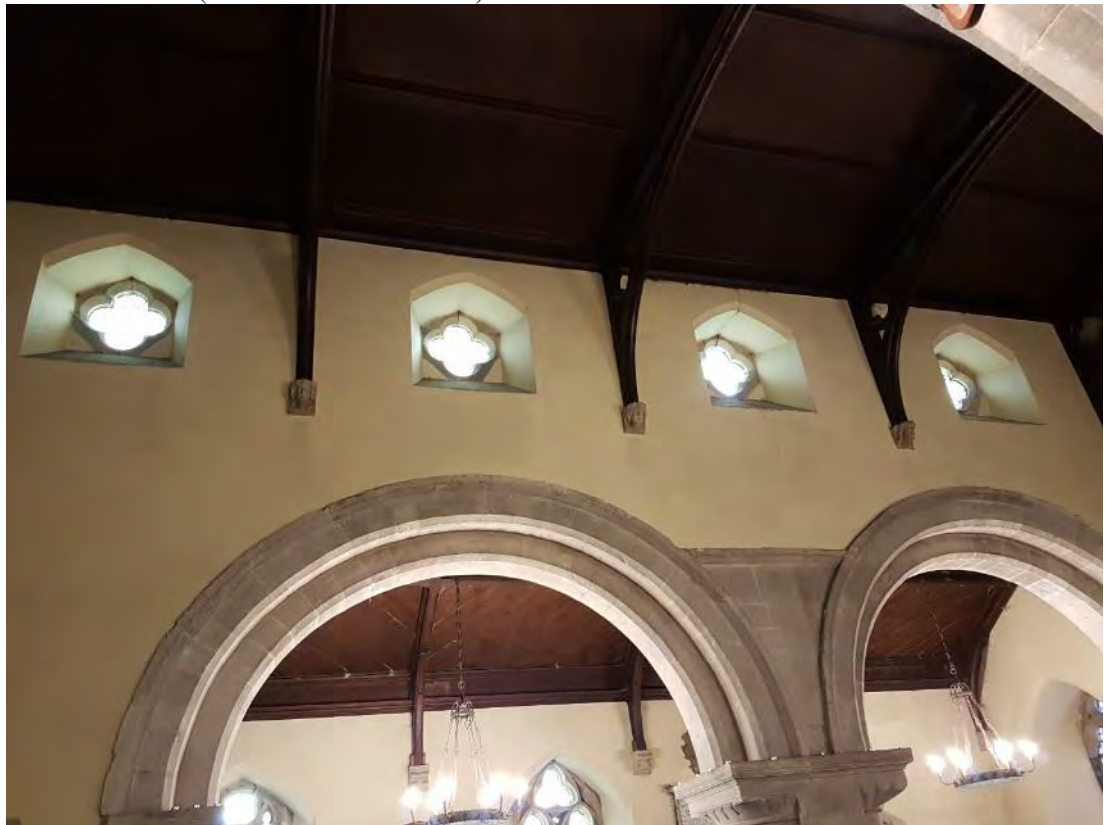
Figure 41: The C15 corbels along the south clerestory wall clerestory windows, displaying human heads, interspersed between windows of quatrefoil tracery set inside a chamfered segmental pointed arched surround and chamfered sill (Source: Author 2019).

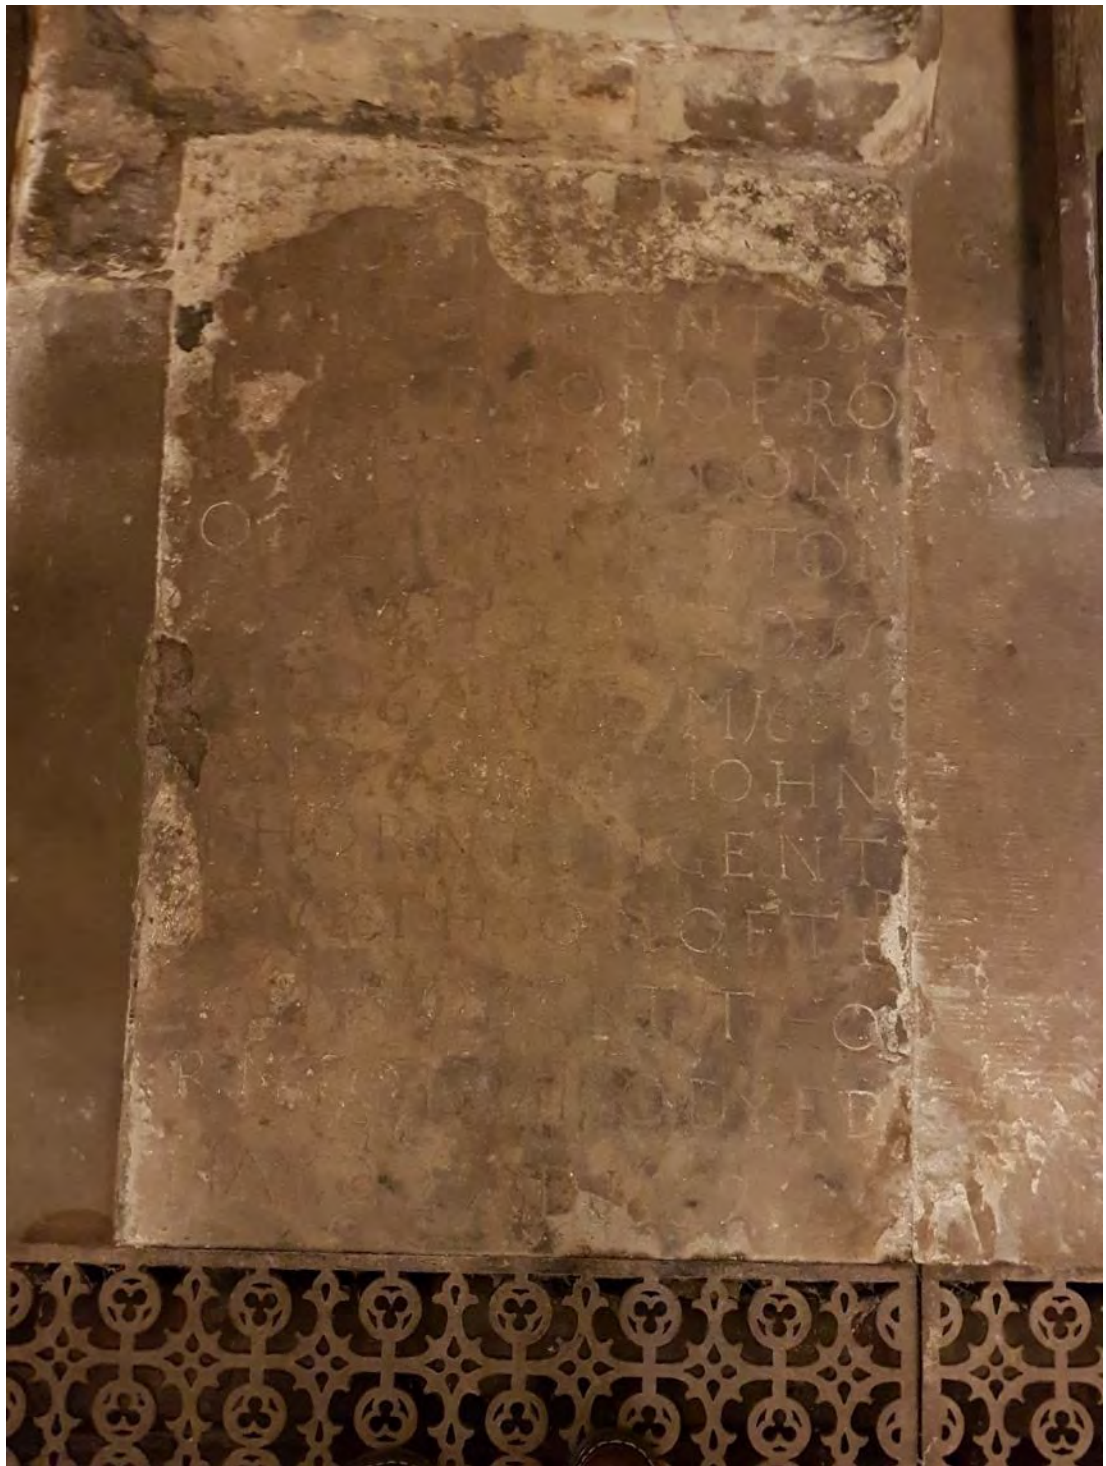
Figure 42: A late seventeenth-century gravestone to a member of the Thornton family, reused as a floor slab of the nave, located immediately east of the western column of the western bay of the northern arcade (Source: Author 2019).

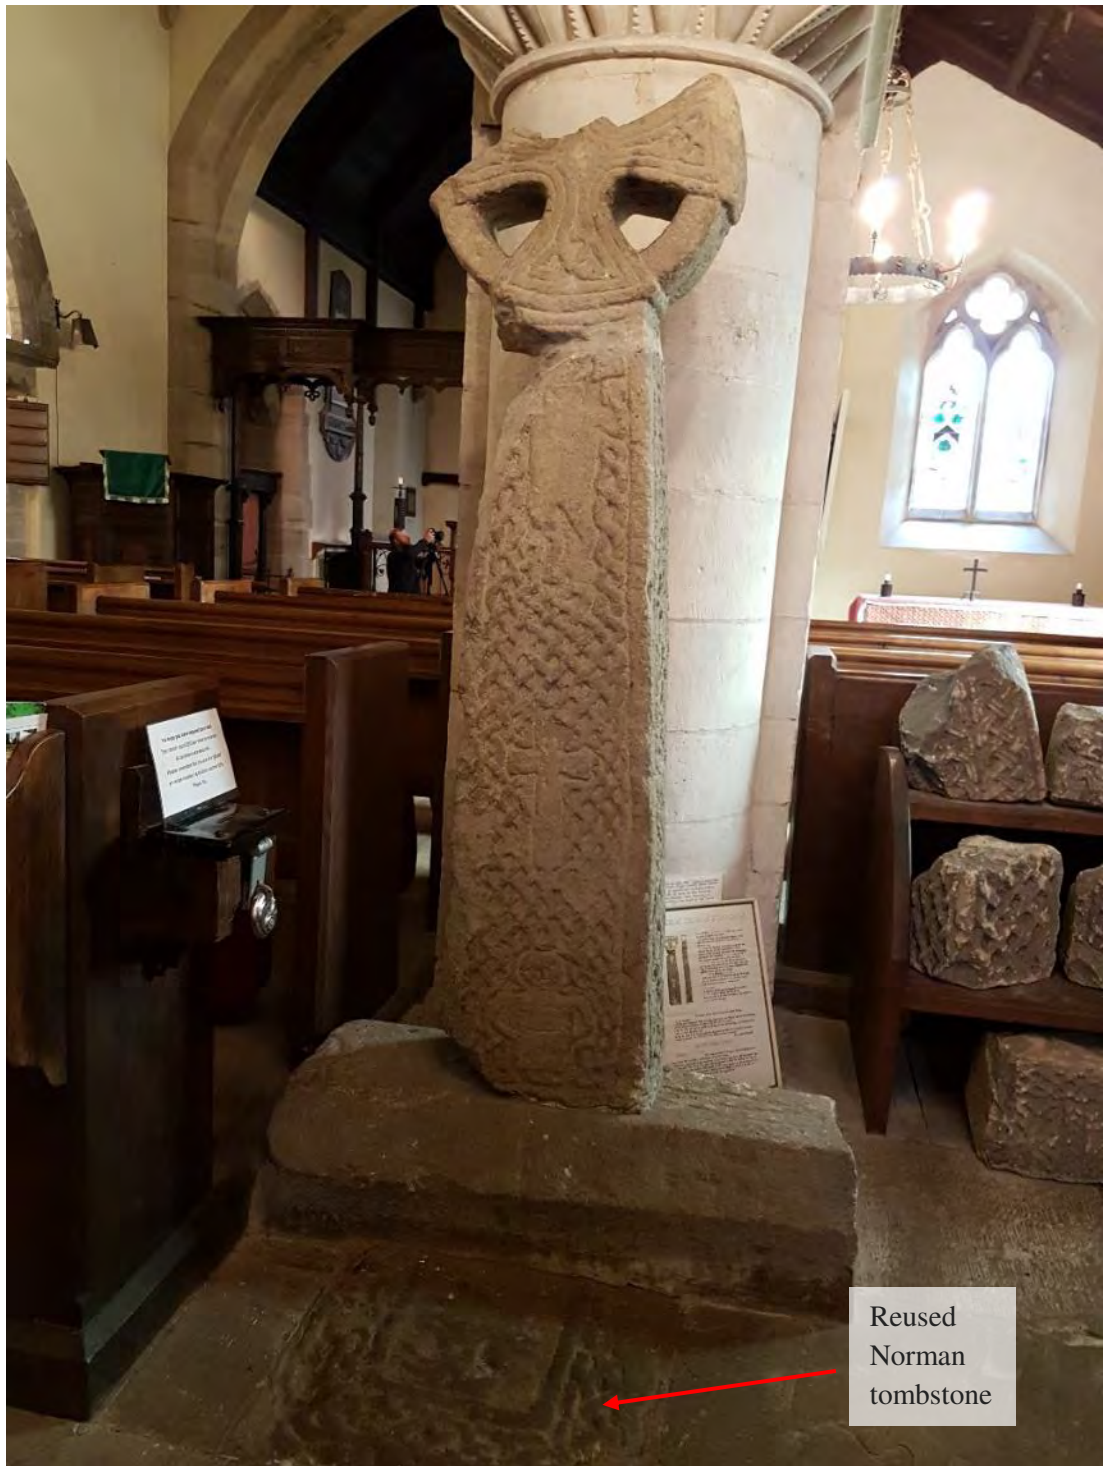
Figure 43: A Norman tombstone reused in the flooring of the south arcade, within the western bay (Source: Author 2019).

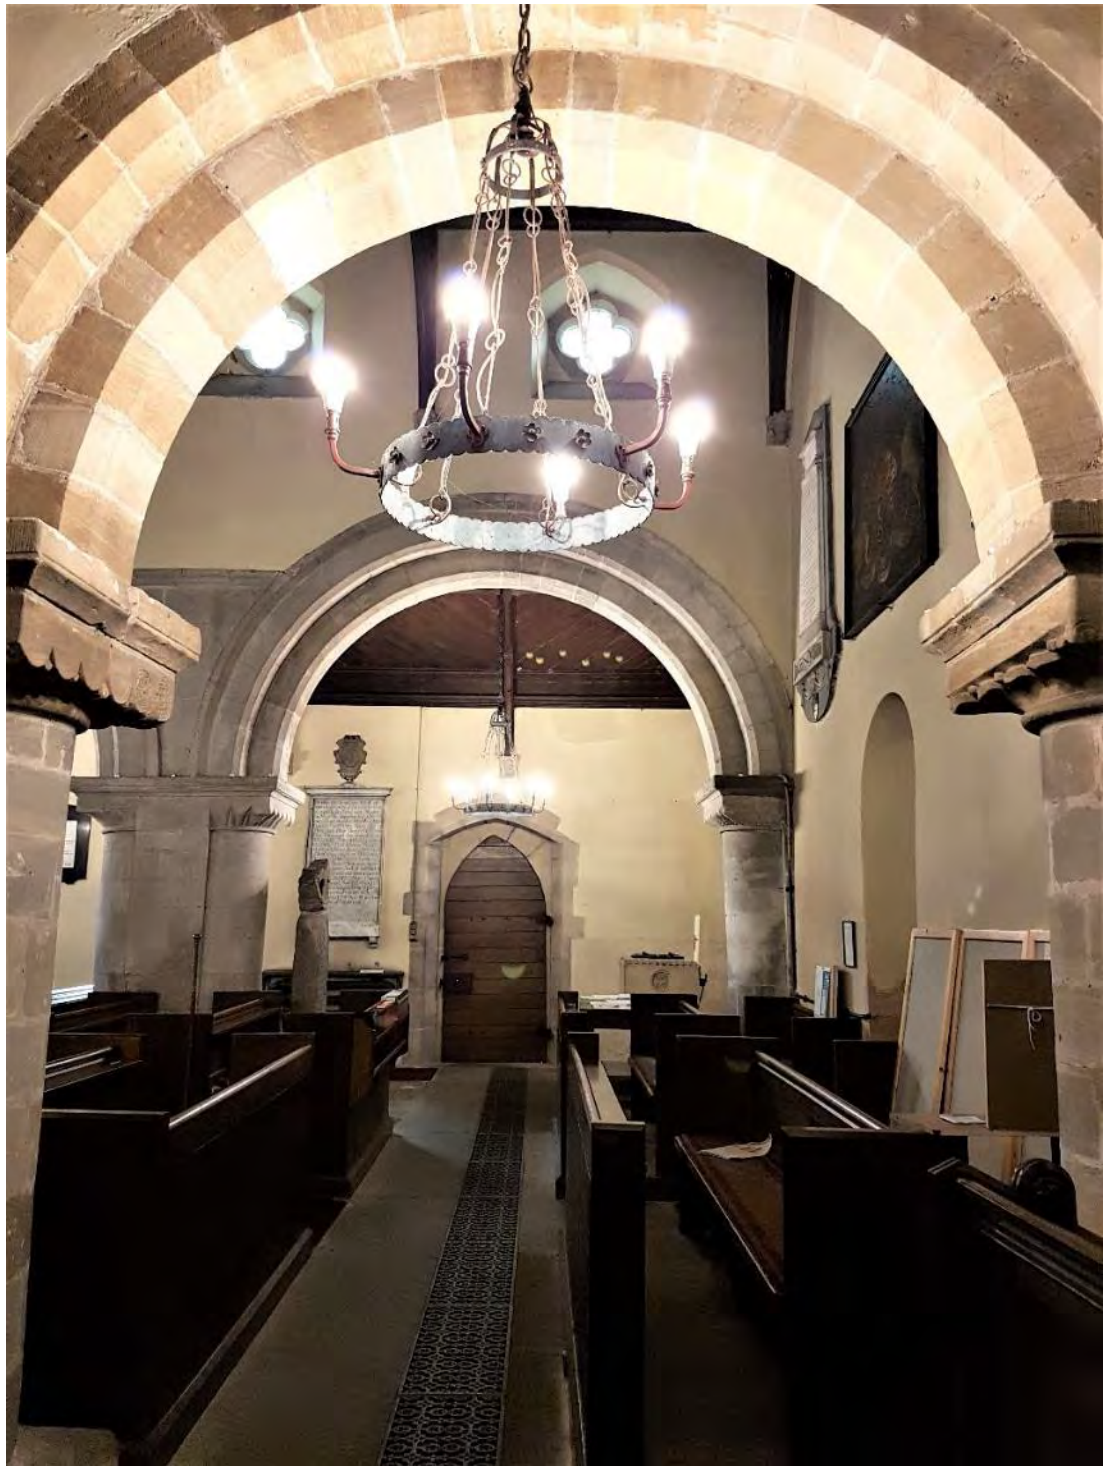
Figure 44: The line of the underfloor heating and ventilation surrounded by 1862-3 floor slabs, taken from the north (Source: Author 2019).

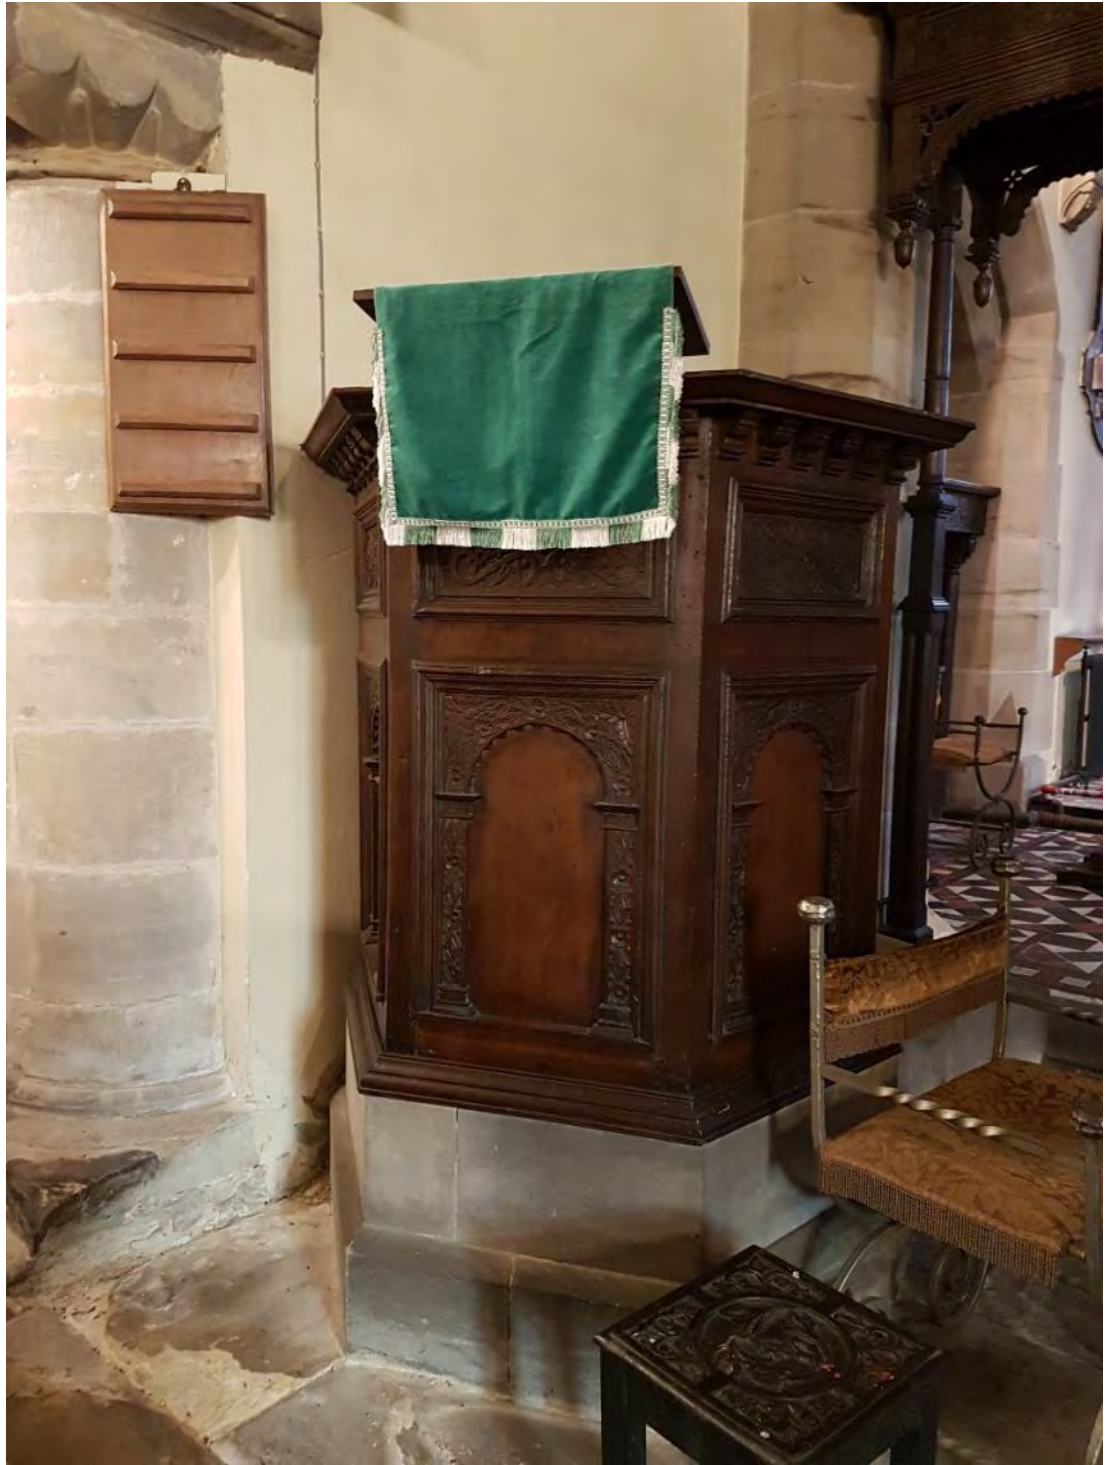
Figure 45: The pulpit at the north-eastern corner of the nave, showing the seventeenth-century pulpit to have been reused, set onto a 1862-3 sandstone base, taken from the south-west (Source: Author 2019).

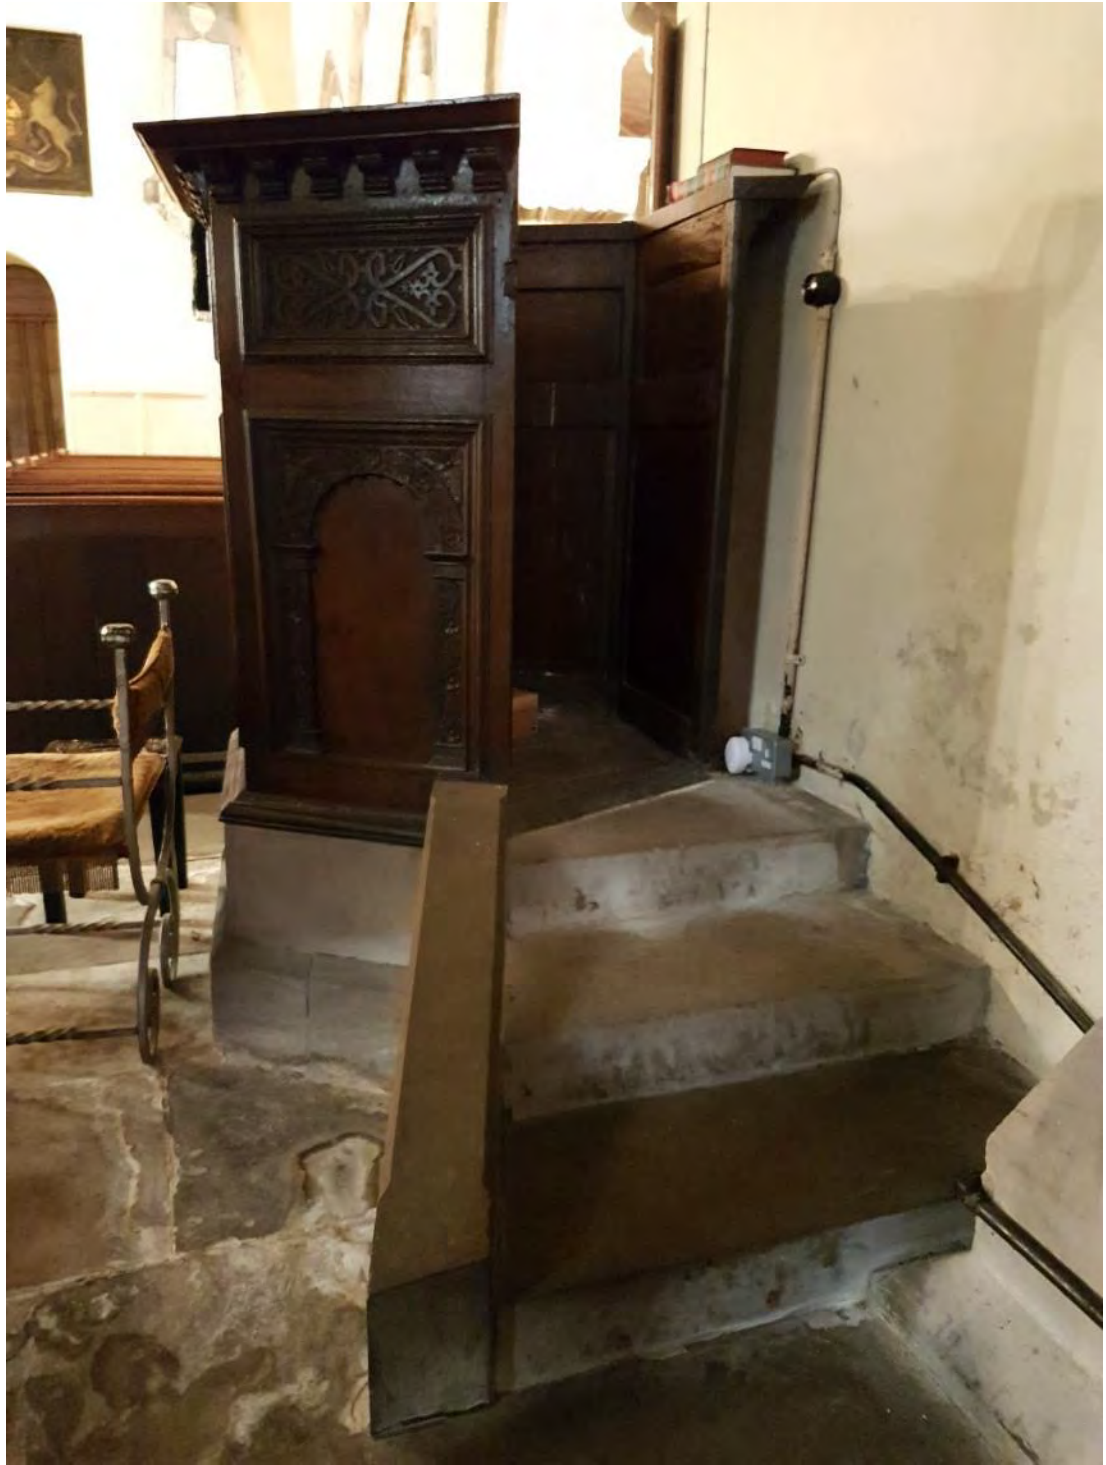
Figure 46: The pulpit at the north-eastern corner of the nave, showing the seventeenth-century pulpit to have been reused, set onto a 1862-3 sandstone base, taken from the east (Source: Author 2019).

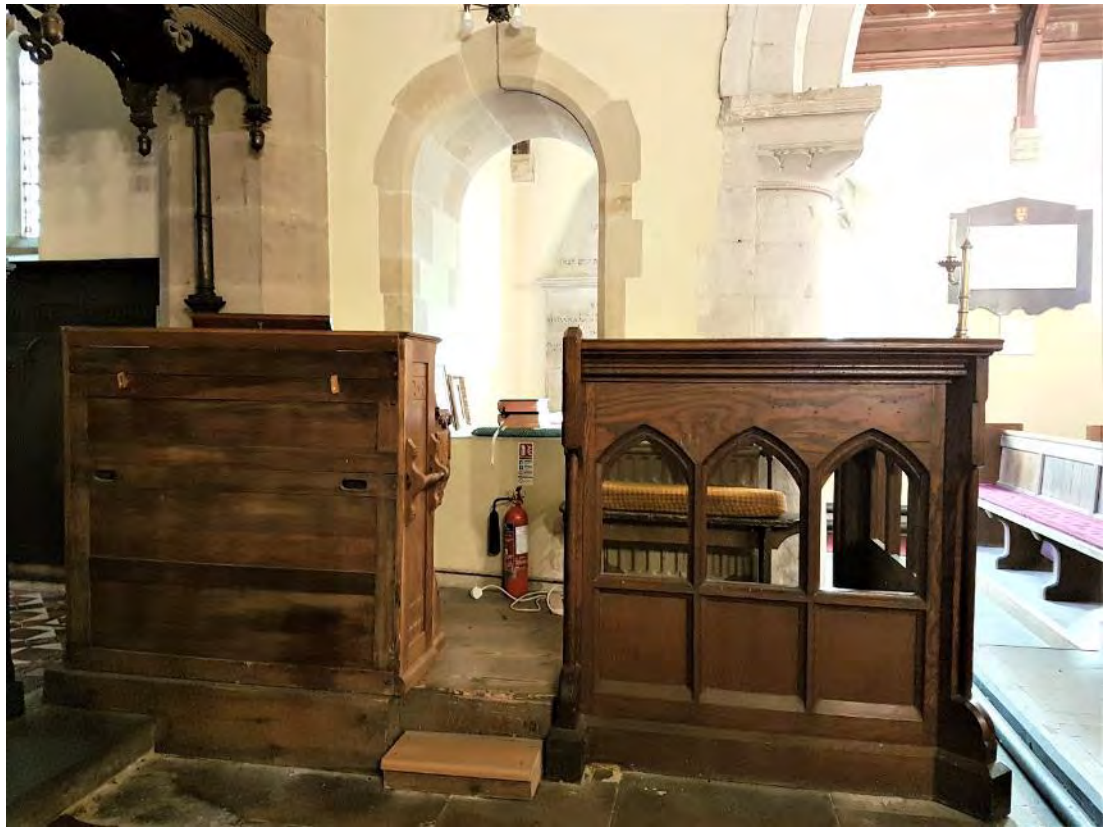
Figure 47: The Victorian organ, installed in 1885 (NYC PR/STV 3), and a timber screen with segmental pointed arches and seats on a raised timber threshold (Source: Author 2019).

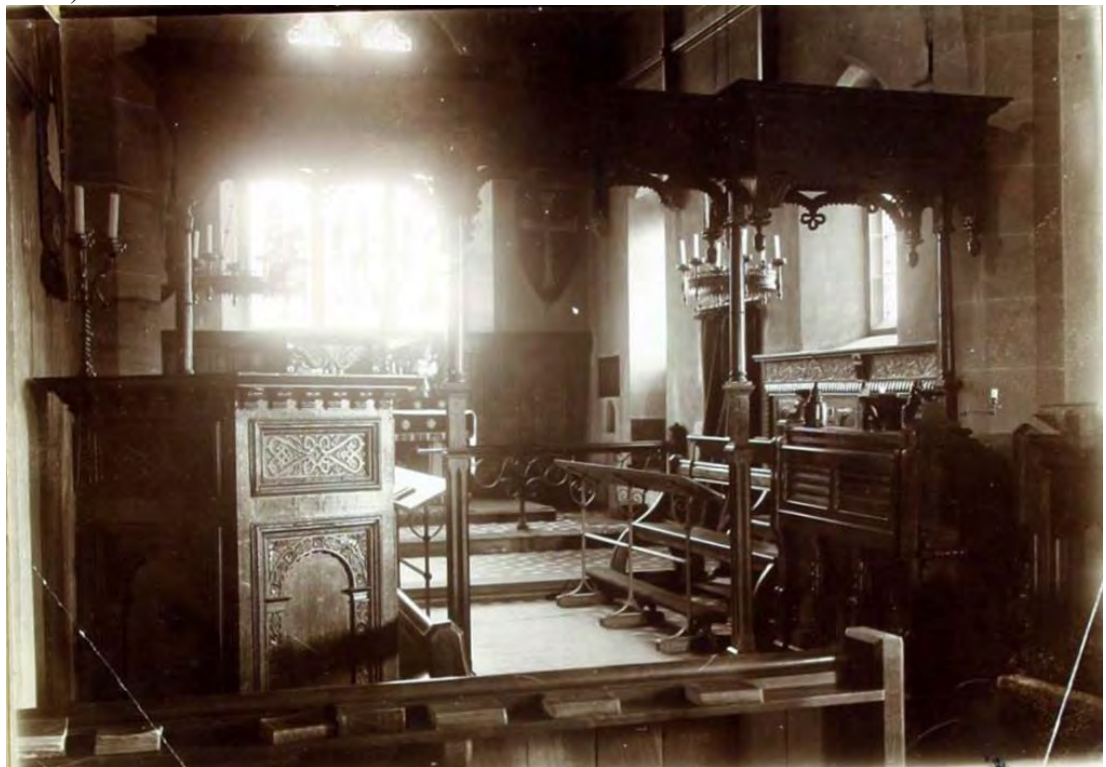
Figure 48: The chancel of Stonegrave Minster from the nave, showing the extant chancel screen, pulpit, reading desk, rails, altar, a now missing hanging curtain, as well as the now missing choir stalls, c. 1914 (Source: HEA 6433\_087).

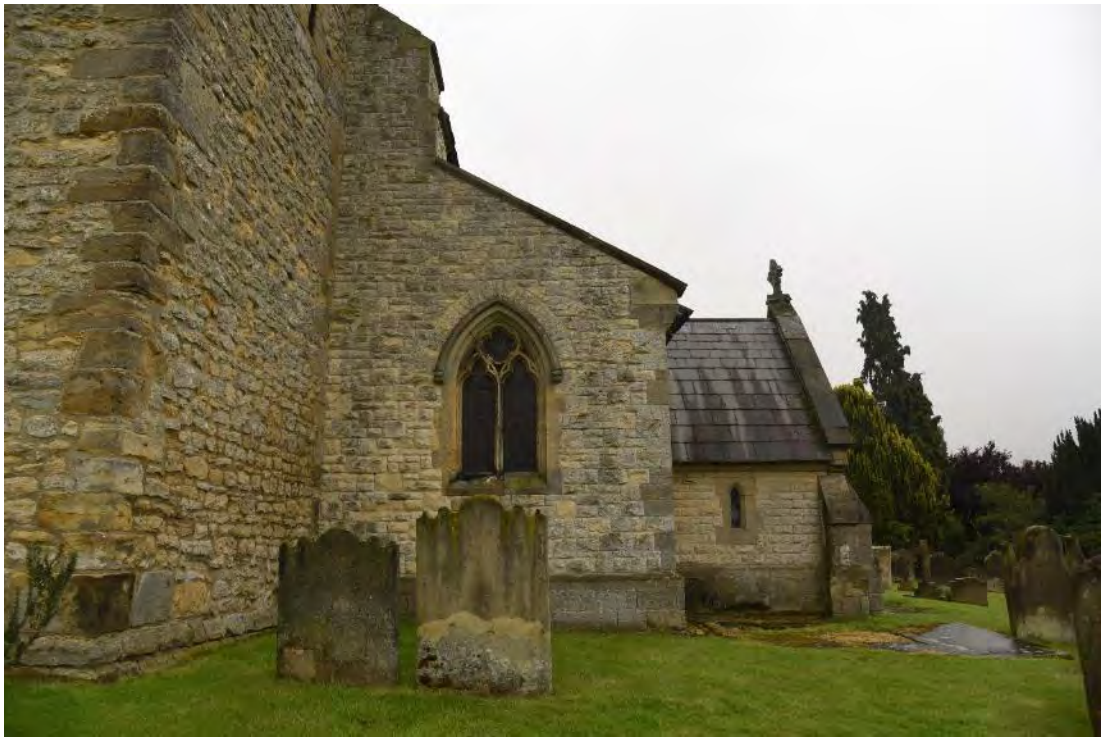
Figure 50: The western elevation of the southern aisle, showing a Victorian Middle Decorated Gothic pointed window, comprising a two-light window with trefoil heads and a central quatrefoil above. The window has an alternating straight and hollow-chamfered surround comprised of stone quoining, with a chamfered sandstone sill. The rounded hood-moulds terminate in moulded label stops (Source: Author 2019).

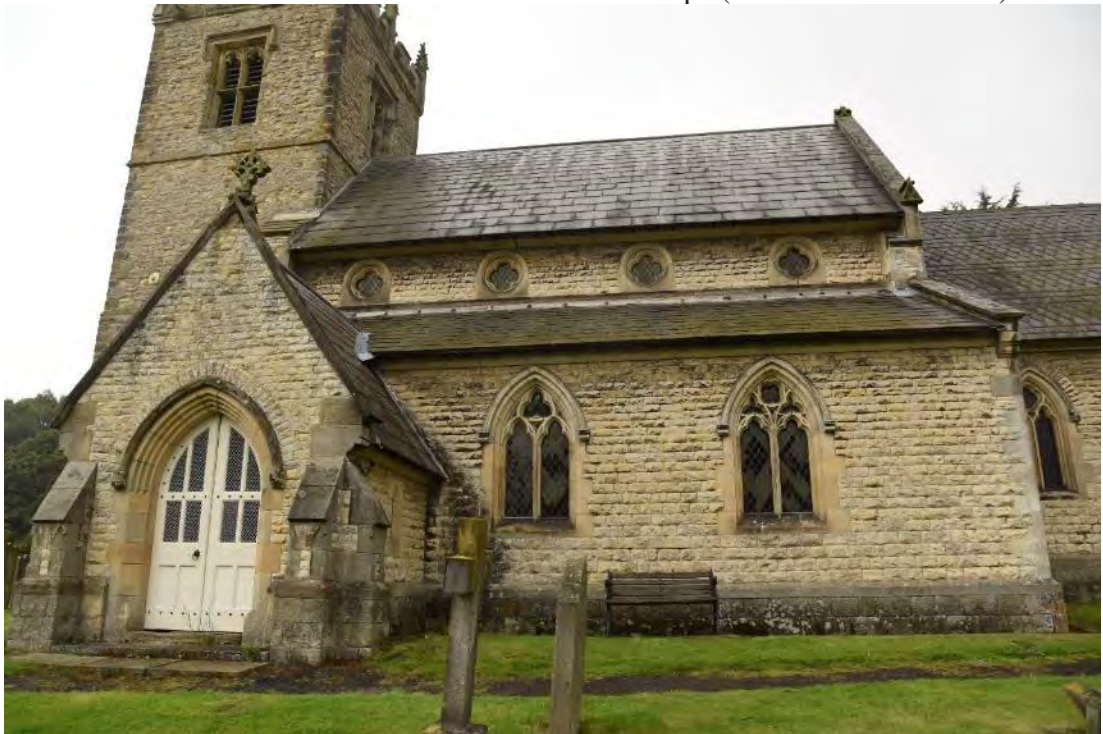
Figure 51: The southern elevation of the southern aisle, showing a porch in the western bay and Victorian Middle Decorated Gothic pointed windows in the eastern two bays. Both windows comprise two-light windows with trefoil heads and alternating trefoil and quatrefoil geometrical tracery (Source: Author 2019).

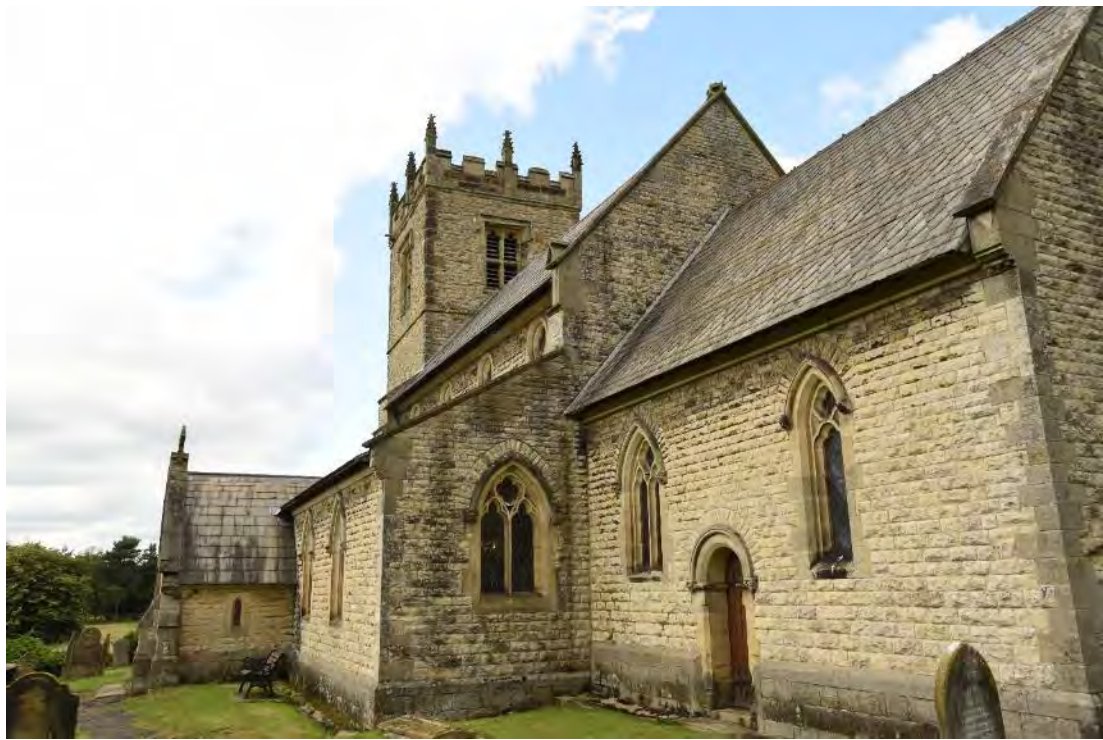
Figure 52: The eastern elevation of the southern aisle, showing a two-light Victorian Middle Decorated Gothic pointed arch window with trefoil heads and quatrefoil geometrical tracery (Source: Author 2019).

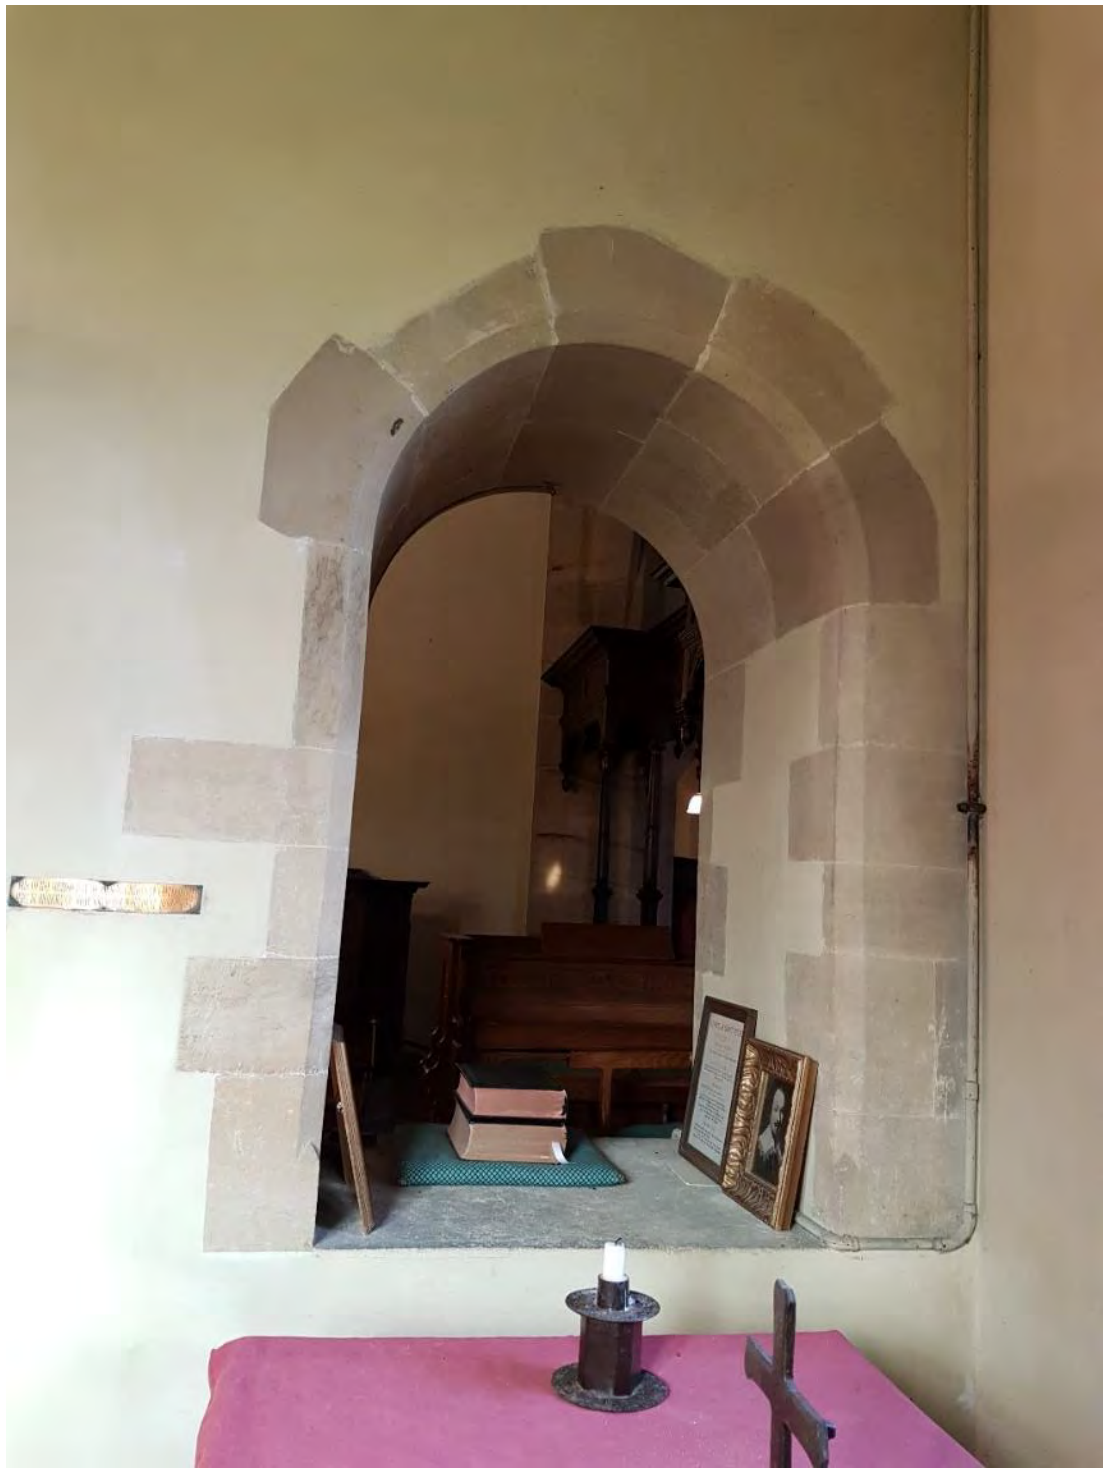
Figure 53: The three bays of the northern side of the south aisle, showing the two arcades and the opening in the eastern chapel, with the north aisle in the background (Source: Author 2019).

Internally, the northern extent of the south aisle is delineated by the twelfth-century Norman arcade in the western and central bays and the 1862-3 round-headed opening in the western bay (Figure 53, Figure 54 and Figure 55). The southern front door in the western bay comprises a pointed Victorian arch (Figure 56). The western bay, used as a baptistry, contains a Victorian limestone 'square cut font' and is lined with painted 1885 geometric tiles (Figure 55 and Figure 57; *The York Herald* 1863, 7; NYC PR/STV 3, 182). Behind the font is a plain eighteenth-century tombstone for John Clark (Figure 58). Within the western bay are memorials ranging from a tenth-century Saxon cross to a thirteenth-century 'coffin lid' (Figure 53 and Figure 59; Pevsner 1966, 360; Lang (Ed.) 1991, 215-220). Three eighteenth-century mural tablets line the south wall (Figure 56, Figure 60 and Figure 61; BIA Fac. 1861/2). The eastern end of the aisle is now a chapel, reusing the seventeenth-century oak altar from the chancel (Figure 61; BIA Fac. 1960/2/11).
