# **NOT ALL THOSE WHO WANDER ARE LOST:**

## **Reconstructing the Post-Medieval Phase of Stonegrave Minster using a Buildings Archaeology Approach**

**MA in the Archaeology of Buildings**

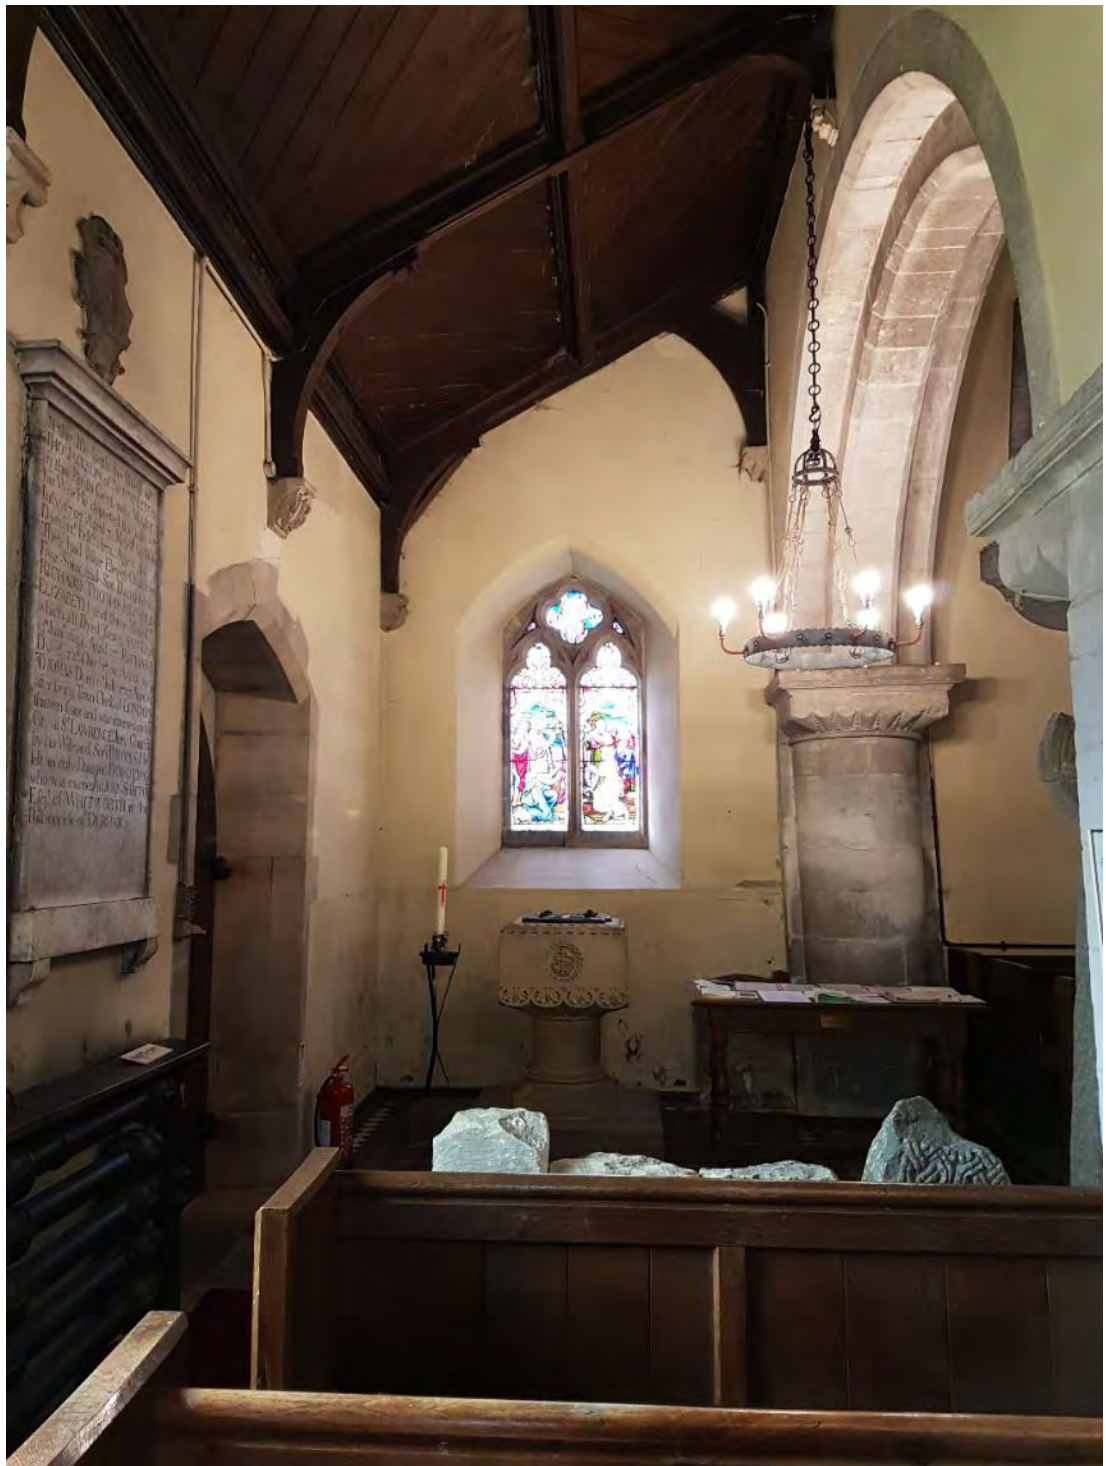
Figure 54: The opening in the eastern chapel, with the nave in the background (Source: Author 2019).

Internally, the northern extent of the south aisle is delineated by the twelfth-century Norman arcade in the western and central bays and the 1862-3 round-headed opening in the western bay (Figure 53, Figure 54 and Figure 55). The southern front door in the western bay comprises a pointed Victorian arch (Figure 56). The western bay, used as a baptistry, contains a Victorian limestone 'square cut font' and is lined with painted 1885 geometric tiles (Figure 55 and Figure 57; *The York Herald* 1863, 7; NYC PR/STV 3, 182). Behind the font is a plain eighteenth-century tombstone for John Clark (Figure 58). Within the western bay are memorials ranging from a tenth-century Saxon cross to a thirteenth-century 'coffin lid' (Figure 53 and Figure 59; Pevsner 1966, 360; Lang (Ed.) 1991, 215-220). Three eighteenth-century mural tablets line the south wall (Figure 56, Figure 60 and Figure 61; BIA Fac. 1861/2). The eastern end of the aisle is now a chapel, reusing the seventeenth-century oak altar from the chancel (Figure 61; BIA Fac. 1960/2/11).

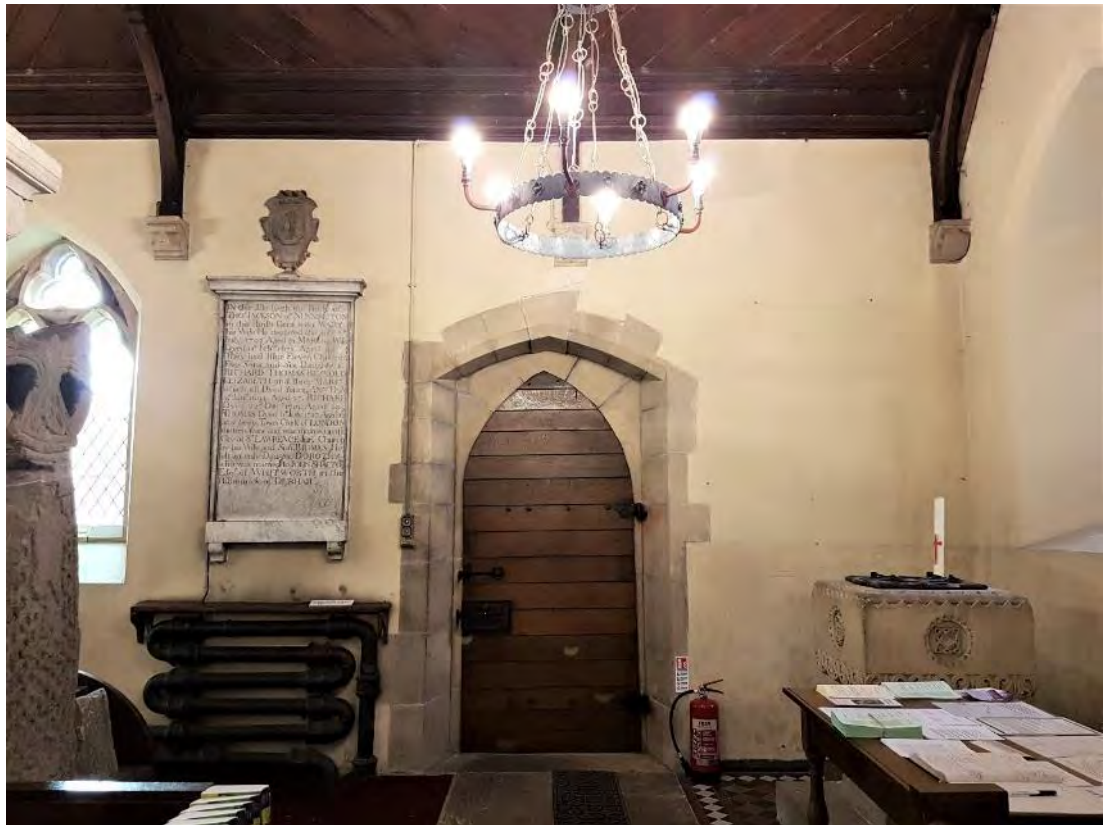
Figure 55: The western end of the south aisle, showing from the left: the C18 memorial tablet; the front door (western bay of the south elevation); the western window with the C19 baptismal font below; the western bay of the southern arcade; and the C19 pews (Source: Author 2019).

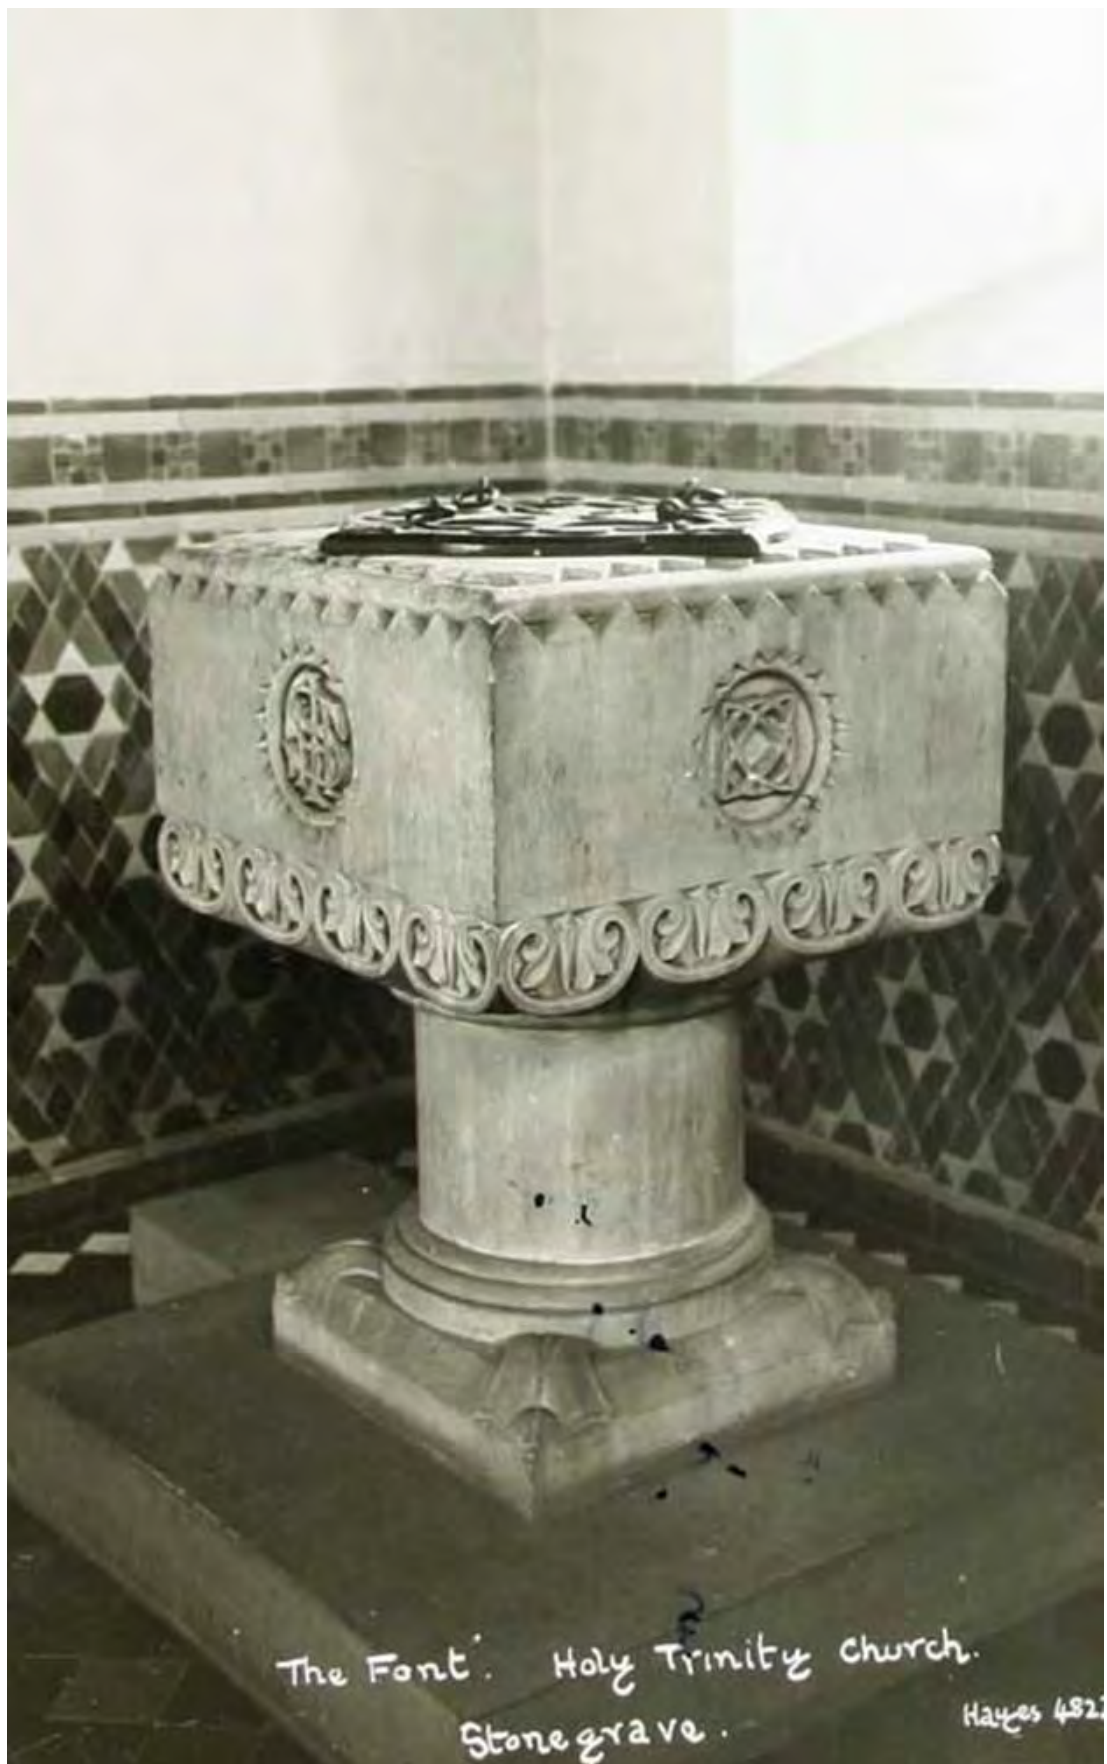
Figure 56: The interior of the western bay of the south aisle, showing from the left: the Anglo-Saxon stone cross; the C18 memorial tablet to Thomas Jackson; the front door; the C19 baptismal font and C19 floor and painted wall tiles; and, a C20 table (Source: Author 2019).

The 1862-3 ceiling comprises timber trusses on machine-cut Victorian corbels (Figure 62; Fac. 1861/2). The Victorian chandeliers were retrofitted for electricity and relocated to the south aisle in 1951 (Figure 63; BIA Fac. 1951/1/39). The flooring comprises 1862-3 stone slabs (Fac. 1861/2) and raised timber flooring for the Victorian pews and 1960s chapel dais, with Victorian geometric tiling in the western bay (Figure 56 and Figure 64).

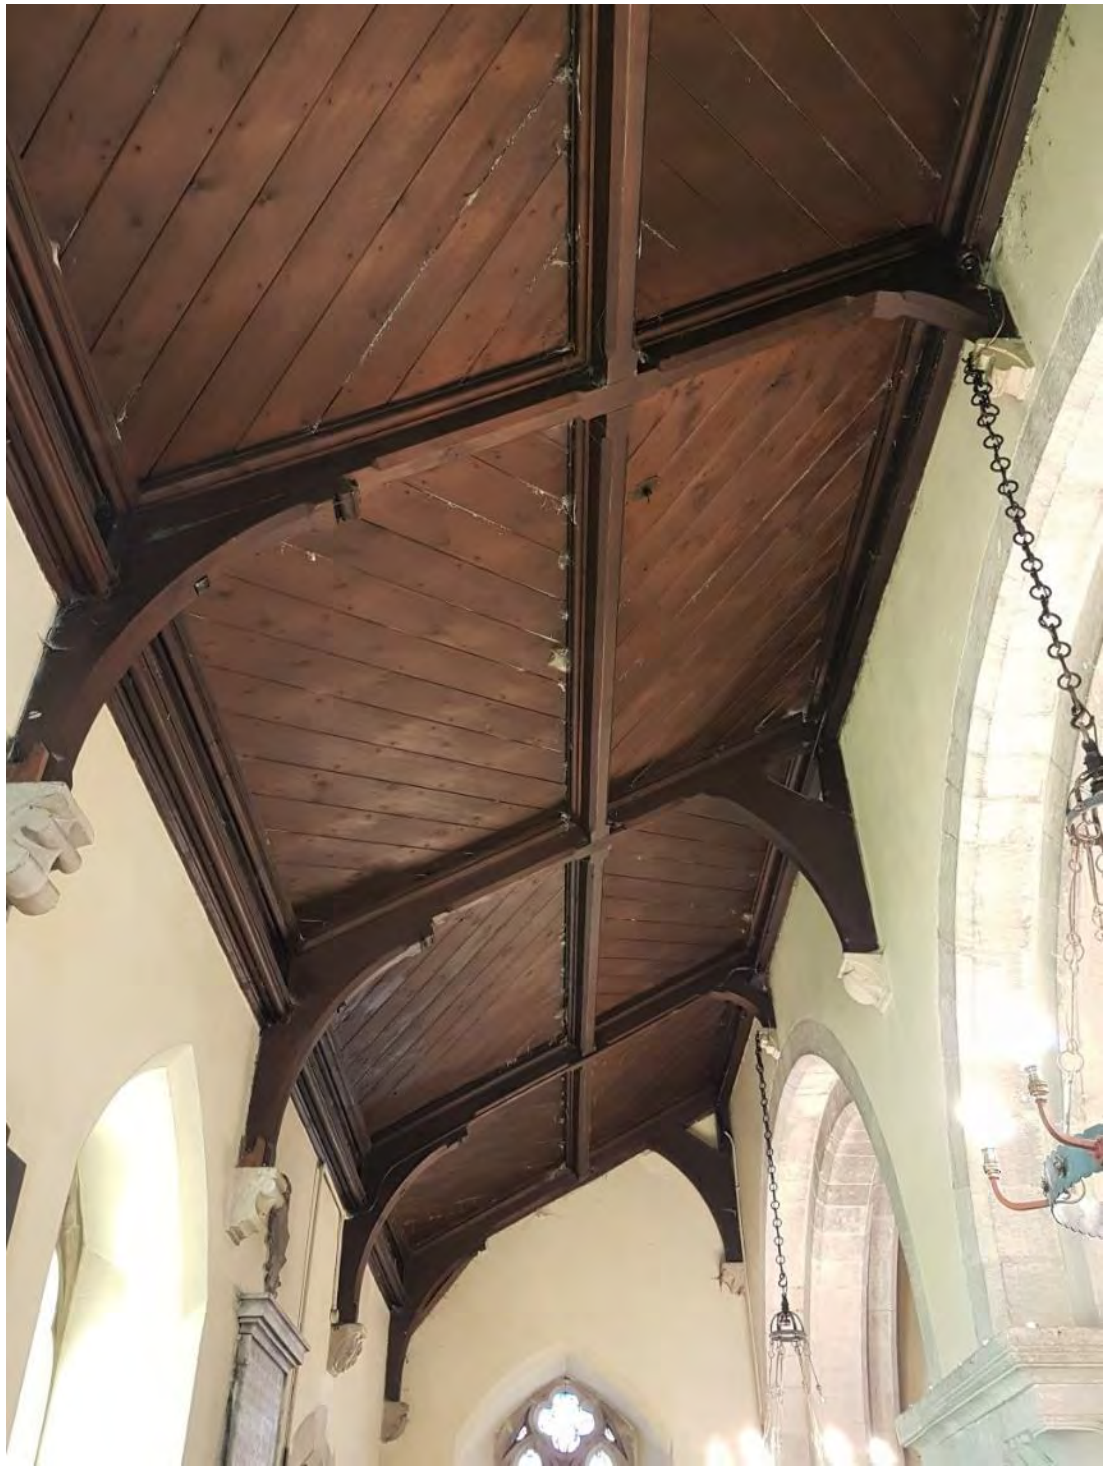
Figure 62: The roof of the south aisle, showing the 1862-3 timber trusses resting on 1862-3 corbels, with diagonal timber boards, looking west (Source: Author 2019).

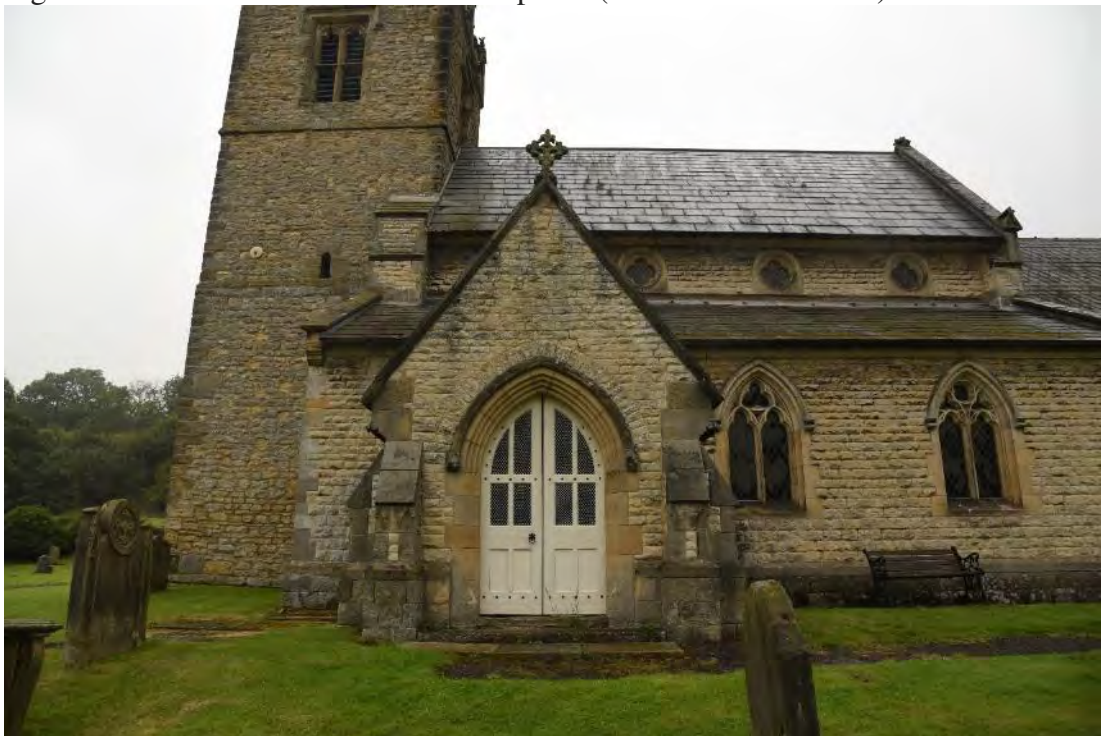
Figure 65: The western elevation of the porch (Source: Author 2019).

The single-bayed gable-roofed porch has two Victorian lancet windows in the eastern and western elevations, with an Early English style pointed arch front door (Figure 65, Figure 66 and Figure 67; BIA Fac. 1861/2). The interior comprises a timber panelled roof, exposed stone walls and stone slab flooring (Figure 68, Figure 69, Figure 70, Figure 71 and Figure 72). All elements date to the 1862-3 restoration.

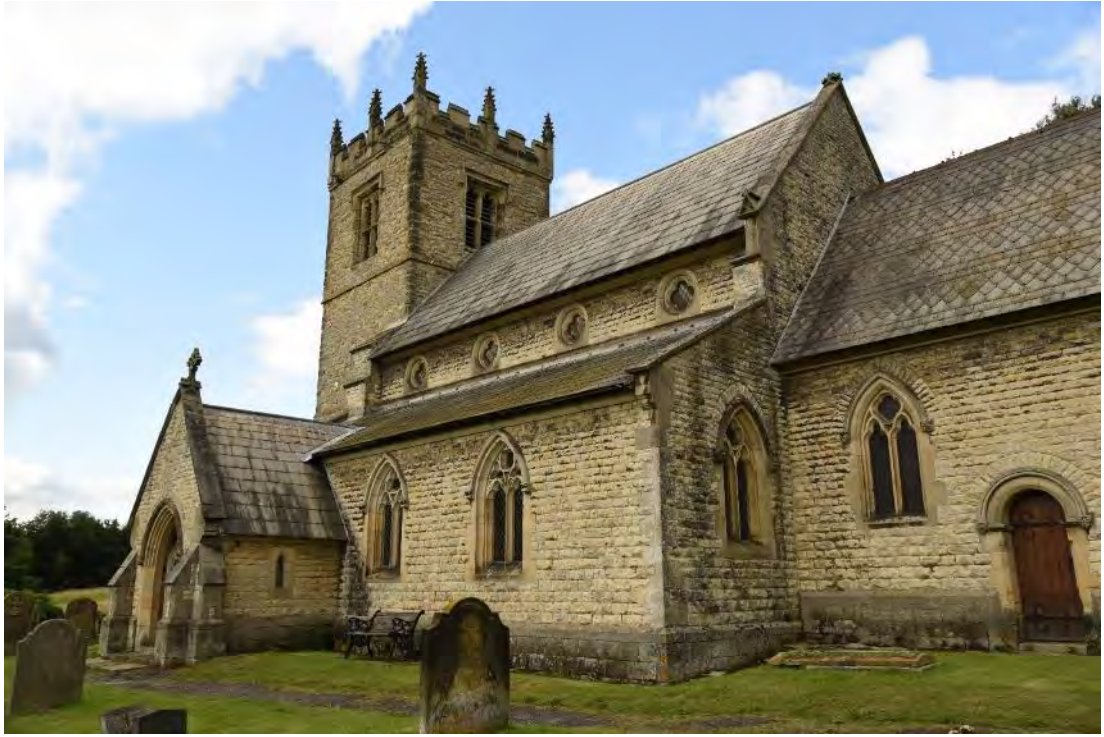
Figure 66: The southern elevation of the porch (Source: Author 2019).

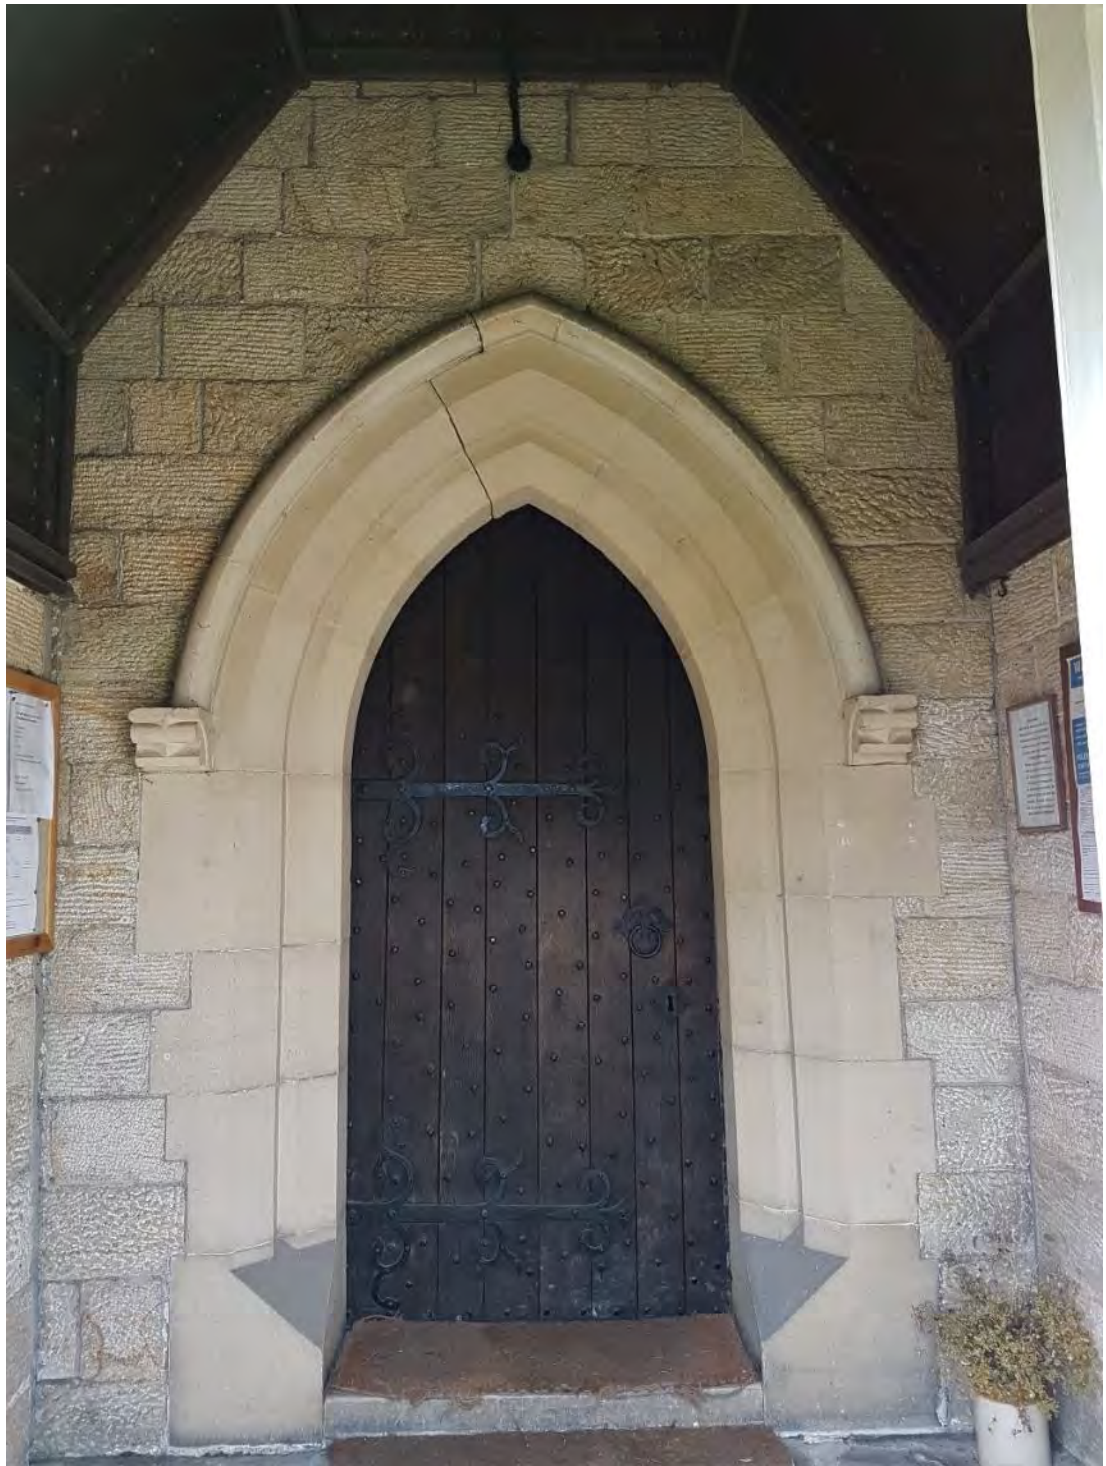
Figure 68: The northern internal elevation of the porch, showing the double-chamfered pointed arch door between the porch and south aisle, as well as the stone courses from the west and east walls not matching up with those of the north wall (Source: Author 2019).

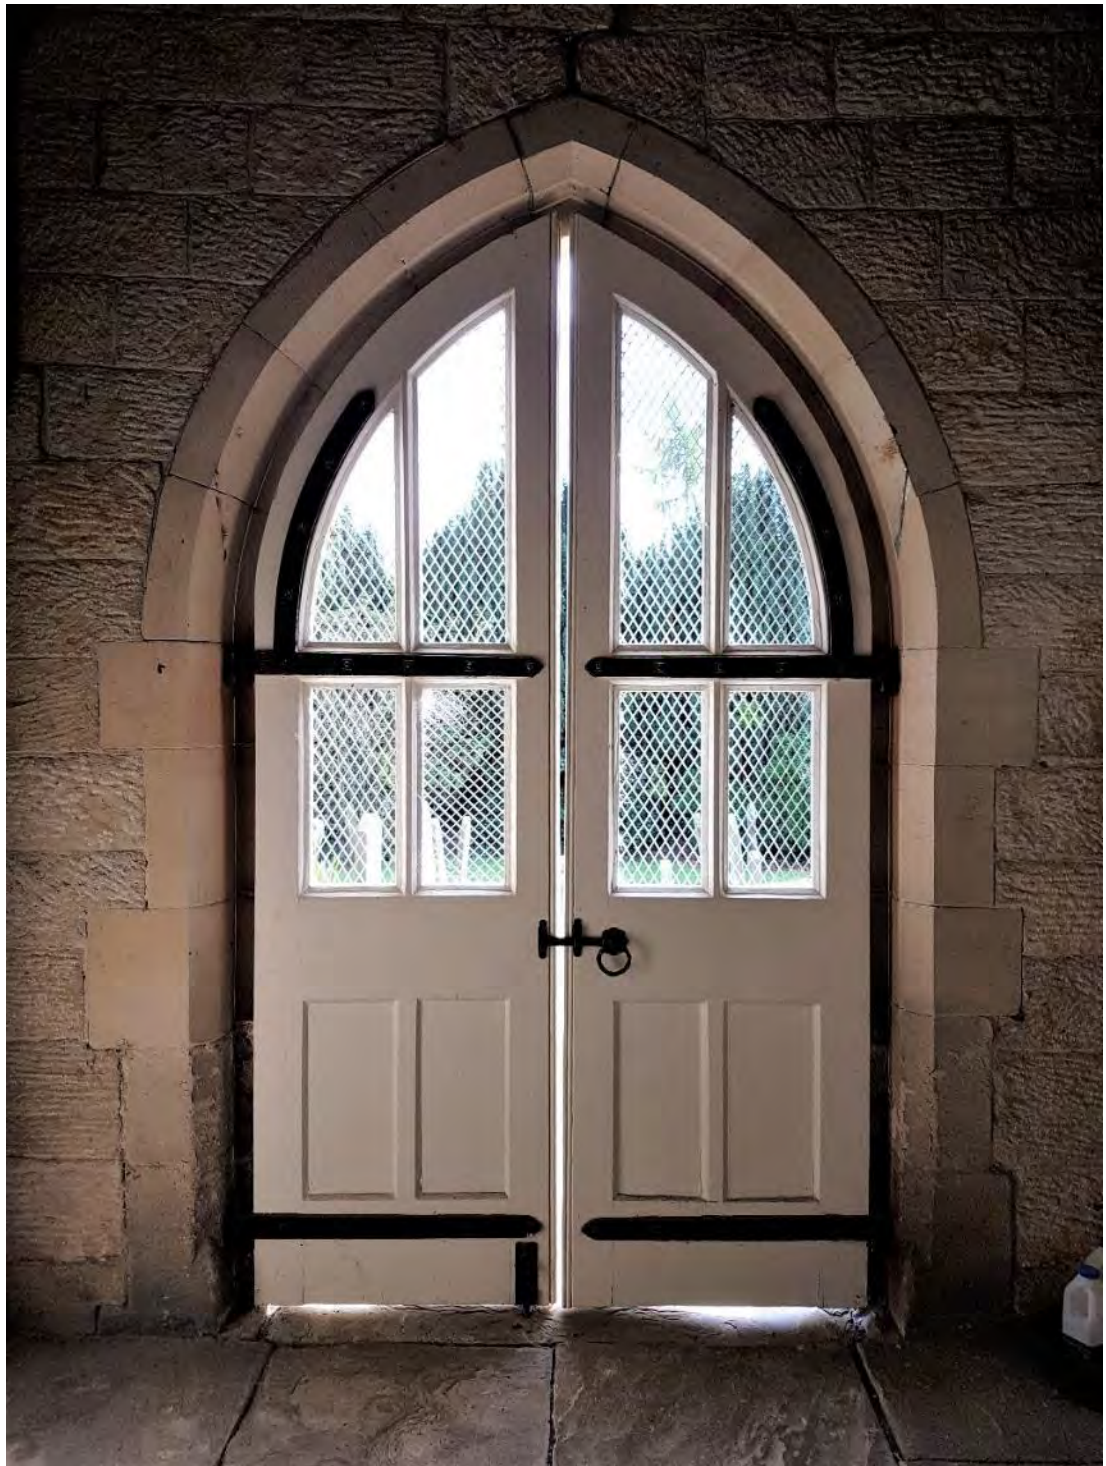
Figure 70: The southern internal elevation of the porch, showing the rear of the front pointed-arch door, displaying a chamfered arch with a chamfered quoin surround with a pyramid stop at the base of the surround. The tooling on the stone coursing is coarse and irregular, with a mix of orientations, but mostly horizontal (Source: Author 2019).

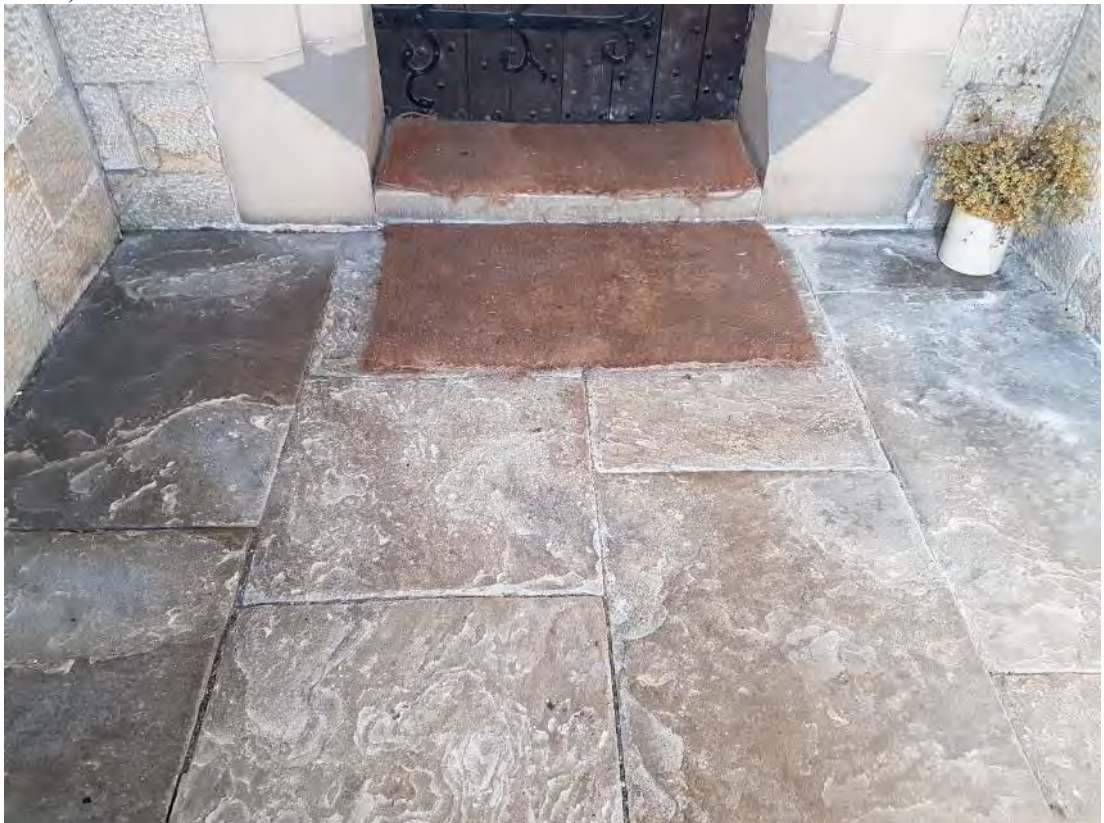
Figure 71: The Victorian timber-boarded mansard ceiling of the porch (Source: Author 2019).

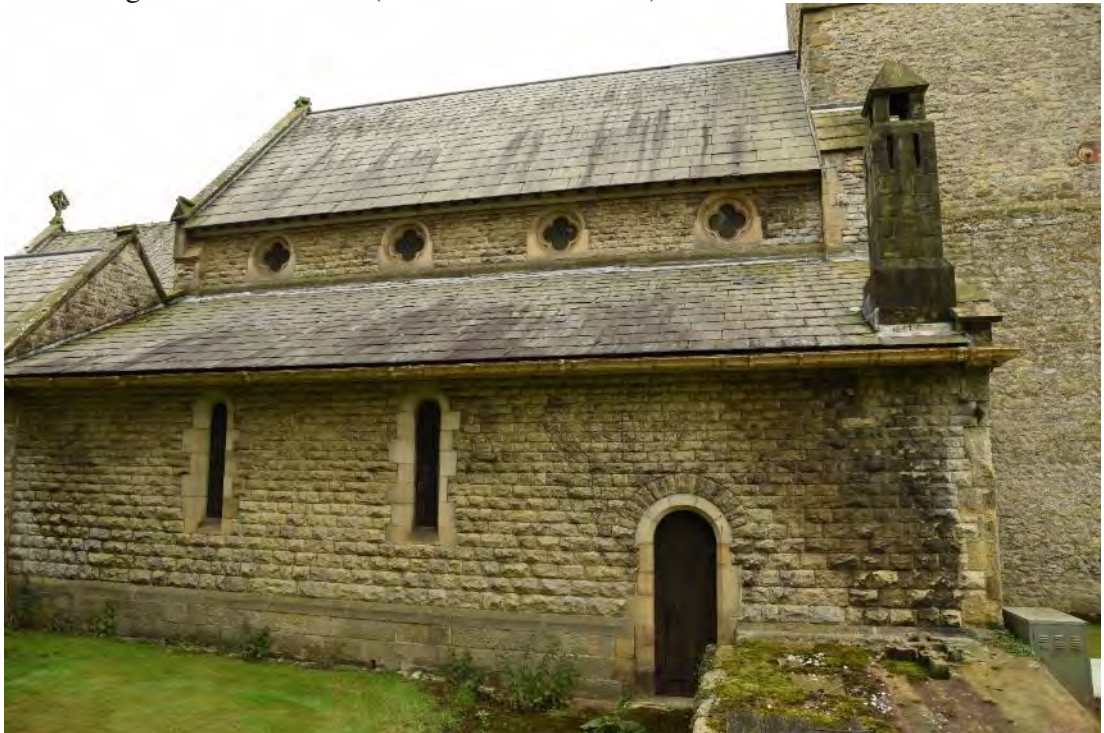
Figure 73: The western elevation of the north aisle abutting the western tower, showing the one-light lancet window (Source: Author 2019).

The north aisle was rebuilt in 1862-3, comprising four bays east-west and one bay north-south, with three nave bays and one chancel bay (Figure 73, Figure 74, Figure 75 and Figure 76; BIA 1861/2; Field and Smith 2014, 270). Externally, the north aisle is supported by a graduated buttress between the nave and chancel bays (Figure 75). The north aisle abuts the tower and the chancel (Figure 73 and Figure 76). The Saxo-Norman style windows and door in the northern and western elevations, and the Decorated Gothic window in the eastern elevation, were rebuilt during the Victorian restoration (Figure 74-Figure 76; BIA Fac. 1861/2).

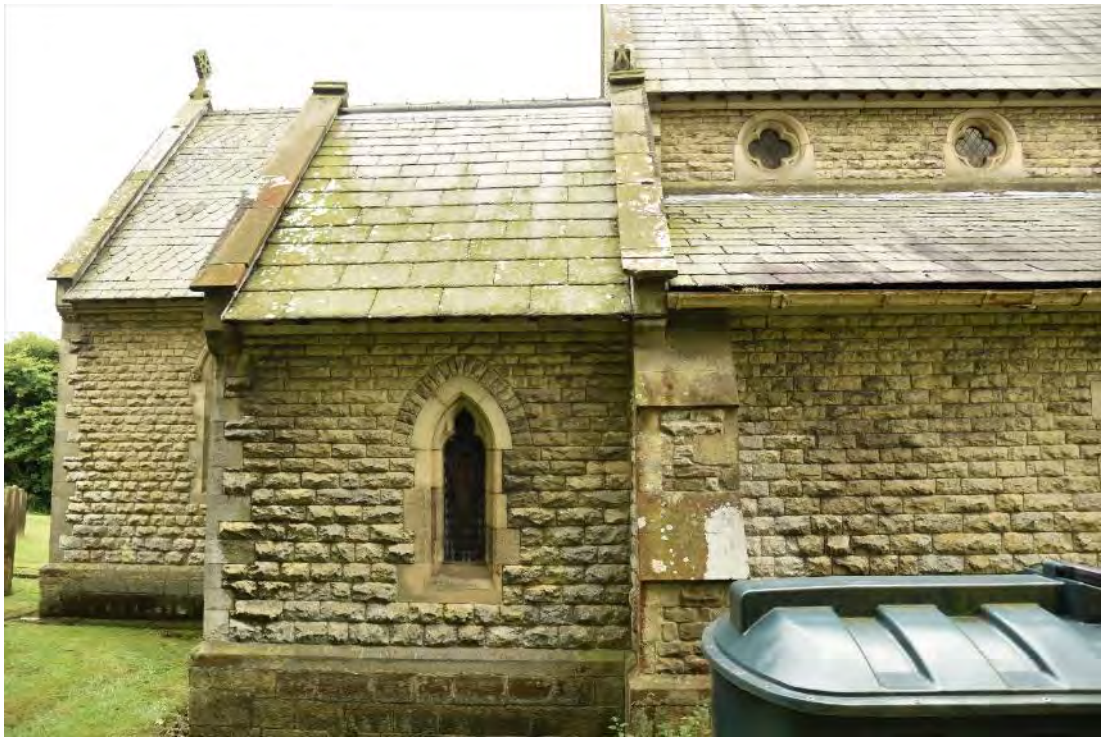
Figure 74: The northern elevation of the three bays of the north aisle, showing the Victorian Norman style door and lancet windows, with the four-bayed clerestory above (Source: Author 2019).

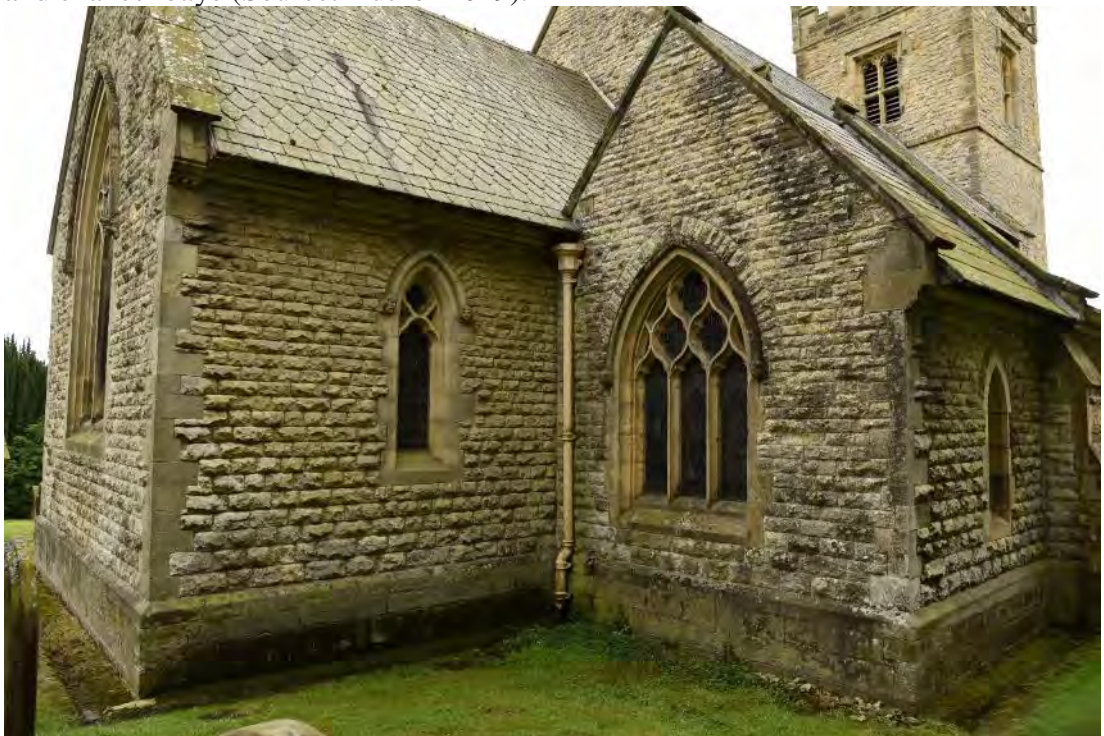
Figure 75: The northern elevation of the vestry, or chancel bay of the north aisle, showing the one-light Victorian window and the graduated buttress between the nave and chancel bays (Source: Author 2019).

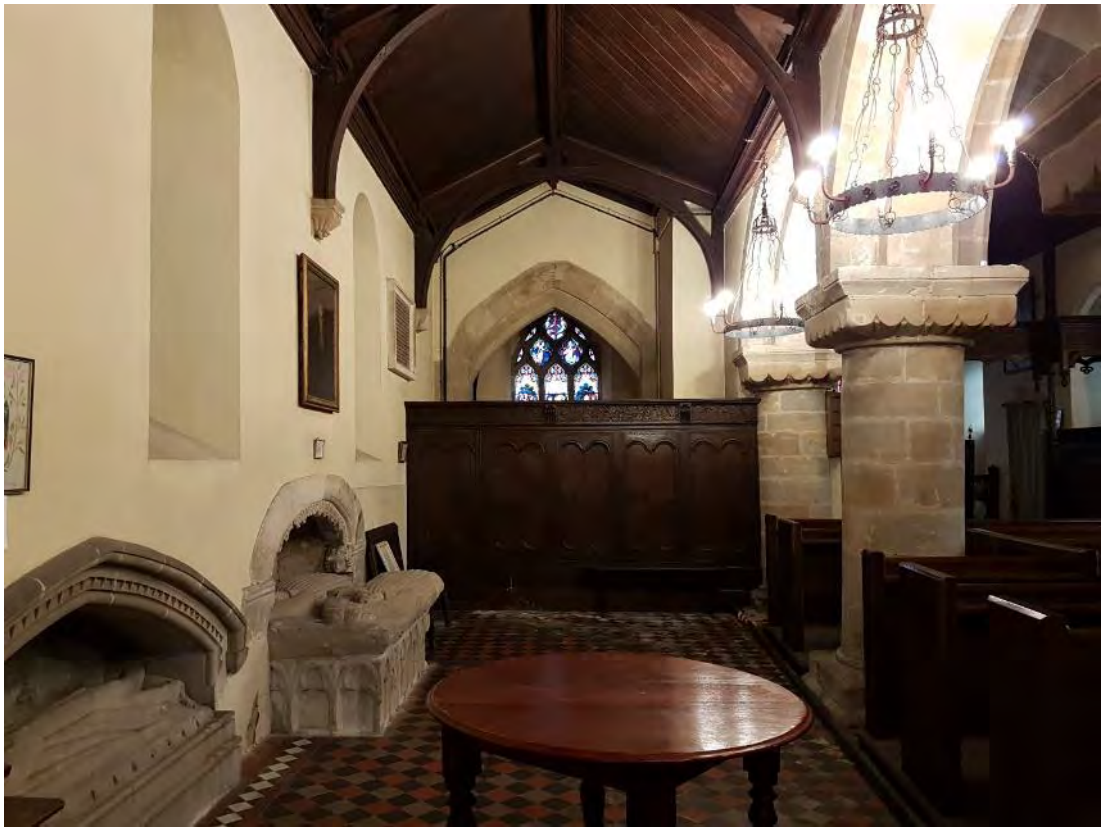
Figure 78: The Victorian double-chamfered pointed-arch southern arch between the chancel and vestry, or chancel bay of the north aisle, inset with an altered and reused seventeenth-century screen (Source: Author 2019).

The interior is bordered by a three-bay Norman arcade to the south (Figure 77). The chancel aisle, now the vestry, is bordered by Victorian double-chamfered pointed arches on the western and southern sides (Figure 78-Figure 79). The aisle contains a Victorian pew at the western end (Figure 80). In the central bay lies an early fourteenth-century effigy within a niche in the north wall, thought to be Roger de Stonegrave (Figure 81; Pevsner 1966, 360; Field and Smith 2014, 263). The pediment and niche appear Victorian due to the sharp finish and lack of deterioration (Figure 81). In between the central and eastern nave bays, resting under a 'reused medieval canopy' in the north wall, lies an early fifteenth-century effigy to Robert Thornton the Elder and his wife, Jane; the parents of the scribe Robert Thornton (Figure 82; Field and Smith 2014, 263, 271). The decoration and coat of arms on the Thornton effigy matching the reused corbels in the clerestory indicates that the Thorntons commissioned the fifteenth-century clerestory (Figure 40 and Figure 82; Page 1914, 561-6; Field and Smith 2014, 263). Within the eastern nave bay is a chair made from reused seventeenth-century panelling (Figure 83) and an 1885 mural tablet to the Dentons, replacing the broken eighteenth-century tablet (Figure 84; NYC PR/STV 3). The chancel bay houses furniture of various dates (Figure 85-Figure 86) with reused seventeenth-century screens separating the chancel bay from the chancel and nave bays of the north aisle (Figure 87-Figure 88).

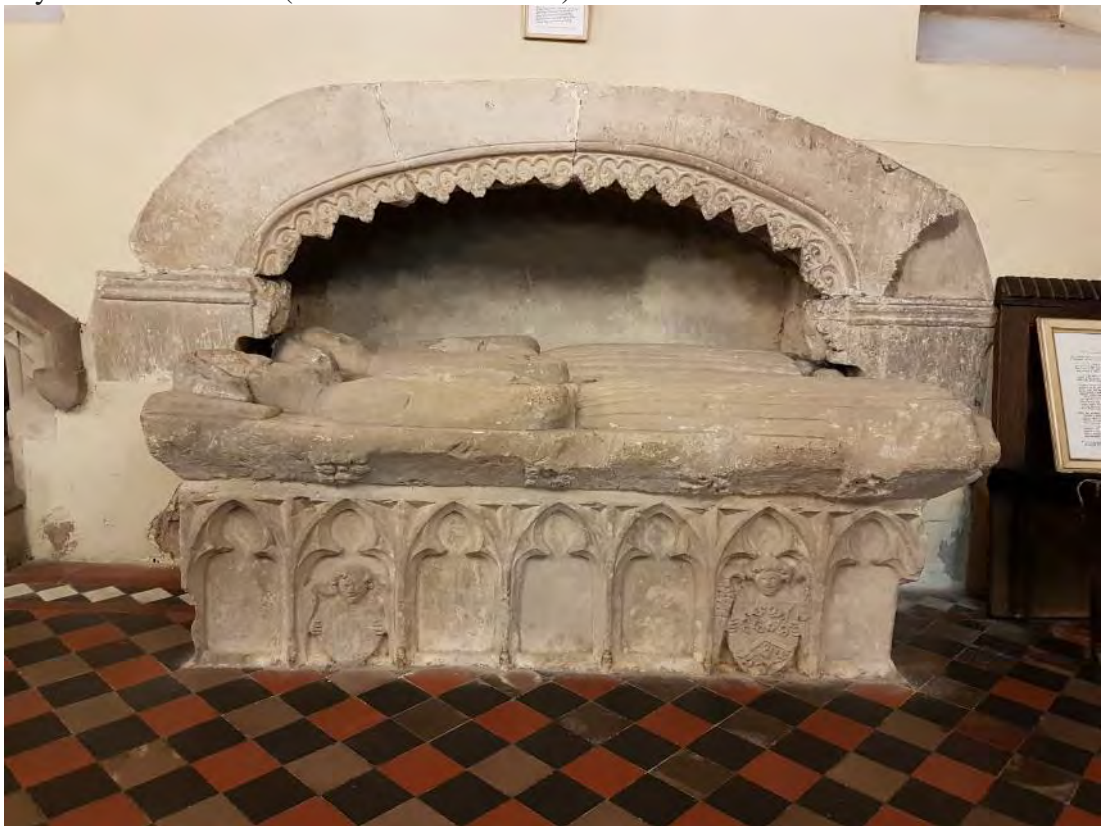
Figure 81: The early fourteenth-century effigy, thought to be Roger de Stonegrave, on a Victorian pediment and set within a Victorian niche in the north wall of the central bay of the north aisle (Source: Author 2019).

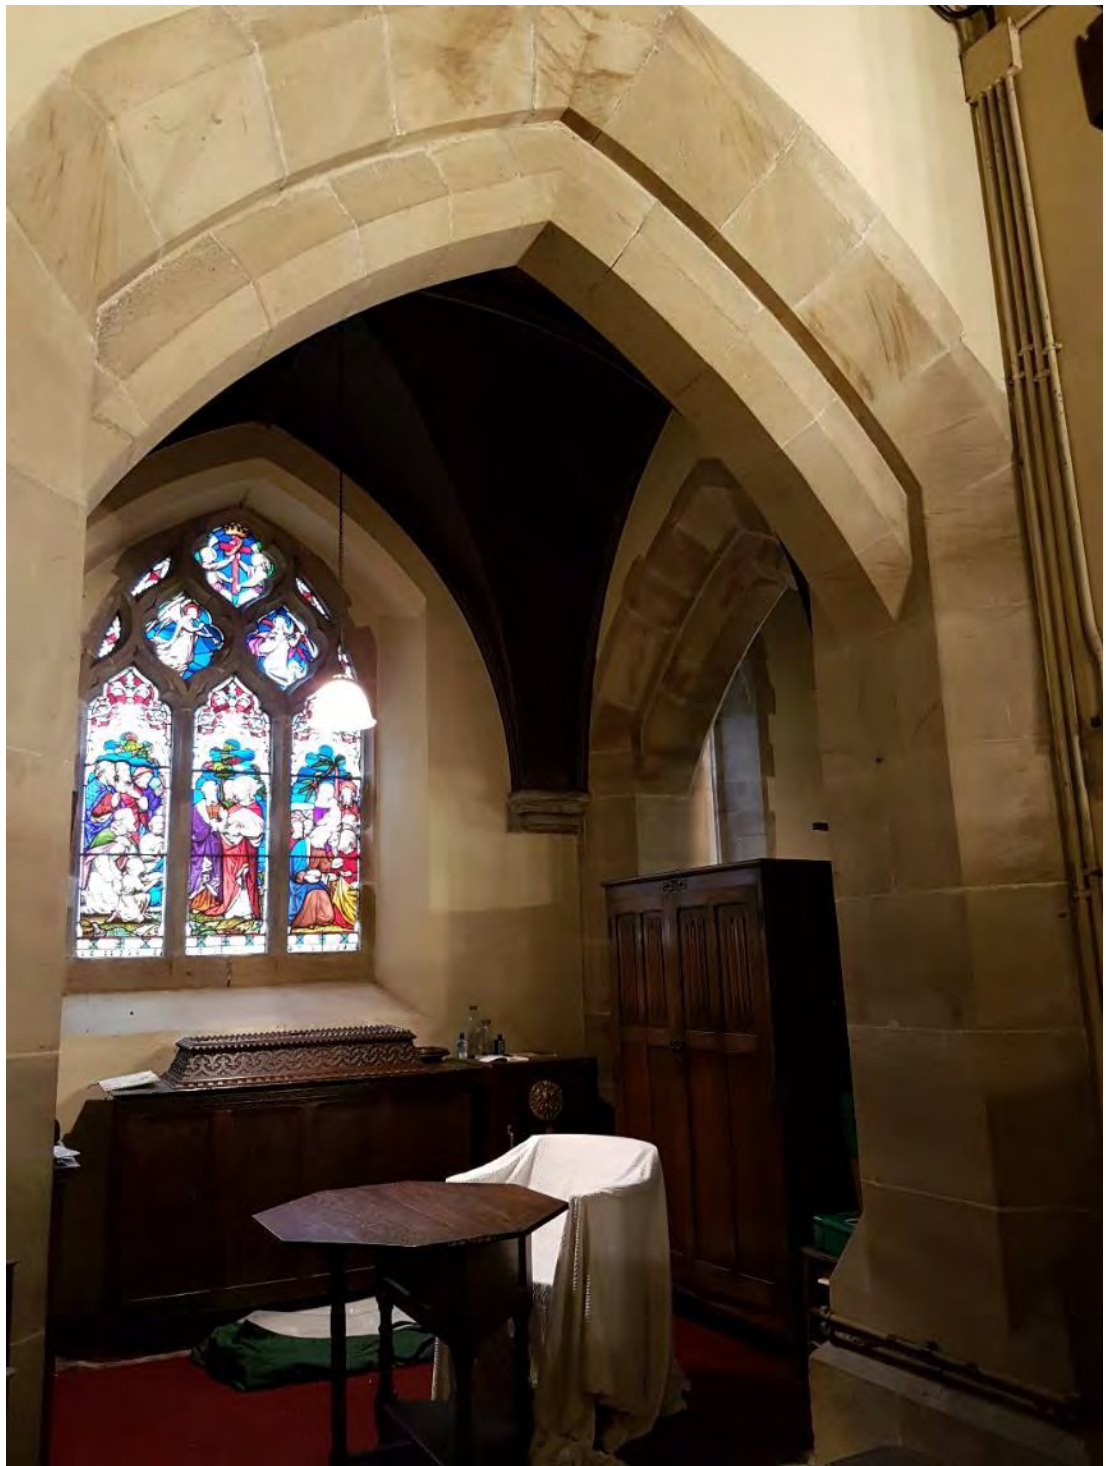
Figure 85: A nineteenth-century cupboard reusing earlier panelling along the northern wall of the chancel bay of the north aisle (Source: Author 2019).

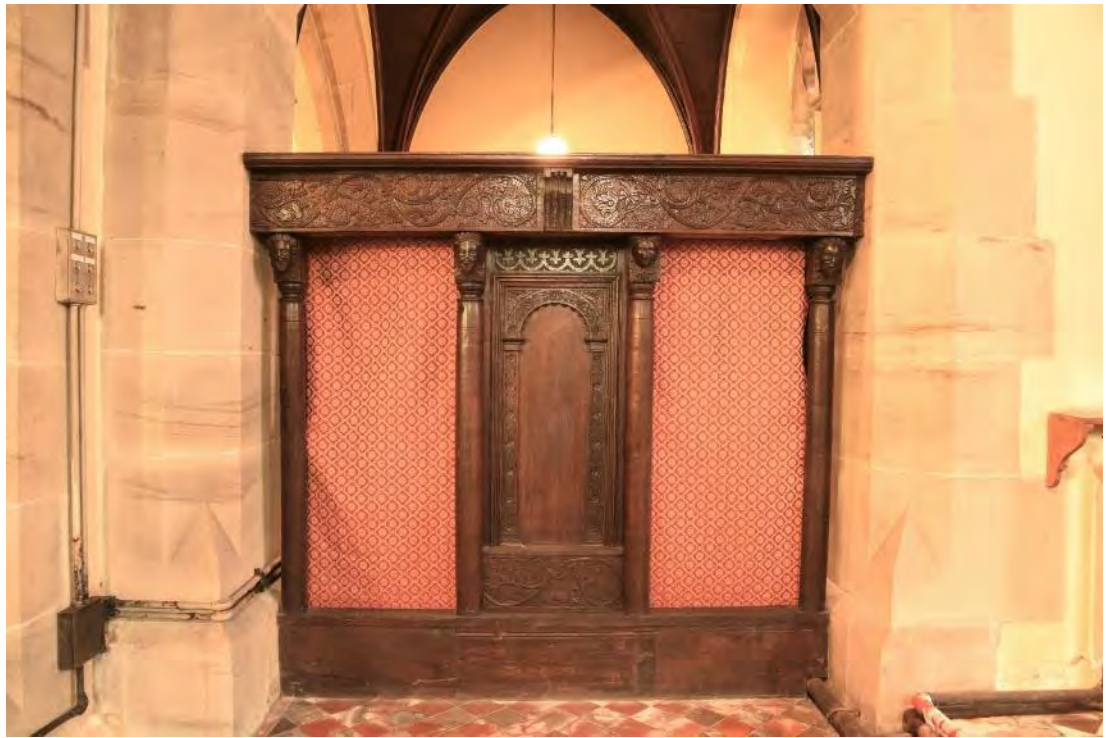
Figure 86: The furniture of various dates in the chancel bay of the north aisle, looking east (Source: Author 2019).

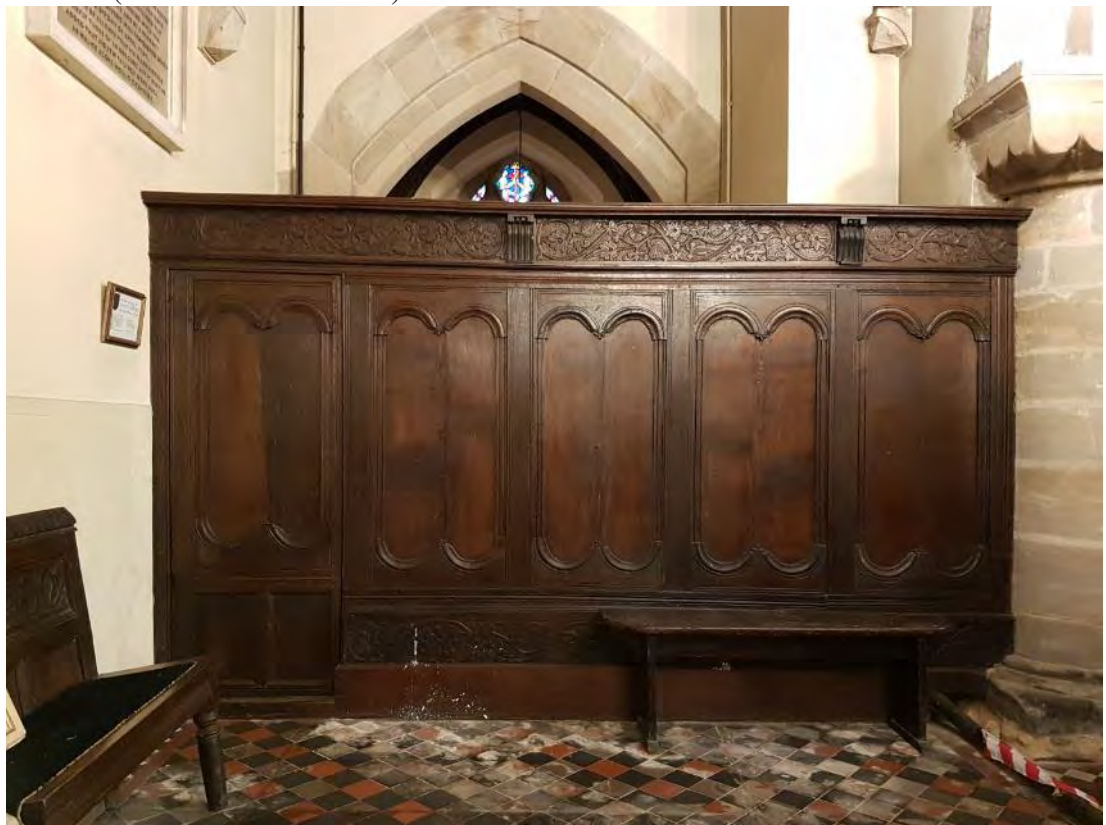
Figure 87: The seventeenth-century screen/panelling separating the chancel bay and chancel (Source: Author 2019).

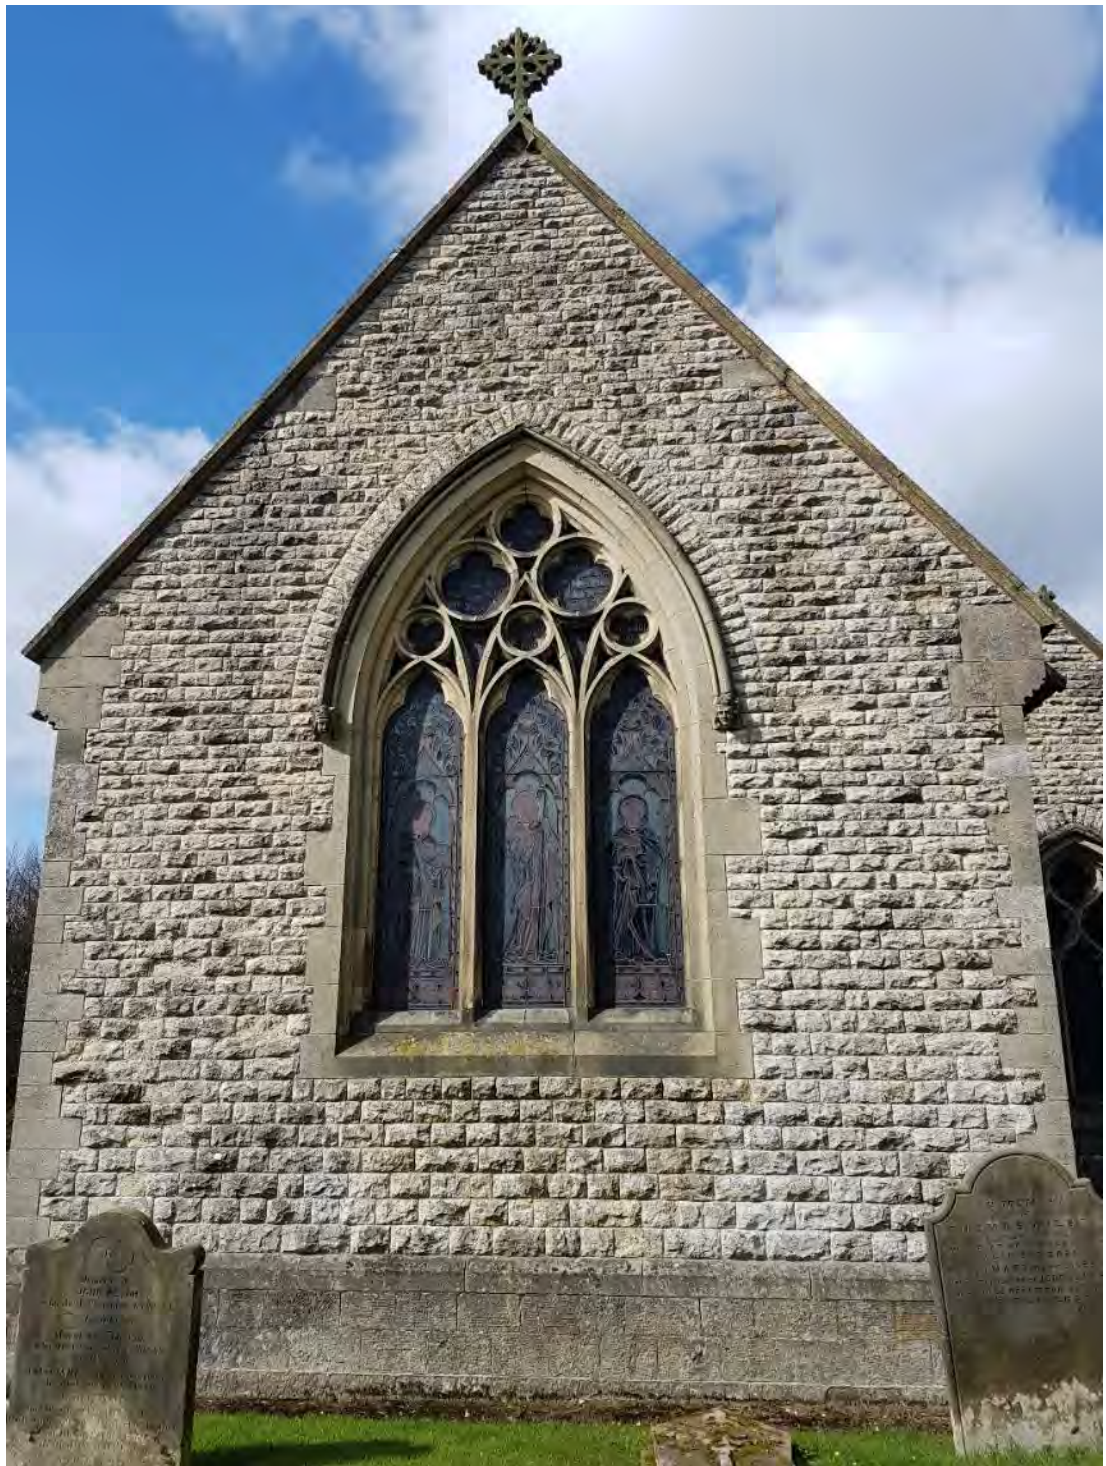
Figure 92: The eastern elevation of the chancel, showing the three-light Victorian Middle Decorated Geometric Gothic pointed arch window with cusped heads and quatrefoil and trefoil tracery and rounded hood-moulds with head-stops, as well as a sandstone coping with a decorative cross finial and moulded kneelers (Source: Author 2019).
