# **NOT ALL THOSE WHO WANDER ARE LOST:**

## **Reconstructing the Post-Medieval Phase of Stonegrave Minster using a Buildings Archaeology Approach**

**MA in the Archaeology of Buildings**

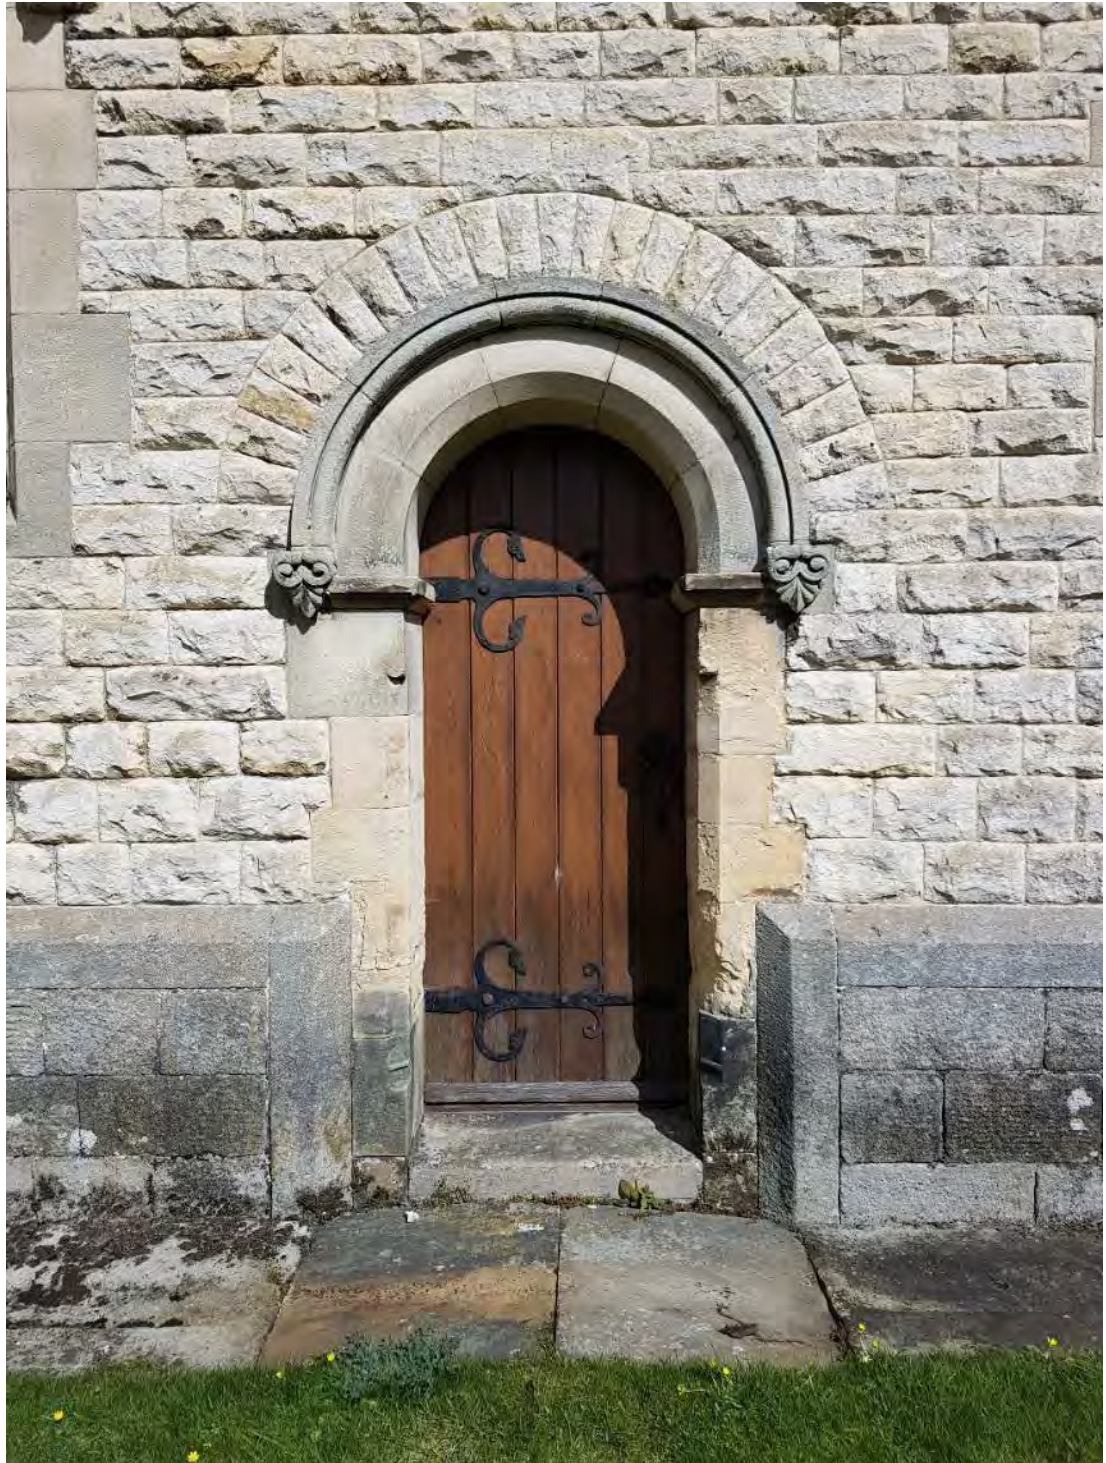
Figure 93: The northern elevation of the chancel and the chancel bay of the north aisle, showing the window on the northern elevation of the chancel to be a cusped one-light Geometric Decorated pointed arch window with quatrefoil tracery and rounded hood-moulds with head-stops (Source: Author 2019).

The chancel is three bays long by one bay wide (Figure 91, Figure 92 and Figure 93). All elevations exhibit Victorian Middle Decorated Geometric pointed-arch windows (Figure 91-Figure 93). The central bay on the southern elevation has a Victorian Norman-style rounded-arched door (Figure 94). Their crisp finish and tooling indicates that these features date to 1862-3, confirming the documentary evidence demonstrating the demolition of the previous chancel (Figure 10-Figure 16, Figure 91-Figure 94; see NYC PR/STV 2; BIA Fac. 1861/2).

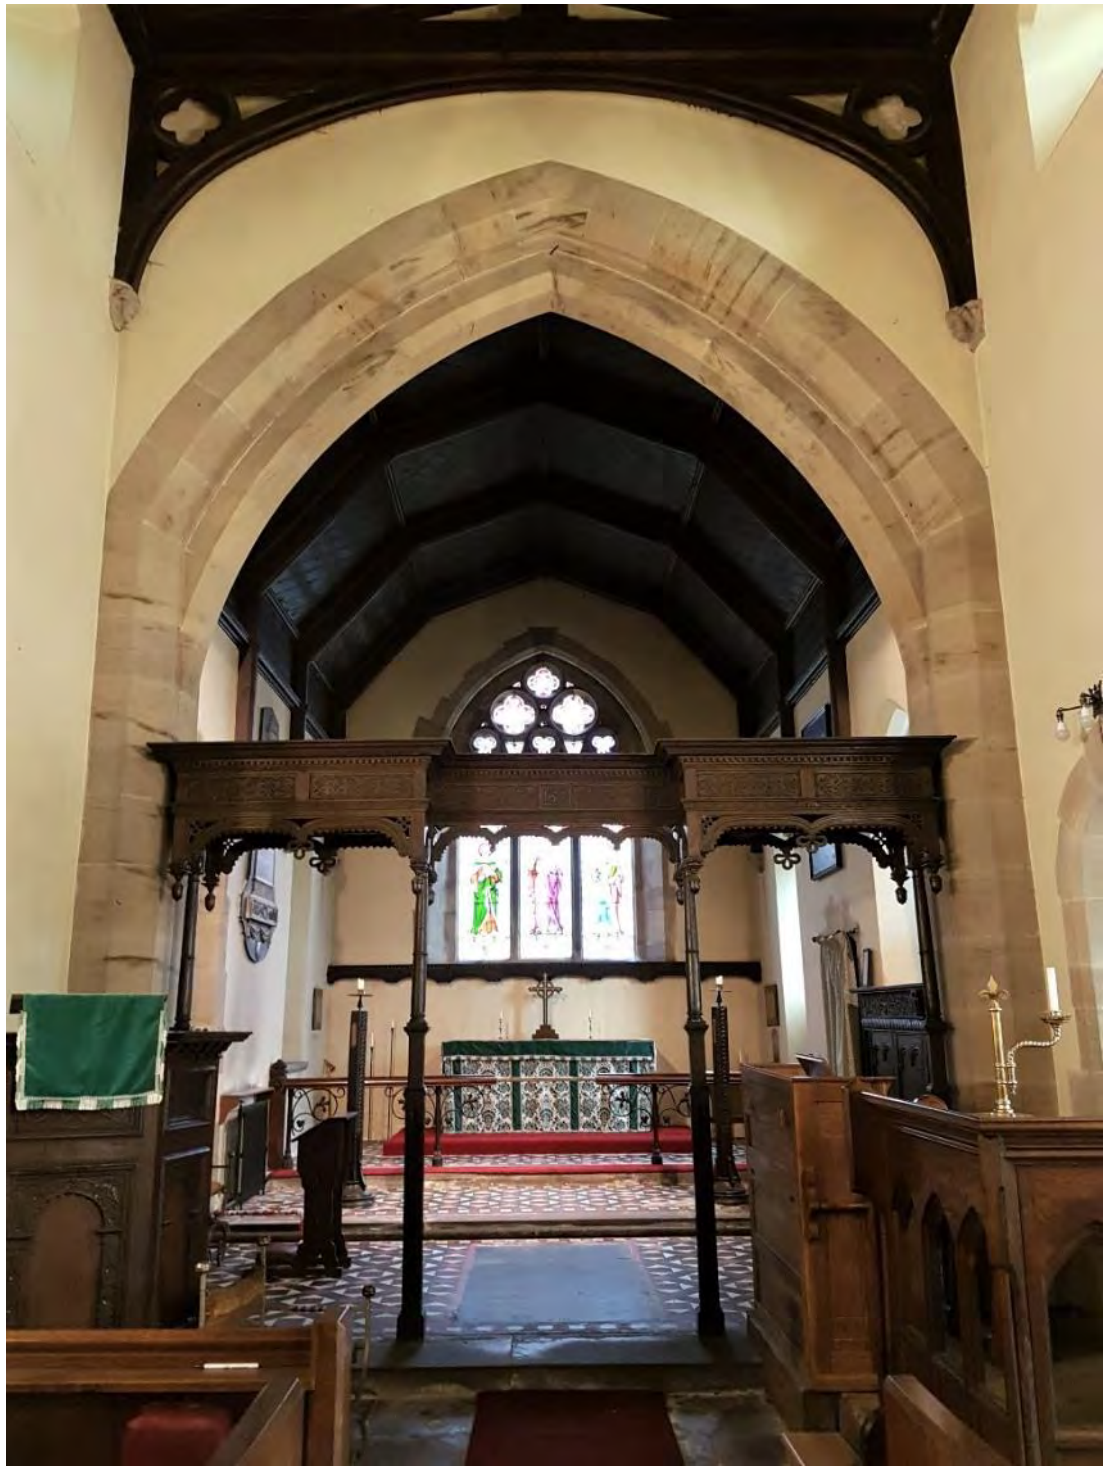
Figure 96: The interior of the chancel from the nave, showing the Victorian double-chamfered pointed chancel arch, the 1637 chancel screen below, the altar and altar rails in the chancel and the flooring and ceiling of the chancel (Source: Author 2019).

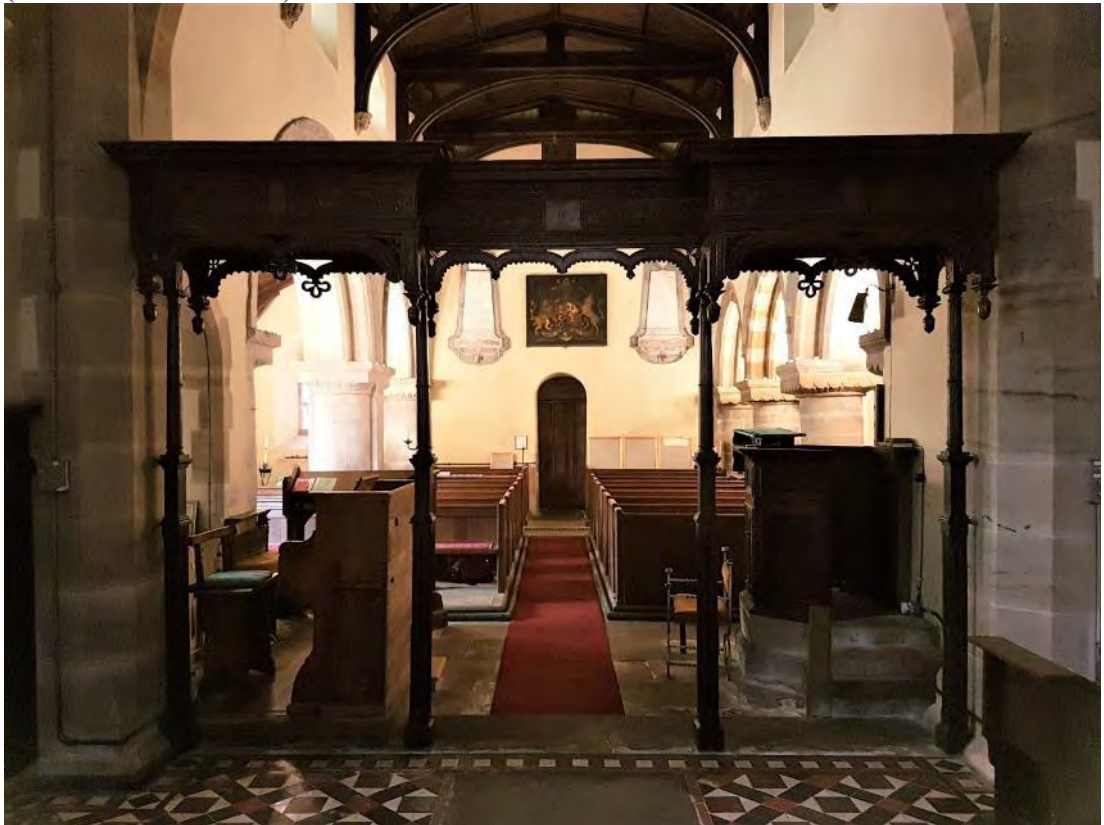
Figure 97: The western side of the reused 1637 chancel screen under the chancel arch (Source: Author 2019).

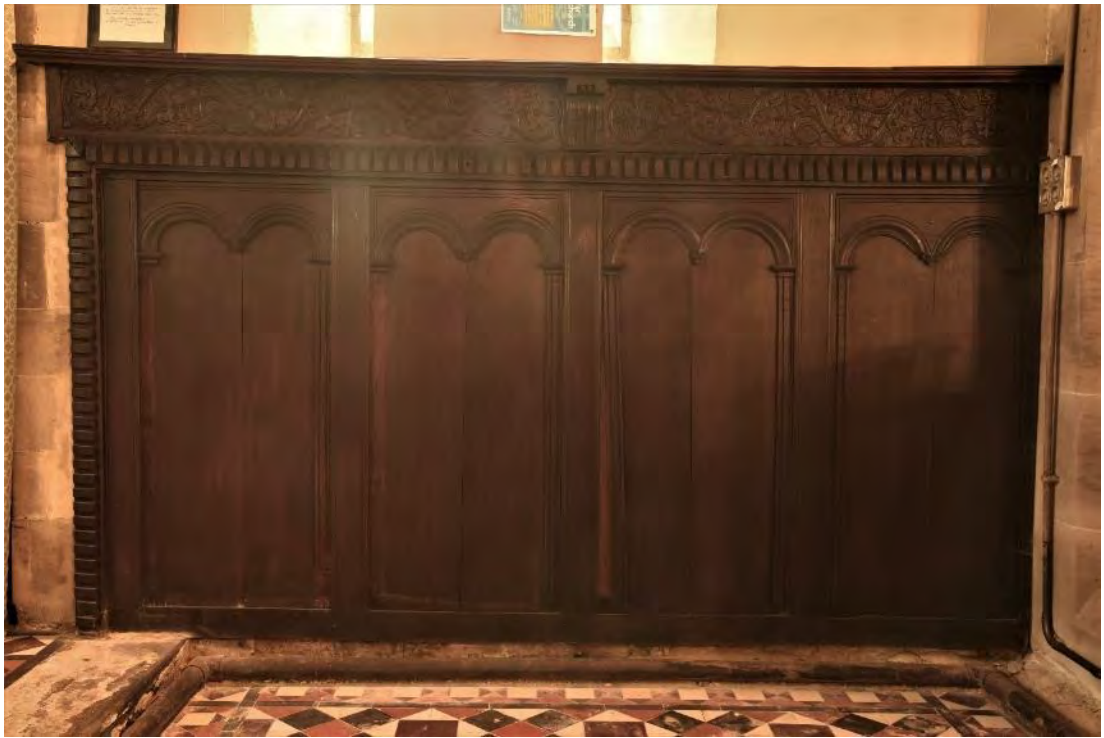
Figure 98: The eastern side of the reused 1637 chancel screen under the chancel arch (Source: Author 2019).

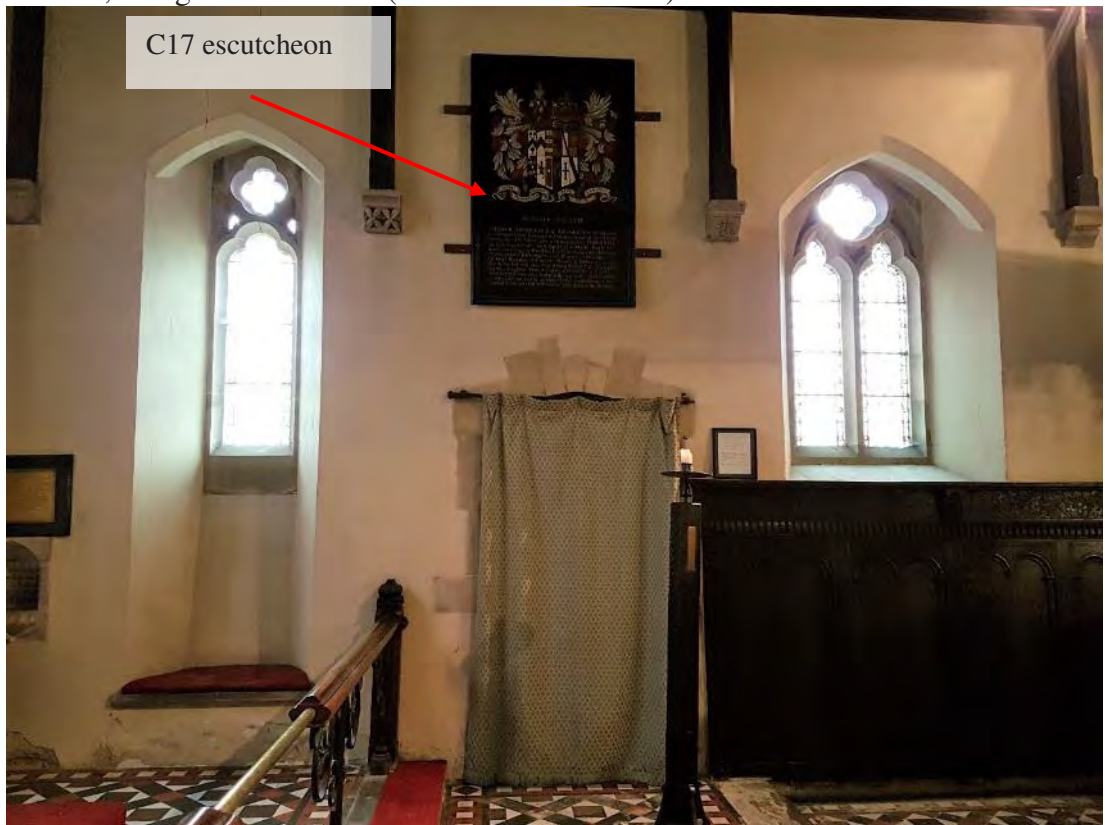
Figure 99: The altered and reused seventeenth-century screen in the western bay of the chancel, along the south wall (Source: Author 2019).

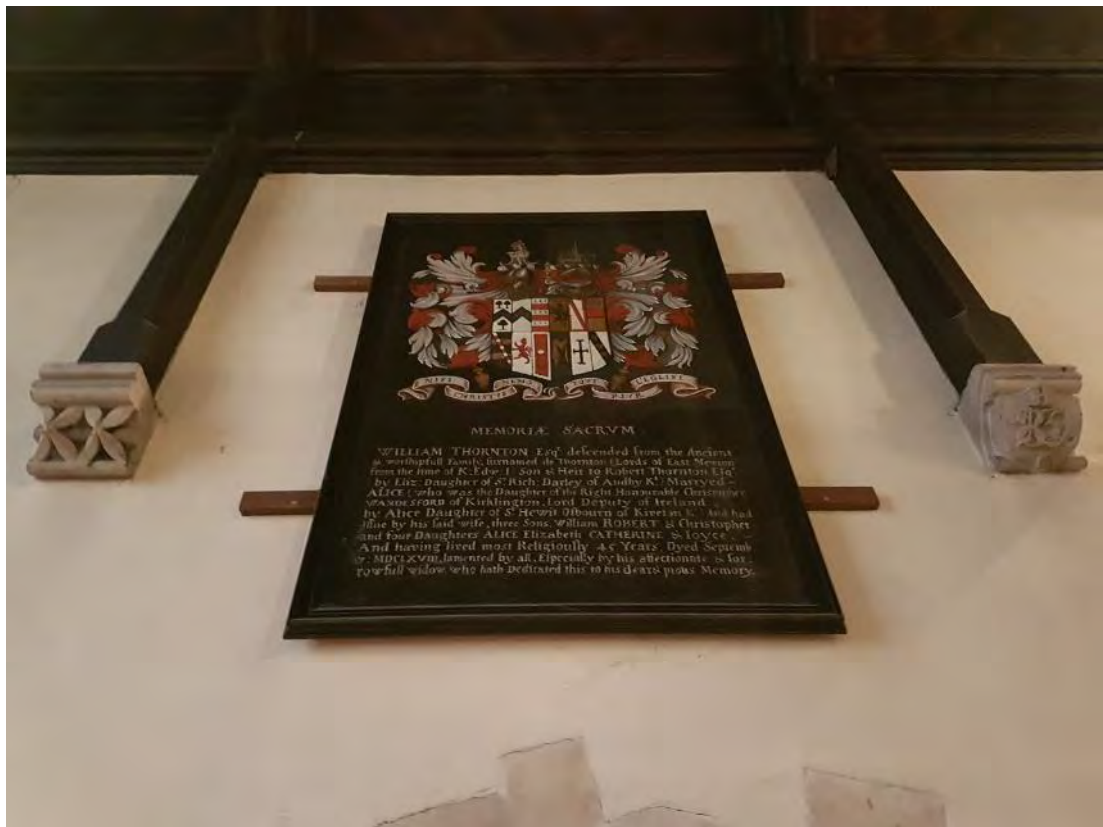
Figure 100: The seventeenth-century painted timber escutcheon to William Thornton above the south door (Source: Author 2019).

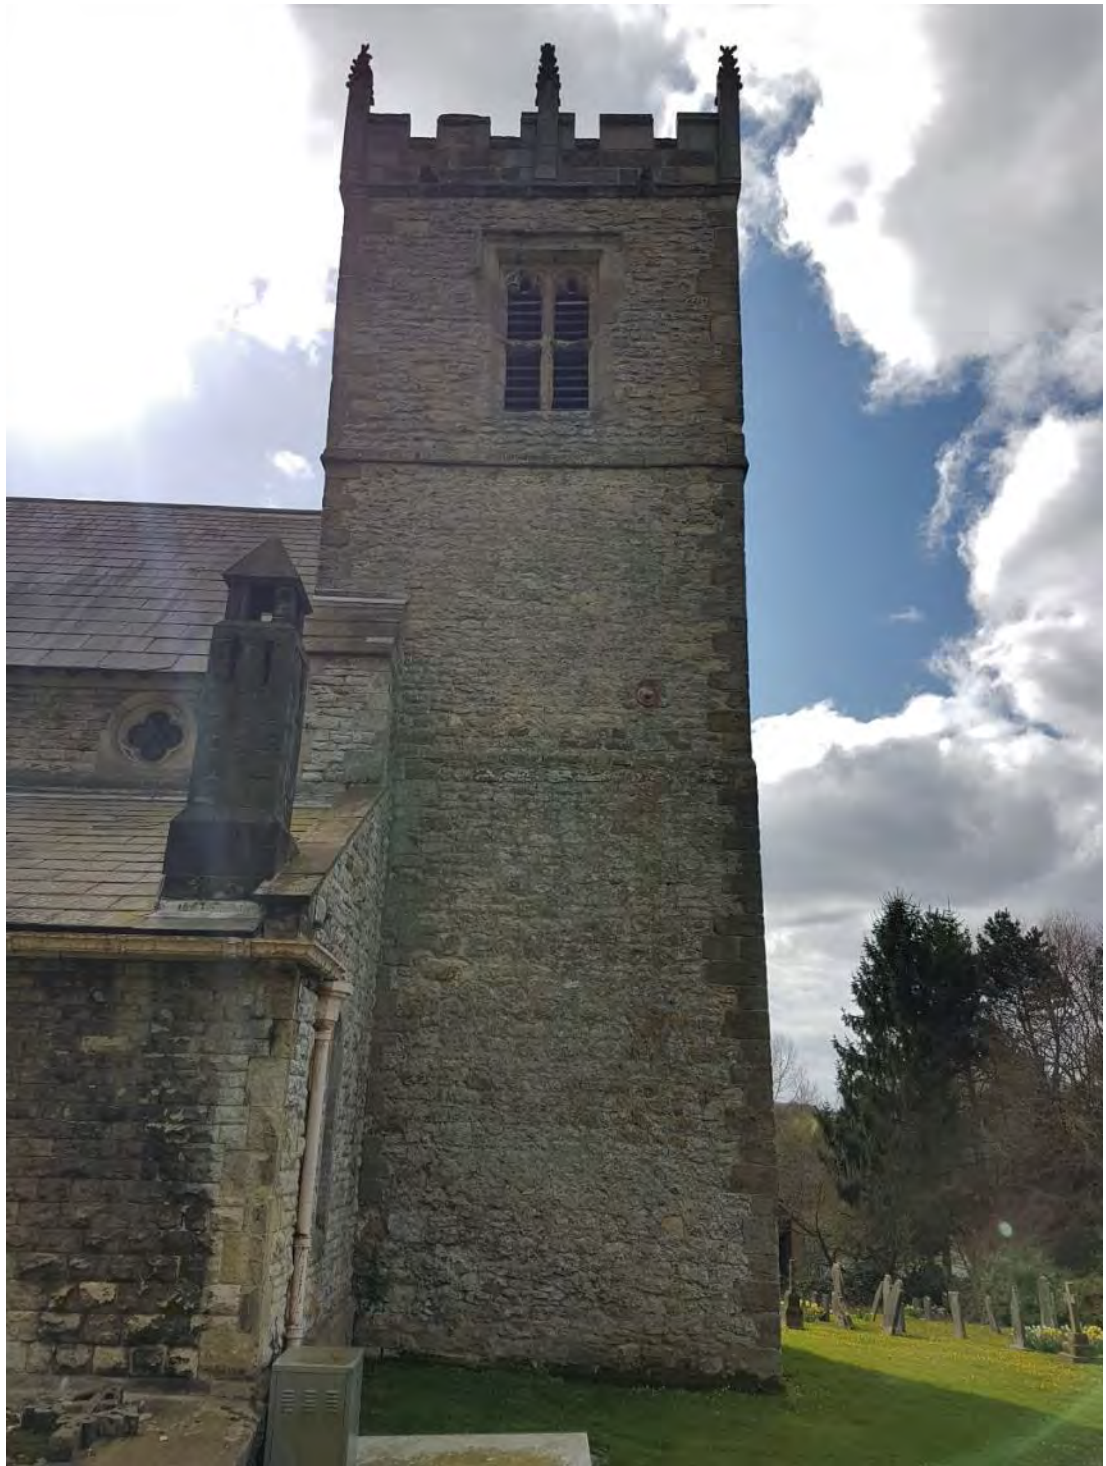
Figure 109: The northern elevation of the three-stage square tower, constructed from coursed rough limestone rubble with dressed calcareous sandstone quoining, with the first two Norman stages and the fifteenth-century Perpendicular belfry (Source: Author 2019).

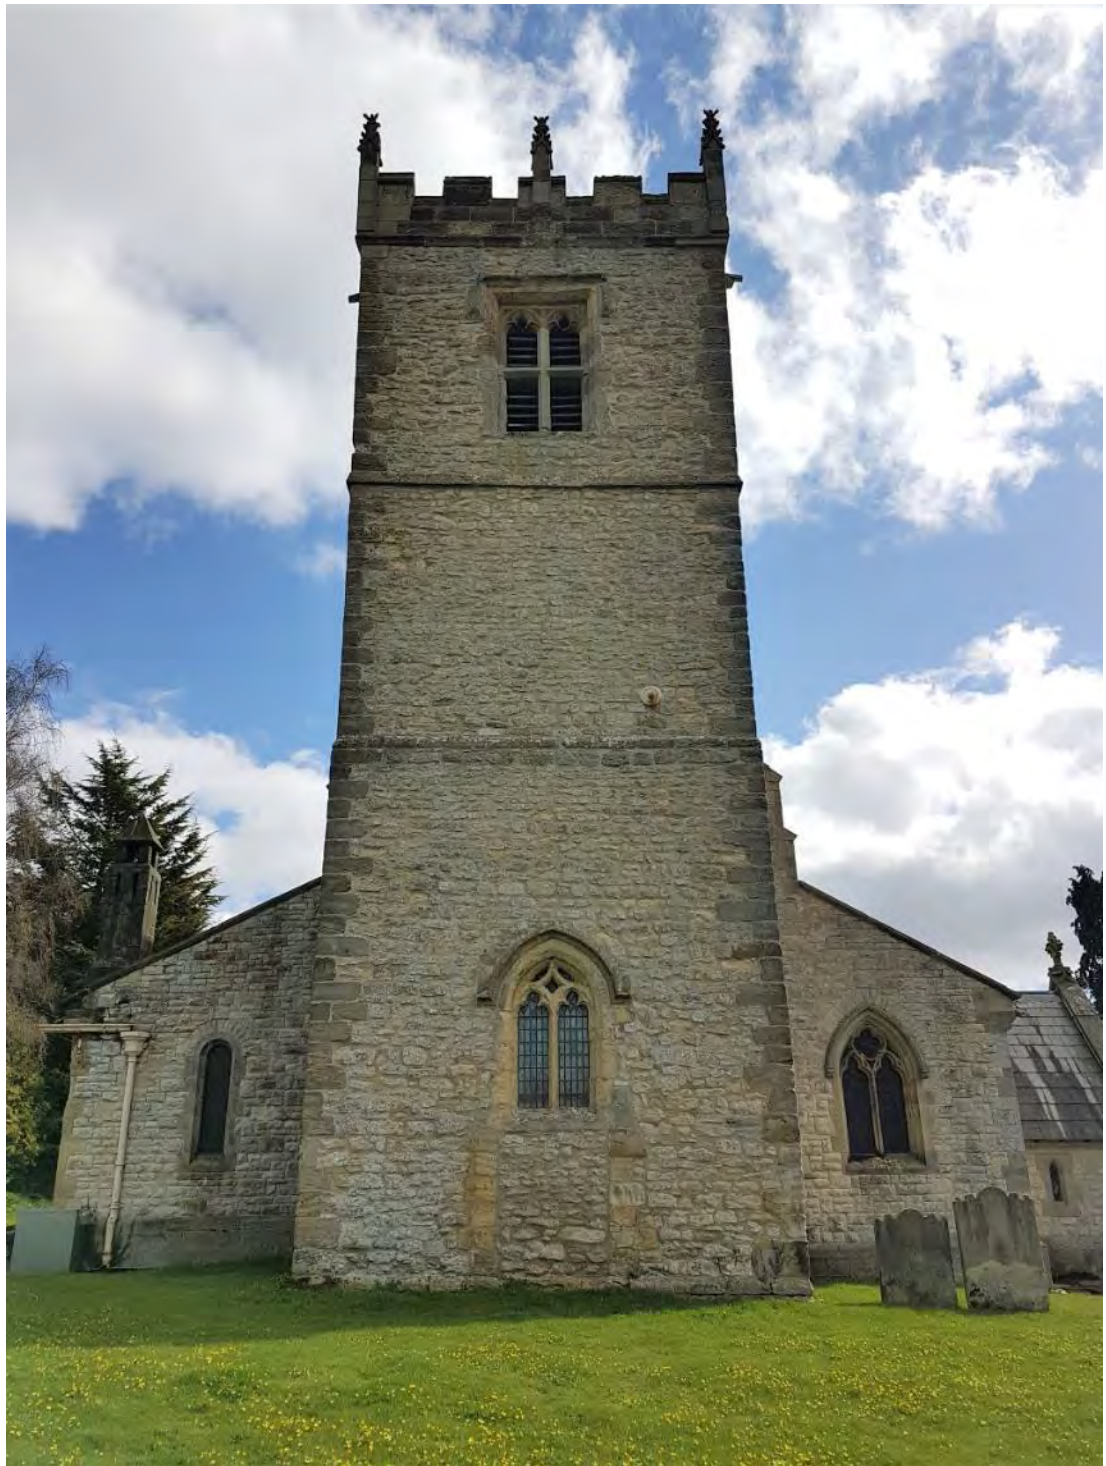
Figure 110: The western elevation of the three-stage square tower, constructed from coursed rough limestone rubble with dressed calcareous sandstone quoining, showing the location of the fifteenth-century Perpendicular window blocking the head of the earlier twelfth-century door (Source: Author 2019).

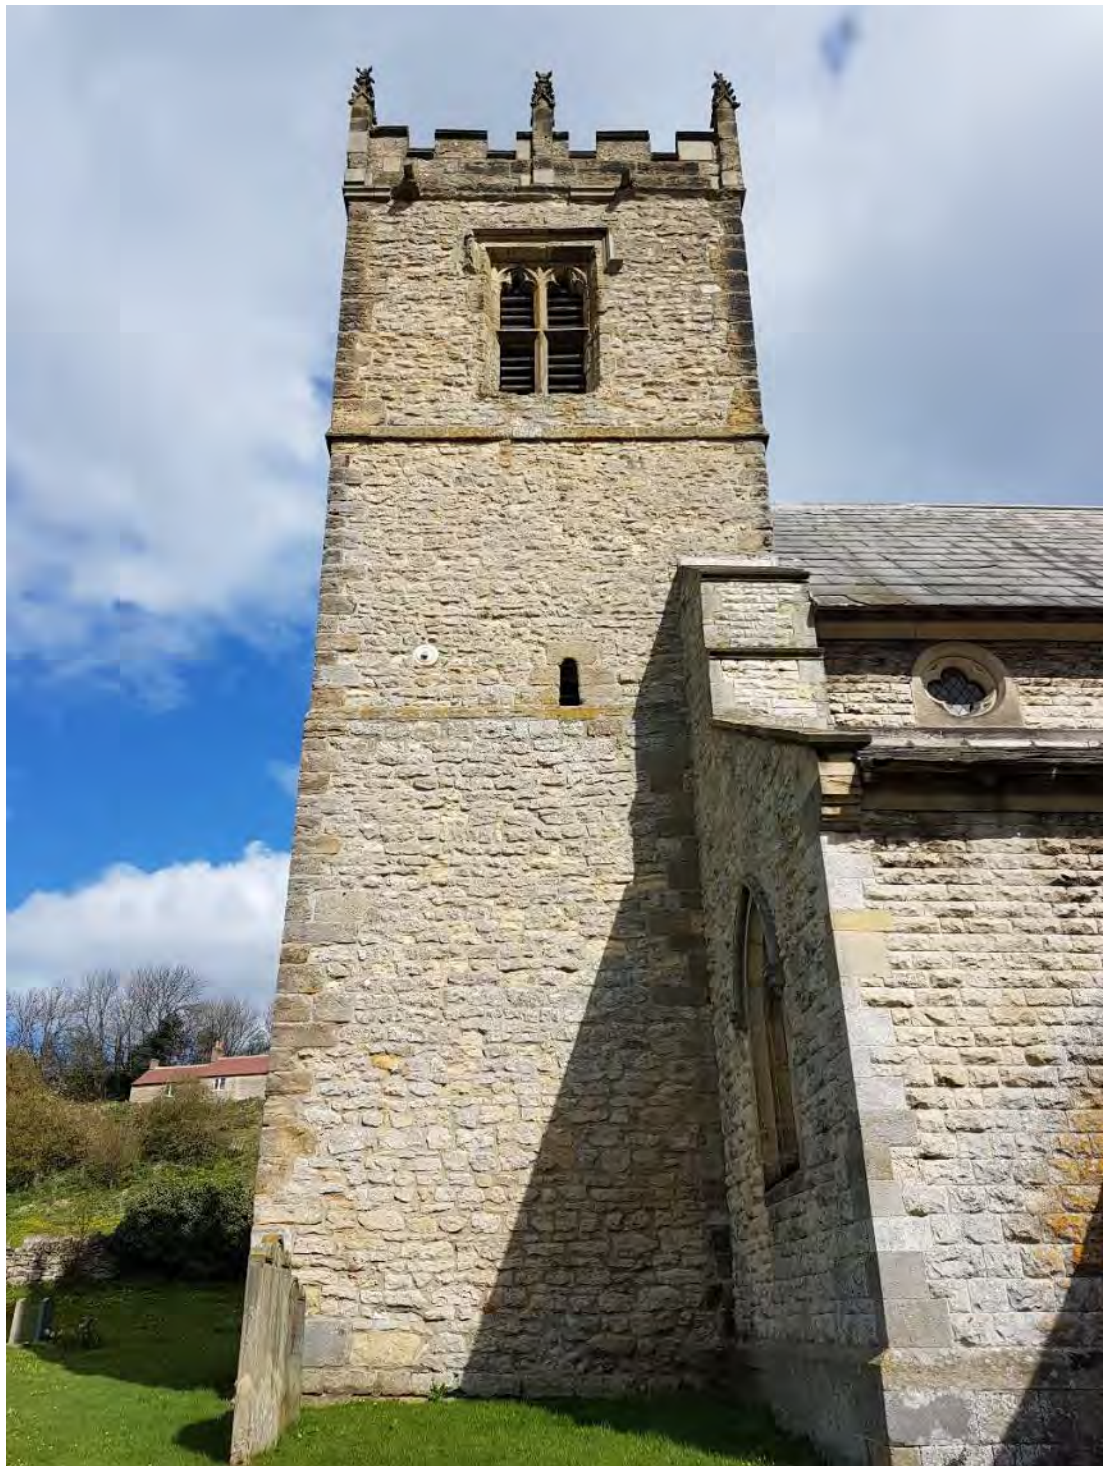
Figure 111: The southern elevation of the three-stage square tower, constructed from coursed rough limestone rubble with dressed calcareous sandstone quoining, with the Norman window in the second stage (Source: Author 2019).

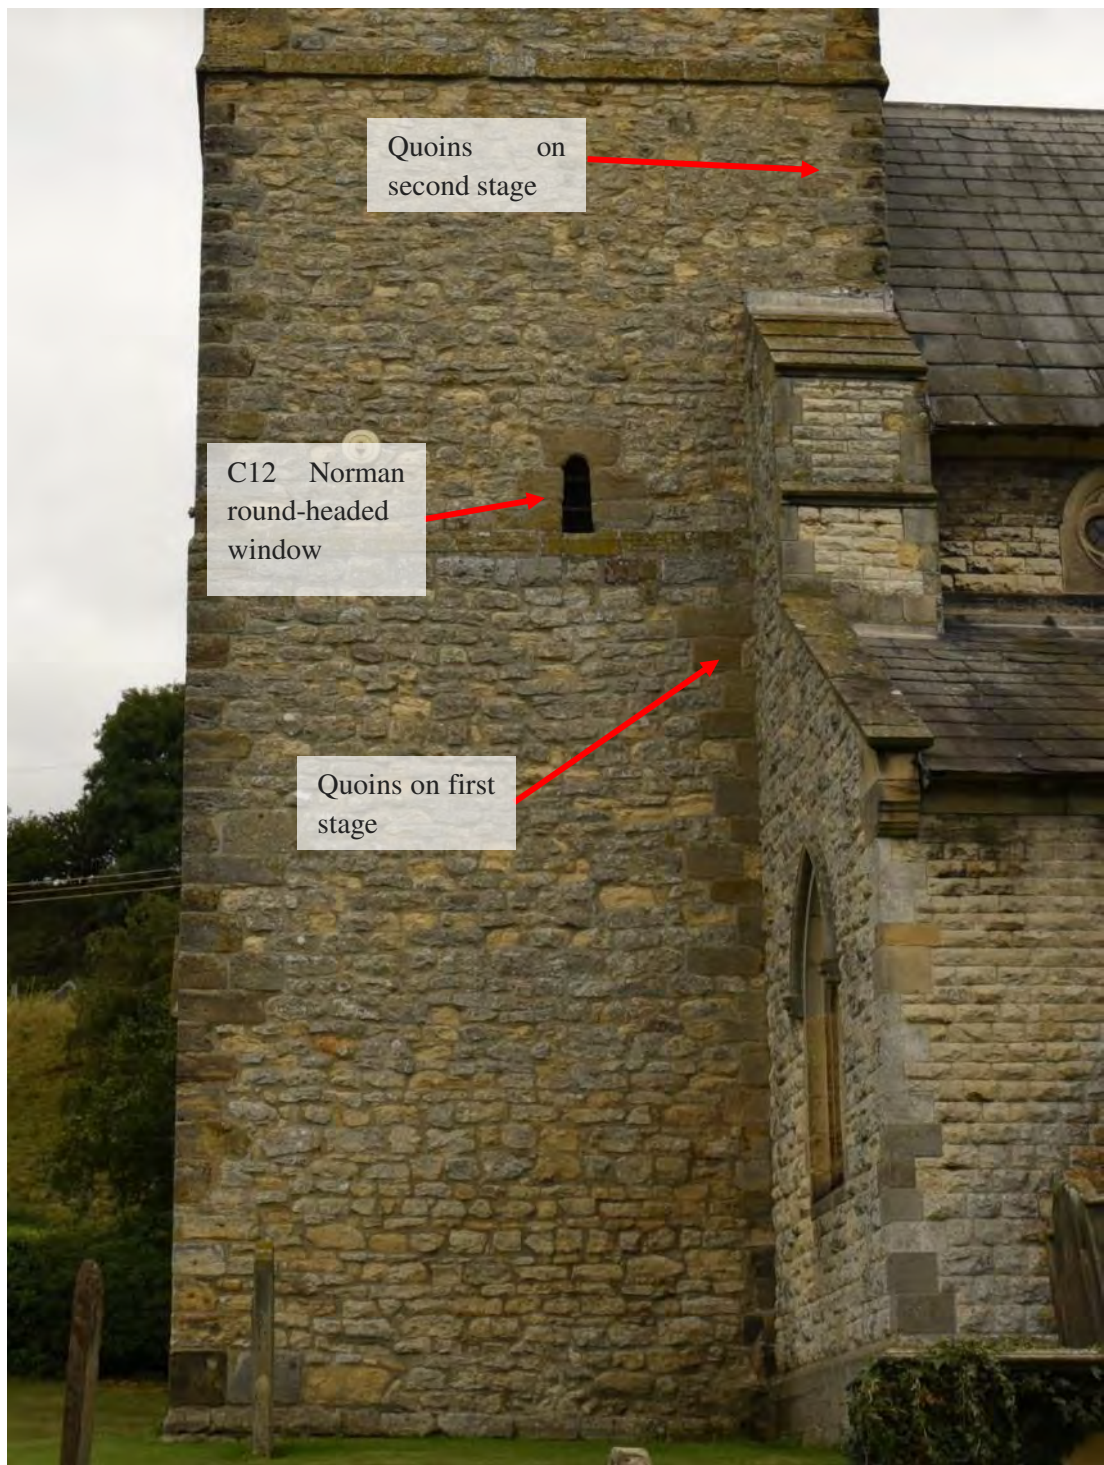
Figure 112: The eastern elevation of the three-stage square tower, constructed from coursed rough limestone rubble with dressed calcareous sandstone quoining, showing the fifteenth-century Perpendicular belfry (Source: Author 2019).

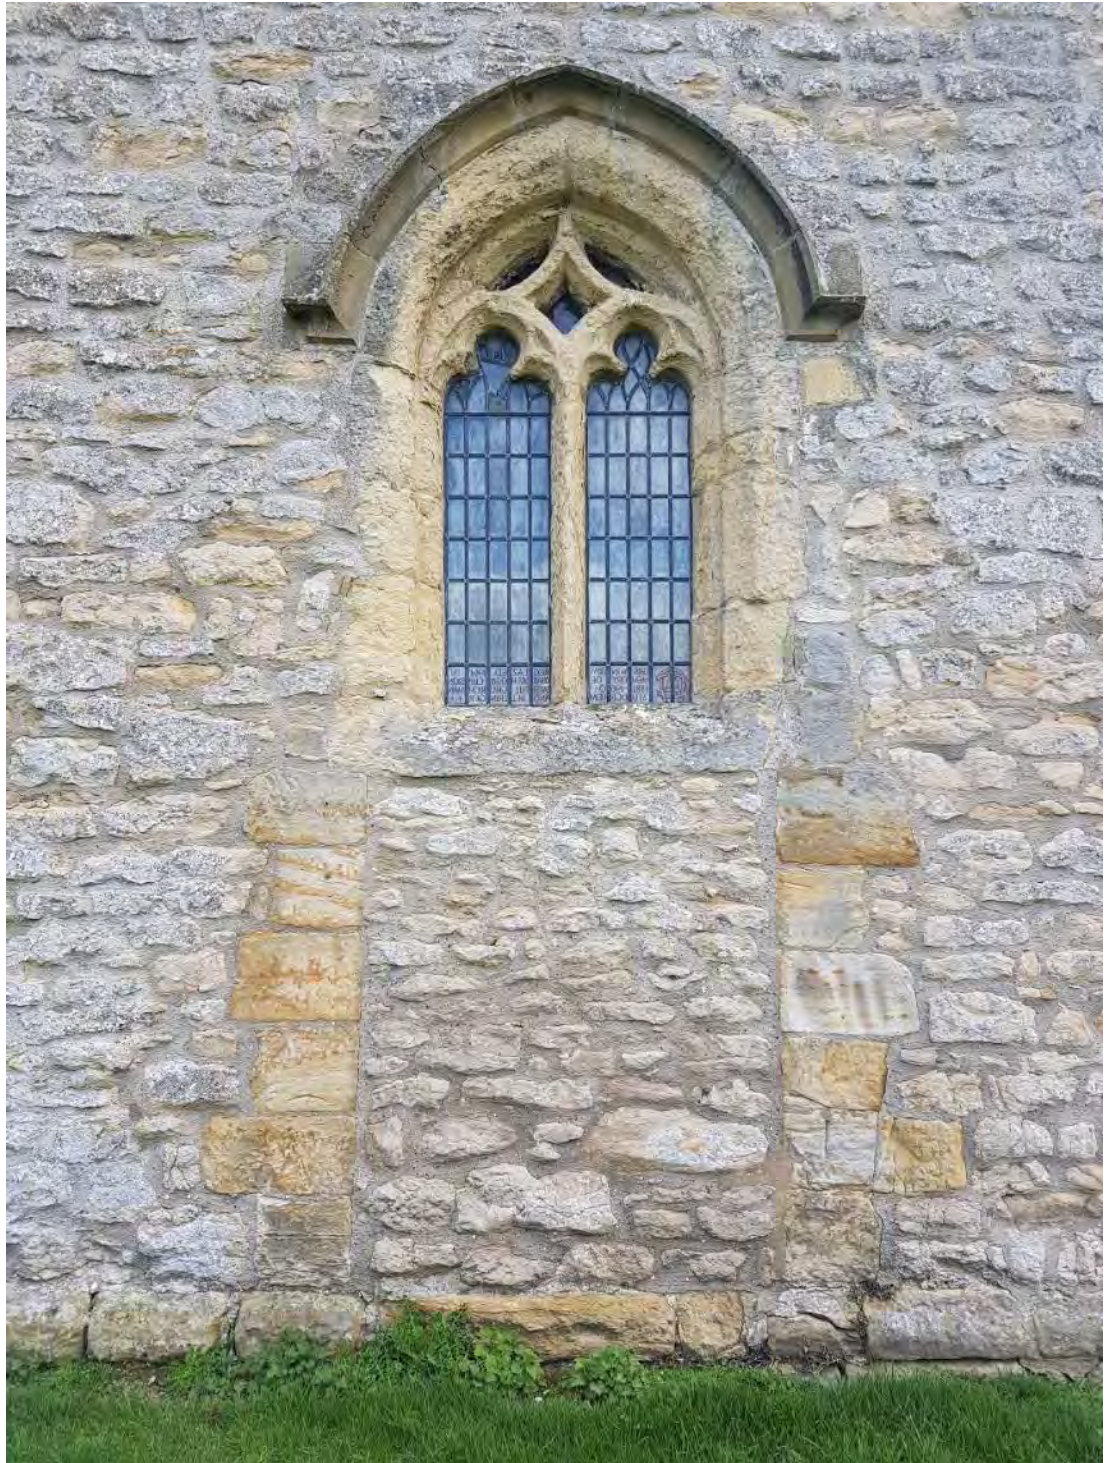
Figure 113: The first two stages of the tower exhibit matching quoining and coursed rubble masonry, and are therefore contemporaneous, but the quoining on each stage of the eastern wall does not align, indicating that the second stage was built over an earlier nave wall. The Norman round-headed window in the second stage is also shown (Source: Author 2019).

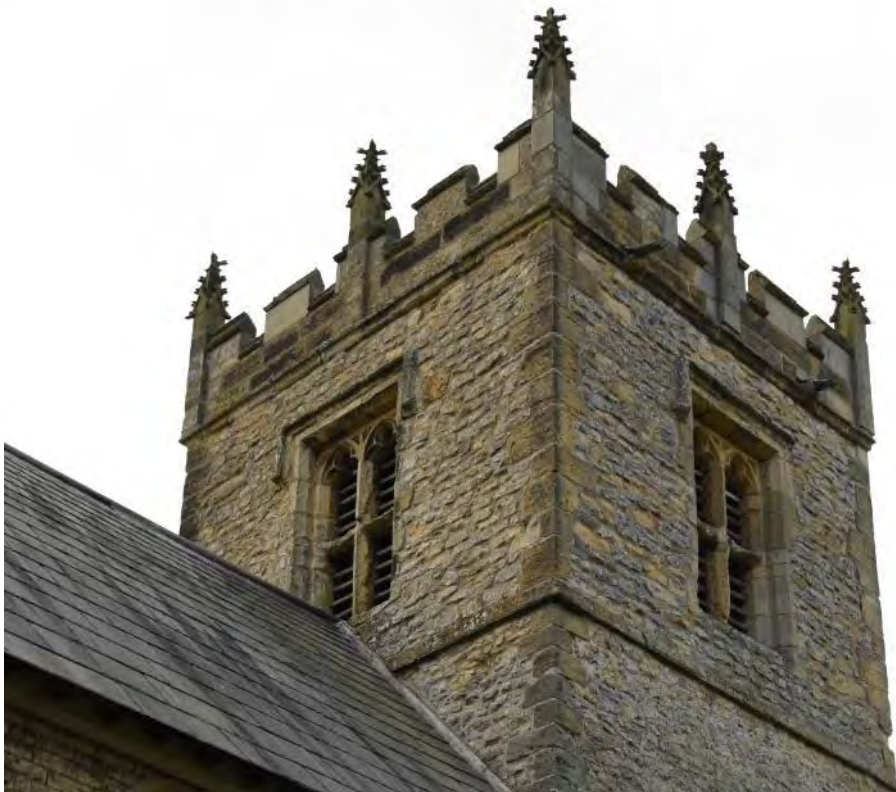
Figure 115: The southern and western elevations of the third stage of the tower, showing undisturbed course rubble limestone masonry with sandstone quoining surrounding a central fifteenth-century Perpendicular louvred window on the elevations, indicating that the belfry dates to the fifteenth century (Source: Author 2019).

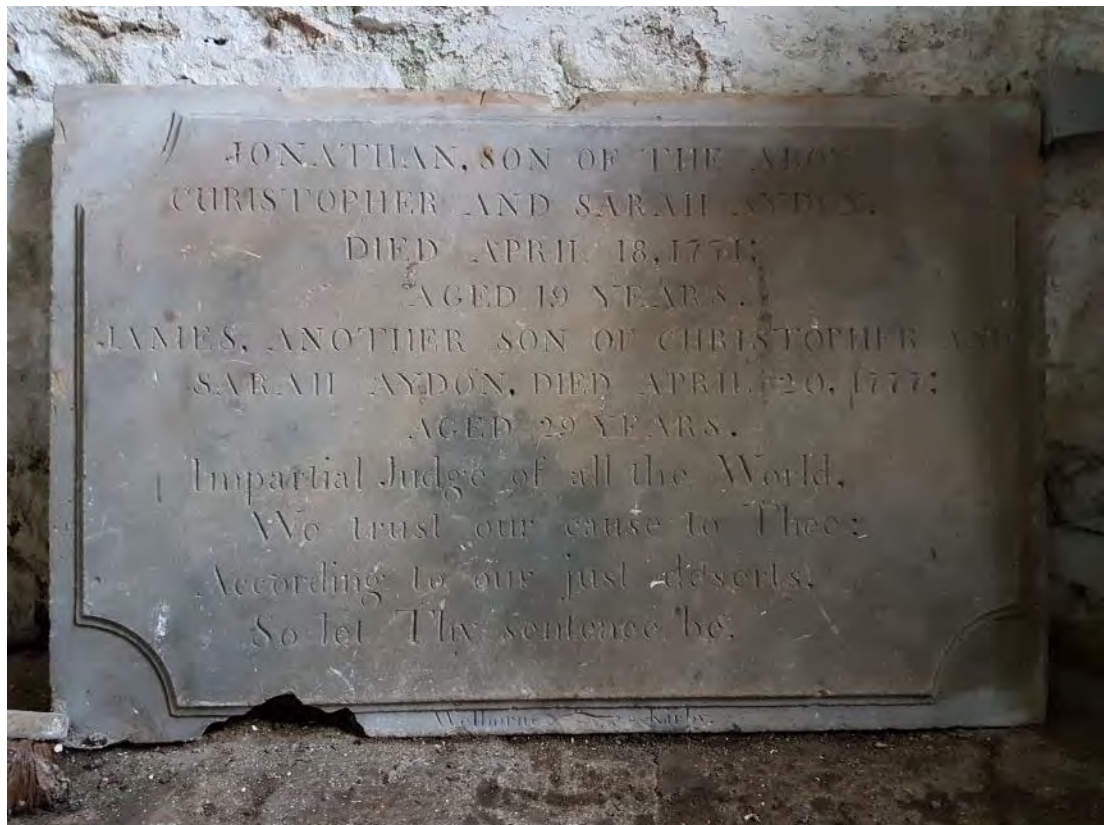
Figure 121: The eighteenth-century benefactors' board on the northern wall of the tower (Source: Author 2019).

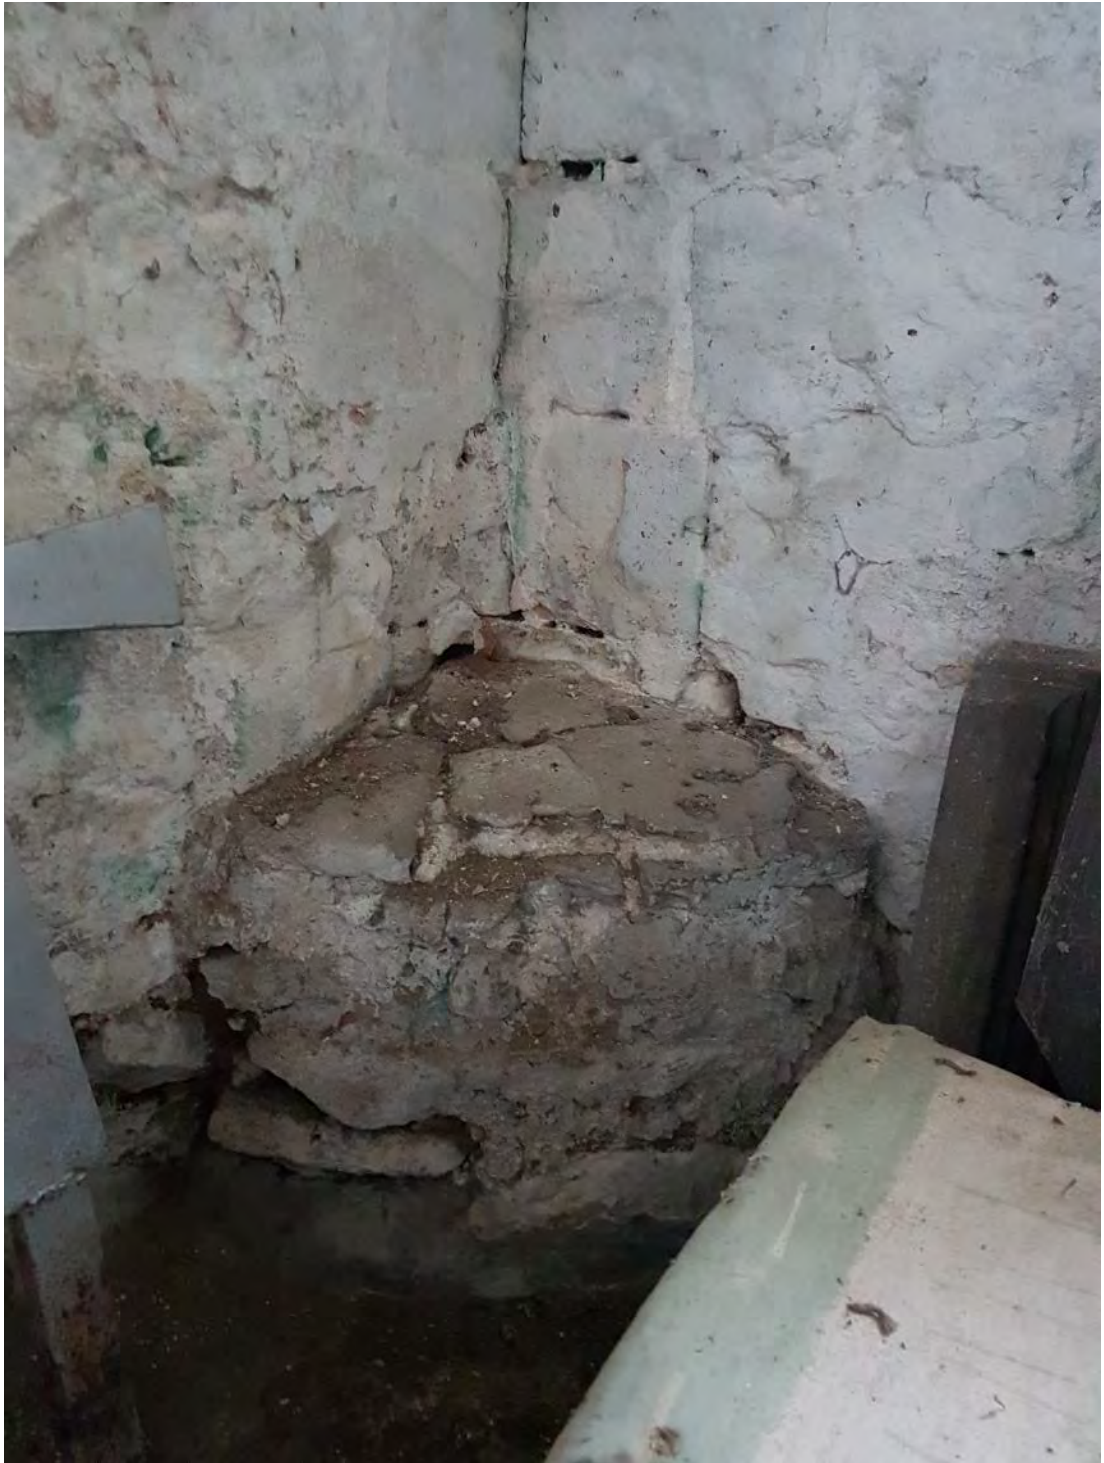
Figure 123: The north-west platform in the tower (Source: Author 2019).

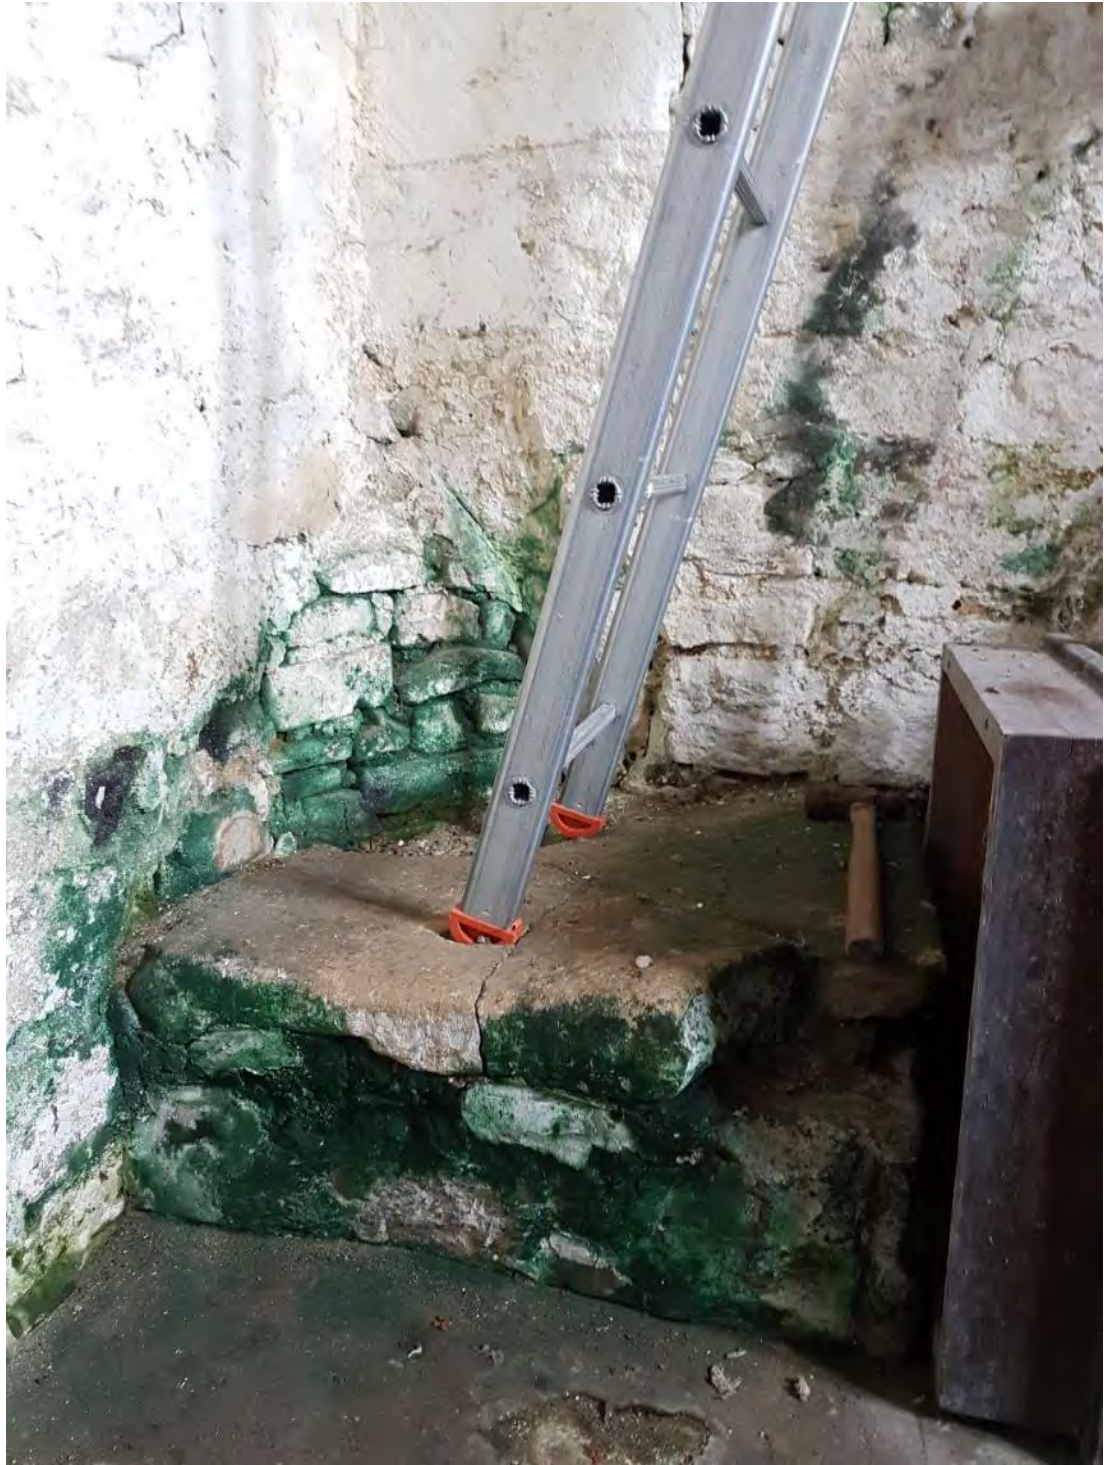
Figure 124: The south-west tower platform (Source: Author 2019).

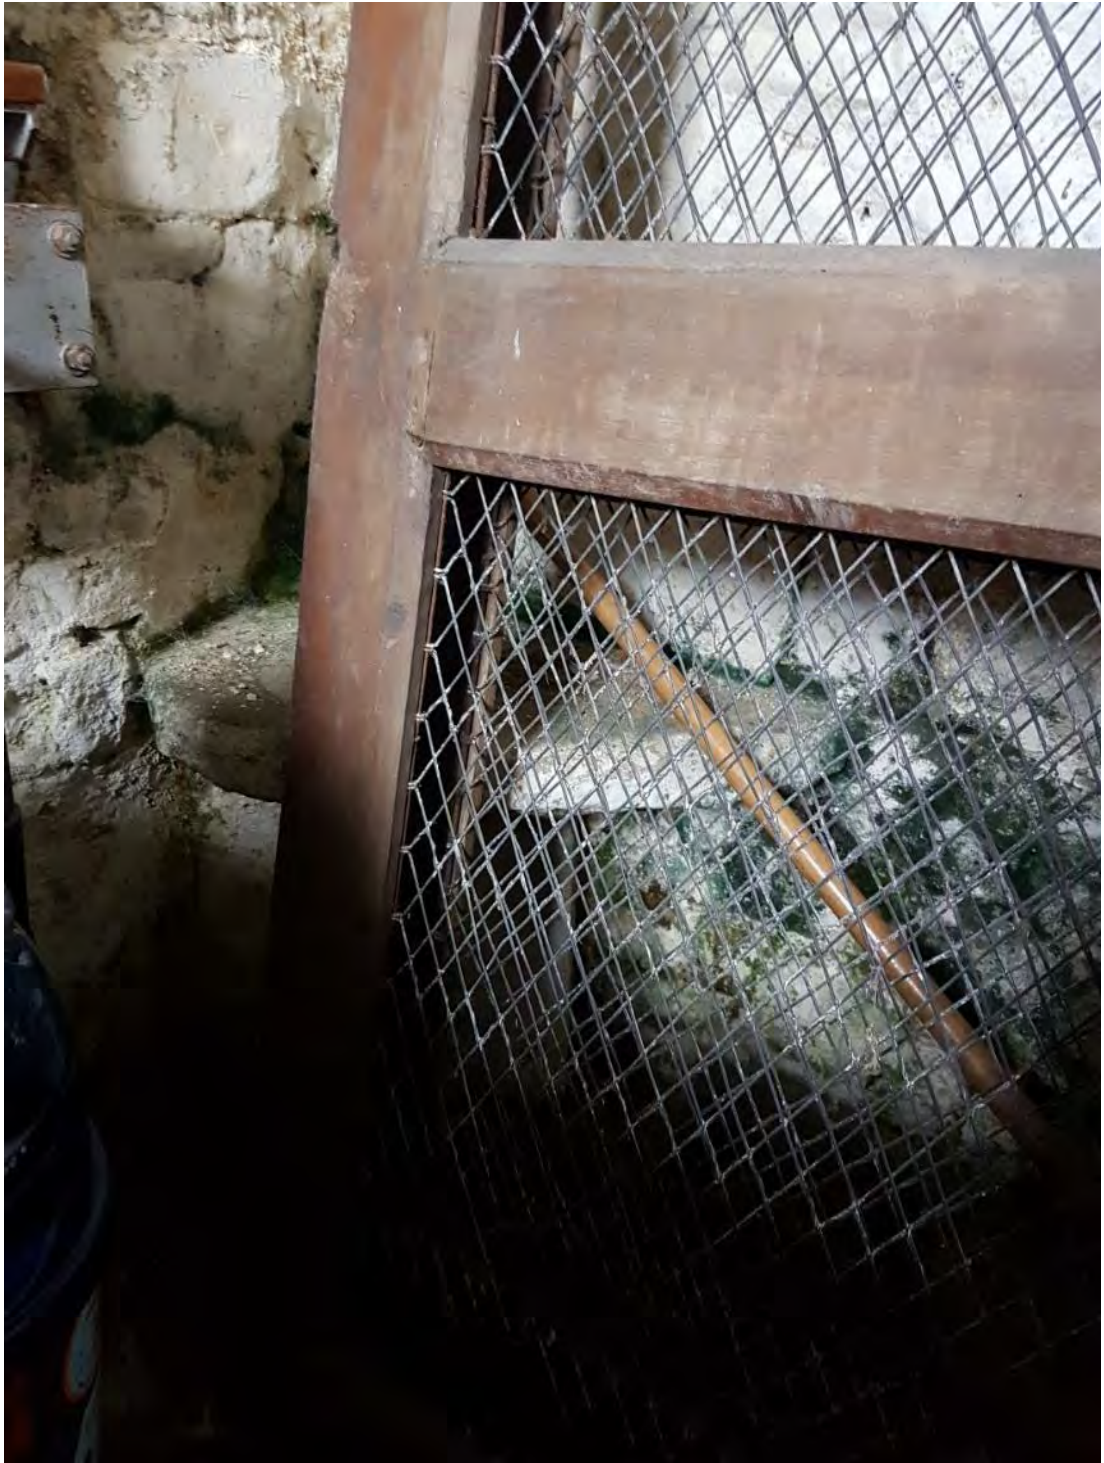
Figure 125: The south-east platform of the tower (Source: Author 2019).

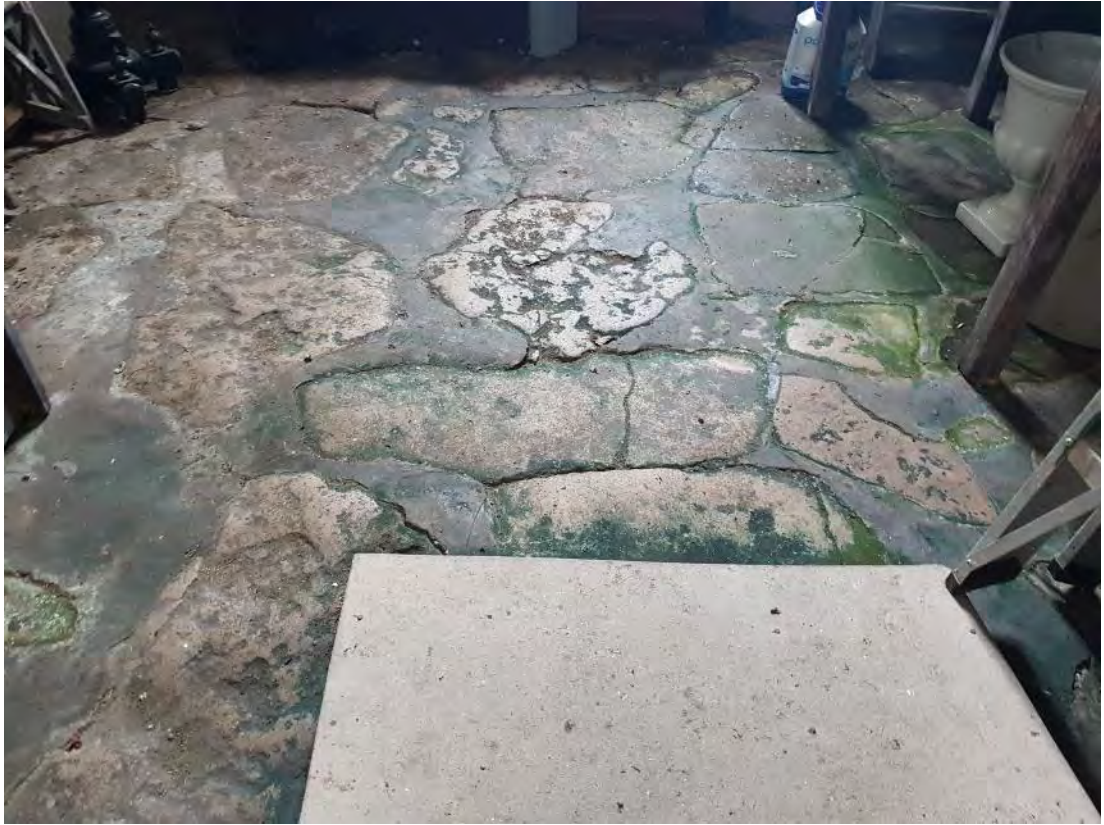
Figure 126: The north-east platform of the tower (Source: Author 2019).
