# **NOT ALL THOSE WHO WANDER ARE LOST:**

## **Reconstructing the Post-Medieval Phase of Stonegrave Minster using a Buildings Archaeology Approach**

**MA in the Archaeology of Buildings**

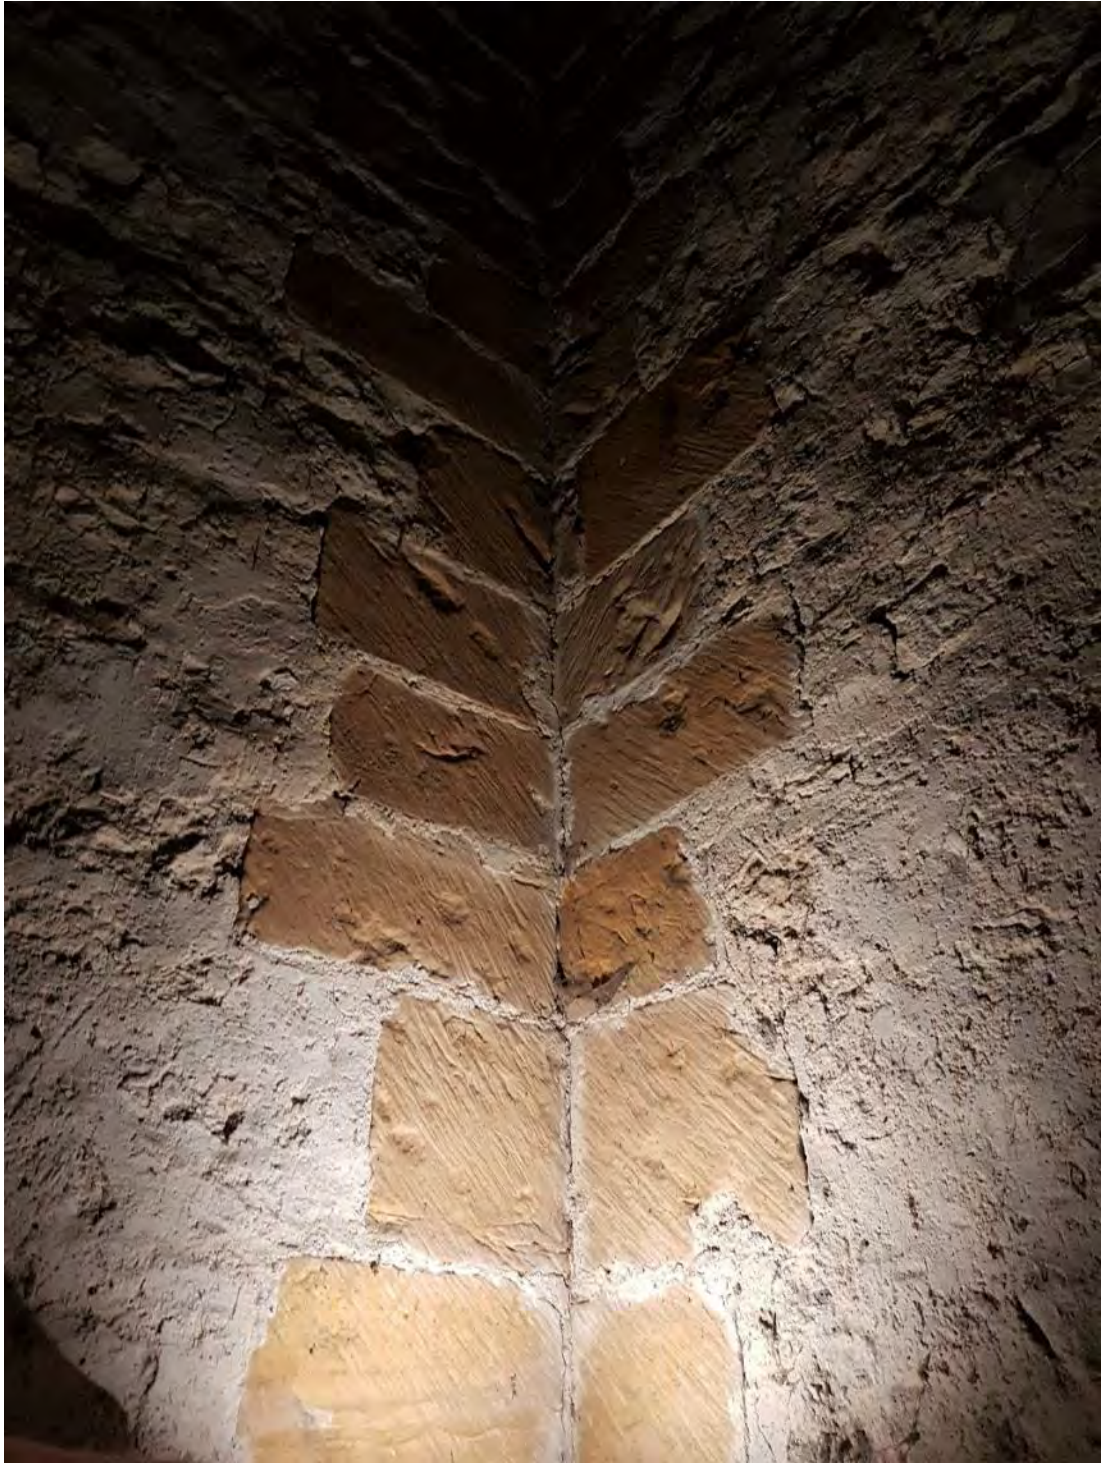
Figure 129: The plastered coursed rubble stone masonry with exposed sandstone quoining in the second stage of the tower (Source: Author 2019).

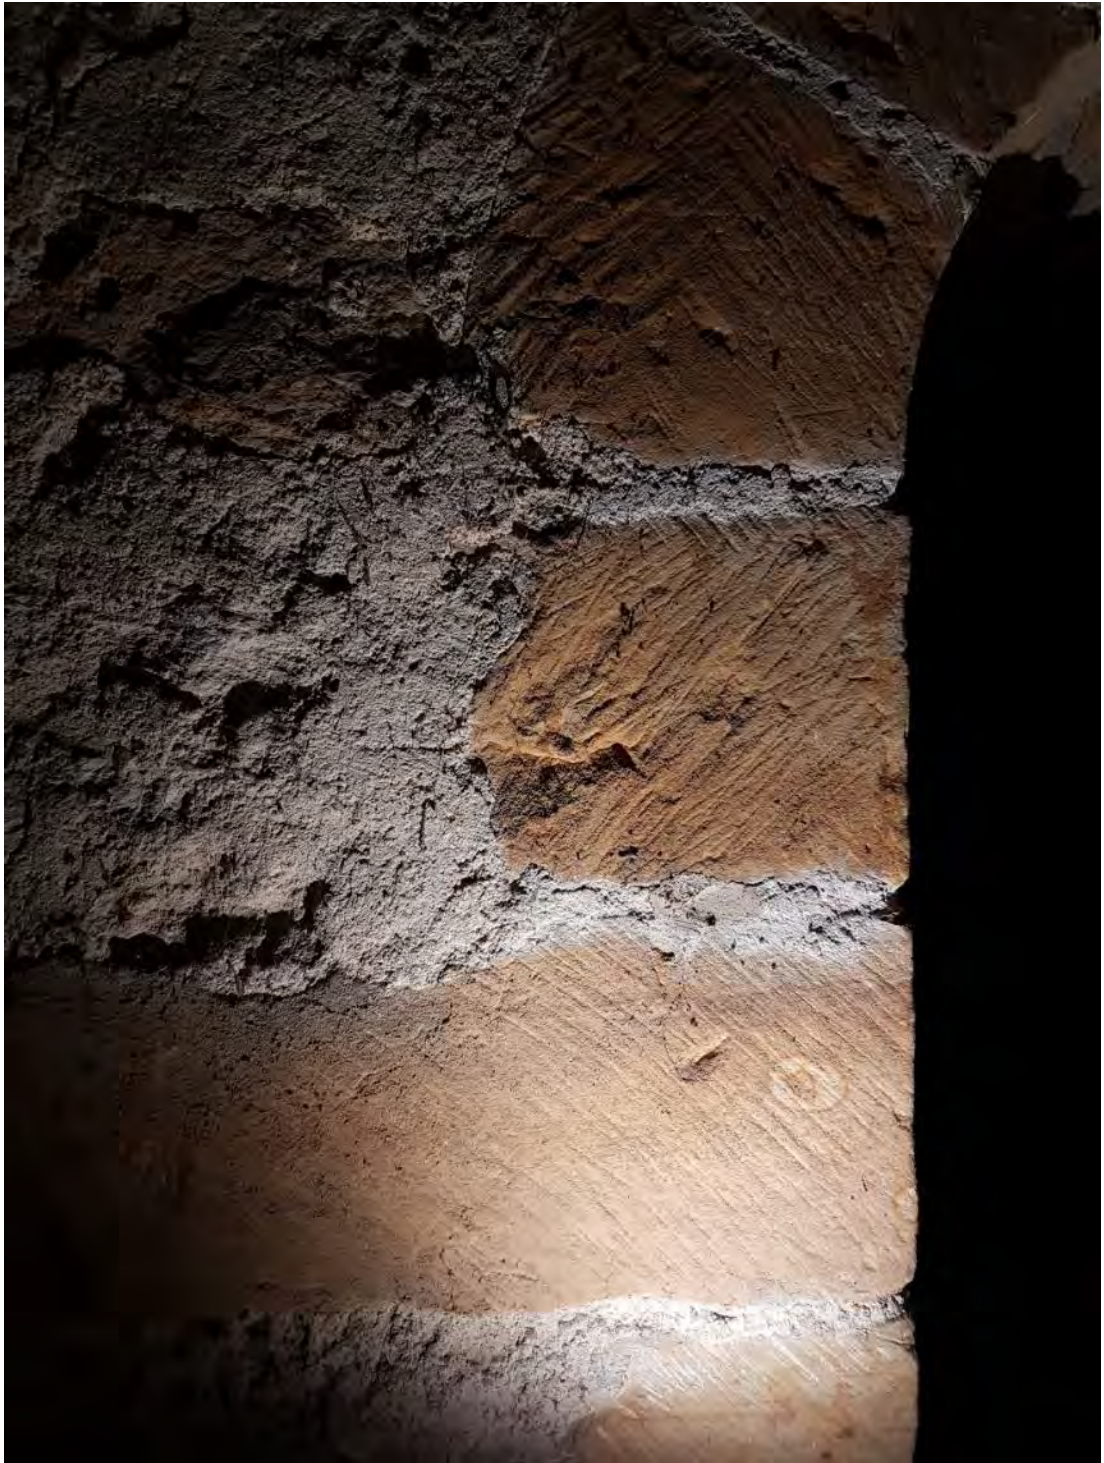
Figure 132: The twelfth-century Norman round-headed door in the eastern wall of the tower, showing the inserted timber door, with the timbers supporting the belfry above in the foreground (Source: Author 2019).

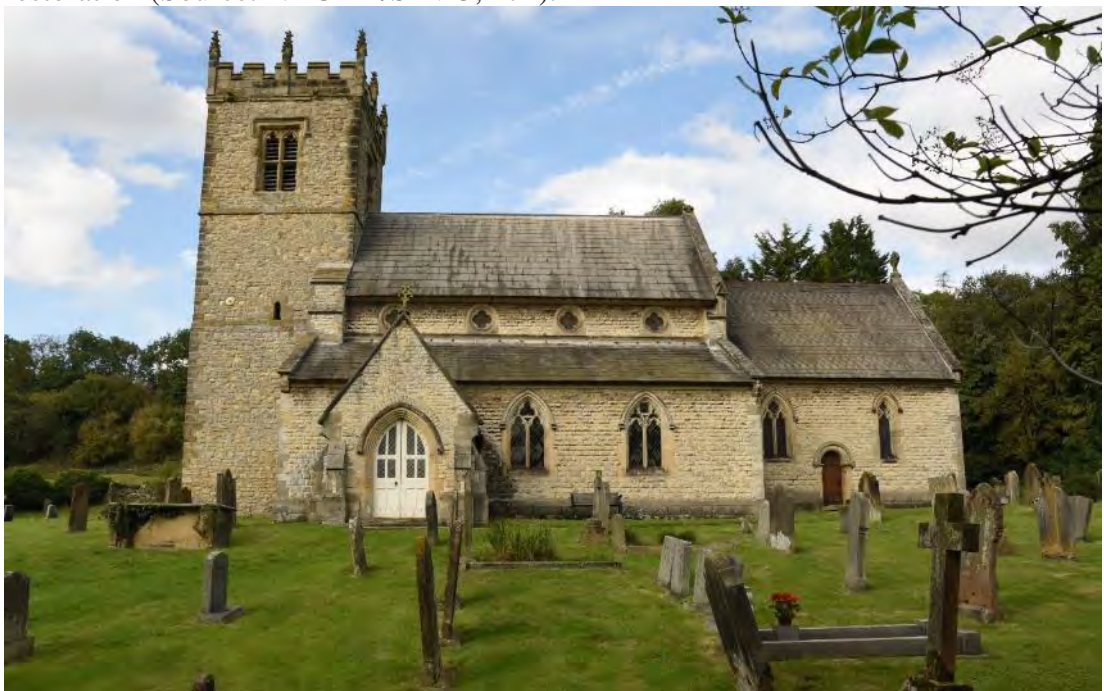
Figure 134: Photograph of the south elevation taken in April 1861, prior to the restoration (Source: NYC PR/STV 3, 174).

Prior to the Victorian restoration of 1862-3, the church tower also comprised a one bay square three-stage western tower constructed from coursed rough limestone rubble with dressed sandstone quoining (Figure 10-Figure 141; Section 4.3.8). Written and photographic evidence confirm the tower's appearance prior to the restoration as little different to its current appearance, with its early twelfth-century Norman lower stages and its fifteenth-century Perpendicular third stage and parapet (Figure 10-Figure 135, Figure 148-Figure 149; Whellan and Sheahan 1859, 886; YAS 1862, cxv; Glynn 1863 in Butler 2007, 395). While the existing pinnacles date to c.1885 (Fac. 1861/2; NYC PR/STV 3), their antecedents were likely constructed in the fifteenth century along with the embattled parapet (Figure 115-Figure 116; Chapter 4). This is due to the pinnacle bases displaying the same stone and deterioration as the battlements, aside from later repairs (Figure 136-Figure 137; BIA Fac. 1983/84; NYC PR/STV 3). However, by the

Post-Medieval period, only stubs remained of these pinnacles on the corners and central battlements (Figure 10-Figure 141). The tower in 1861-3 also displayed evidence of repair to the mortar joints of the quoining, parapet and stonework surrounding the fourteenth-century western window (Figure 10 and Figure 138). An 1840 disbursement for ‘John Buck’s Bill bell roof’ for 17 shillings in the Churchwarden’s accounts indicates the re-roofing of the belfry (NYC PR/STV 2). Aside from repairs and an 1840s roof, the Post-Medieval tower was, therefore, little different to the extant tower.

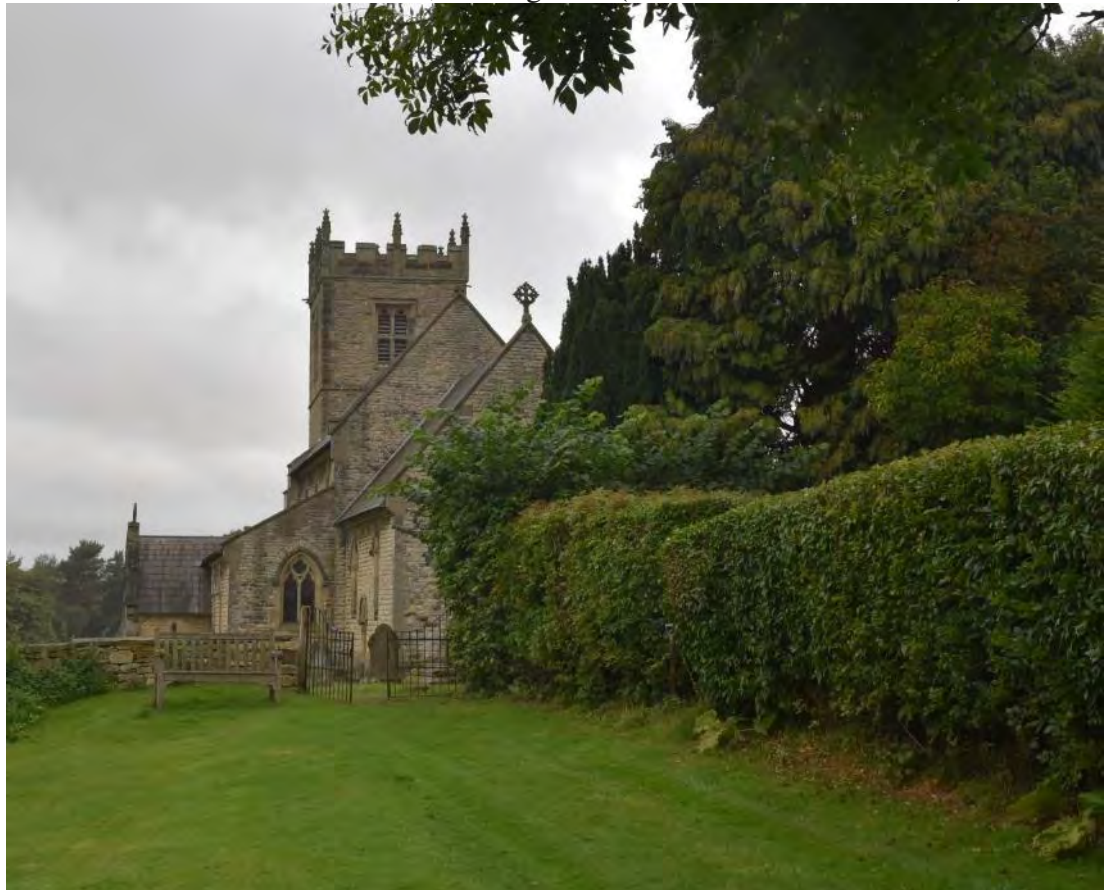
Figure 136: Photograph of the eastern elevation during the demolition in 1862-3, showing the C18/early C19 intersecting y-tracery of the eastern window, the C15 roof structure of the chancel and nave, looking west (Source: NSM RPS 18950).

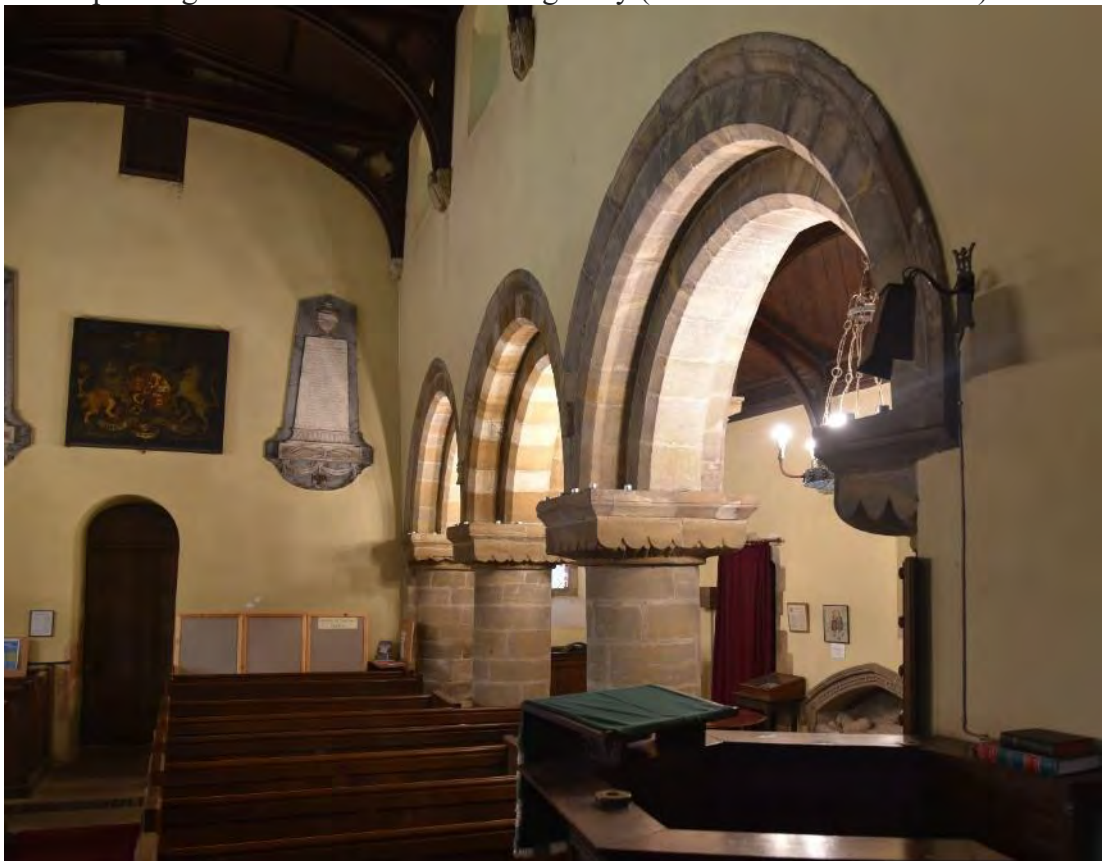
Figure 145: Photograph taken in 2019, showing the interior, demonstrating the plastered walls and the repair work to the arcade (Source: Author 2019).

Both visual analysis and archival research demonstrate the existence of a three-decker pulpit in the north-eastern corner of the nave during the Post-Medieval period (Figure 142-Figure 145). Two sections of the chamfered label above the eastern column of the eastern bay of the northern arcade, as well as the removal of a section of the abacus and echinus of this capital, appear to have been undertaken in the Post-Medieval period (Figure 150). These elements, as well as the base of the column, were repaired during the Victorian restoration (Figure 151-Figure 152). The 1861 interior sketch shows a three-decker pulpit with its tester adjacent to this column in the north-eastern corner of the nave (Figure 142); it is likely that the sections of the arcade were removed to allow the pulpit and tester to be flush with the wall (Figure 150-Figure 152). This pulpit comprised the extant c.1637 oak hexagonal pulpit (YAS 1862, cxv), a now missing c.1637 hexagonal tester, and an eighteenth-century Georgian plain panelled reading desk and Clerk's desk (Figure 142 and Figure 153). This reuse of an extant pulpit in a three-decker pulpit was common in the late Post-Medieval period (Yates 2000, 34).

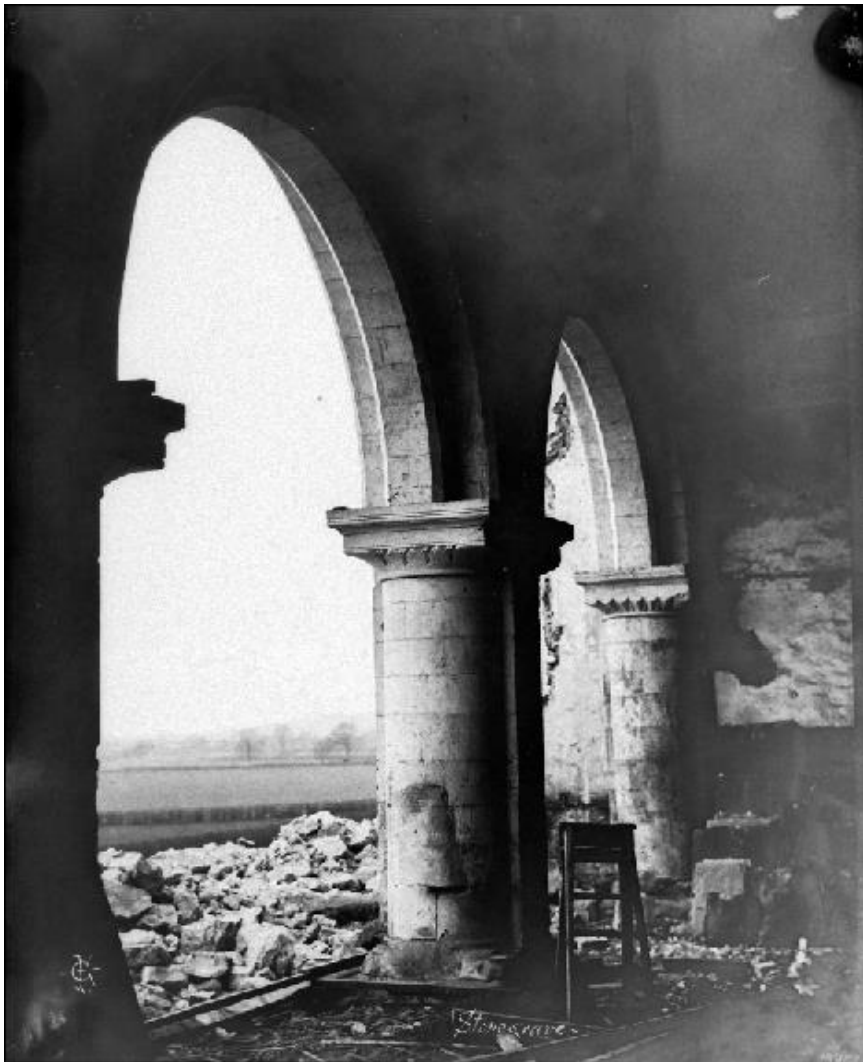
Figure 146: 1862-3 photograph of the south arcade, taken from the chancel entrance (Source: NSM RPS 18952).

The interior of the south aisle exhibited whitewashed masonry, shown by the 1862-3 photographs (Figure 135 and Figure 146). A.W. Wetherall noted the discovery of hagiographical Medieval paintings beneath the whitewash on the south wall and central pillar during the demolition of the south wall (NYC PR/STV 2, 35). This indicates that at least some of the Medieval paint scheme was preserved under the post-Reformation whitewashing in the Post-Medieval church. There is no evidence for Post-Medieval paintings in the south aisle.

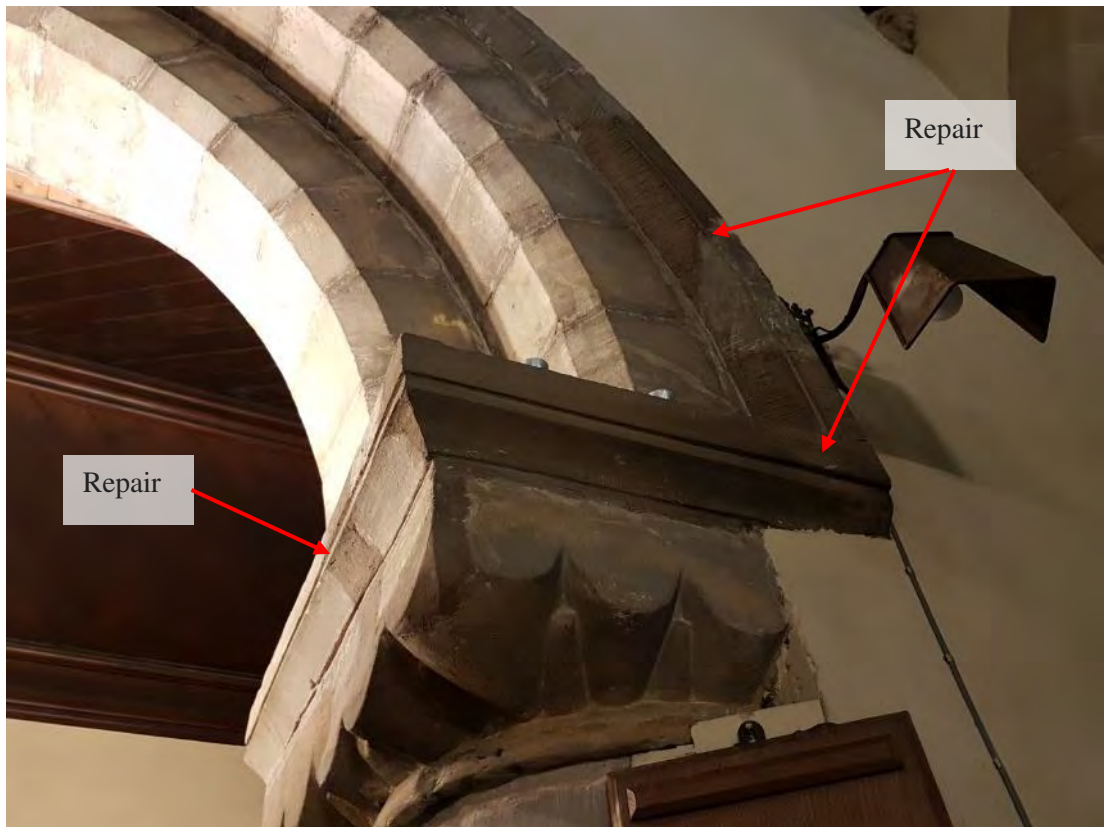
Figure 151: The eastern end of the northern arcade, showing the cementitious repair to the chamfered label and the capital (Source: Author 2019).

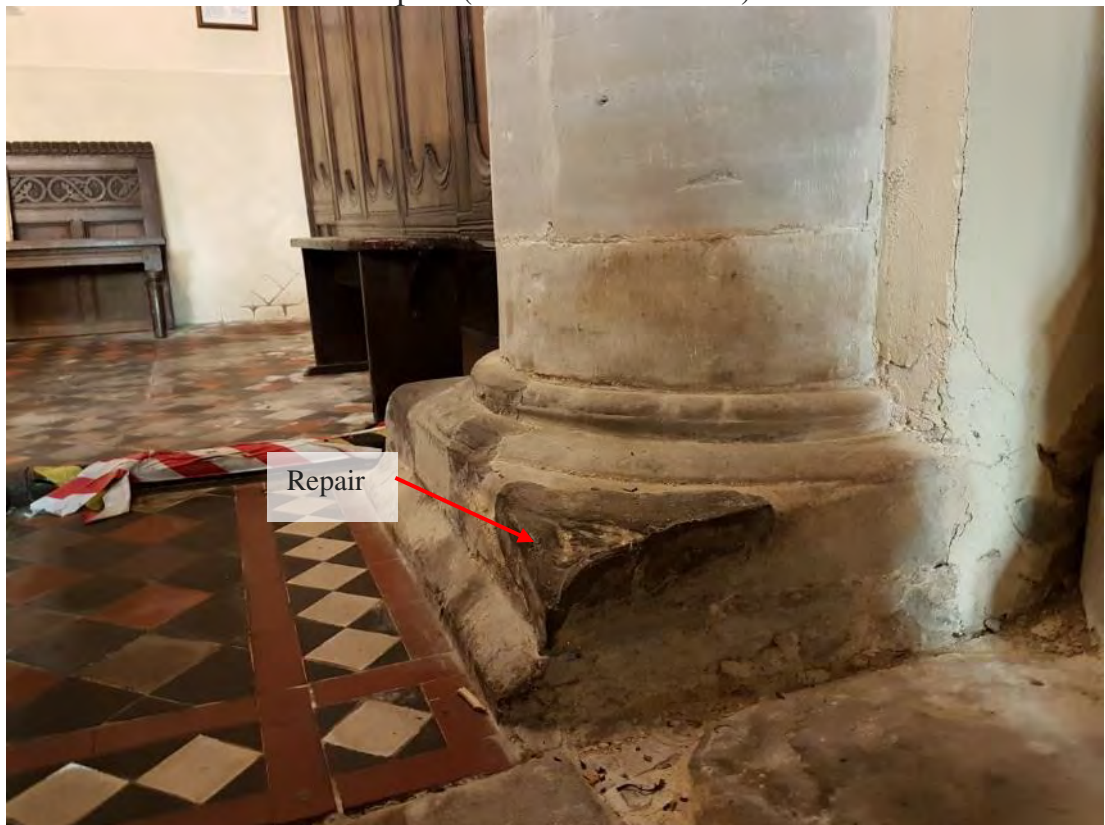
Figure 152: The eastern end of the northern arcade, showing the cementitious repair to the base of the eastern column, which may be evidence of the location of the three-decker pulpit (Source: Author 2019).

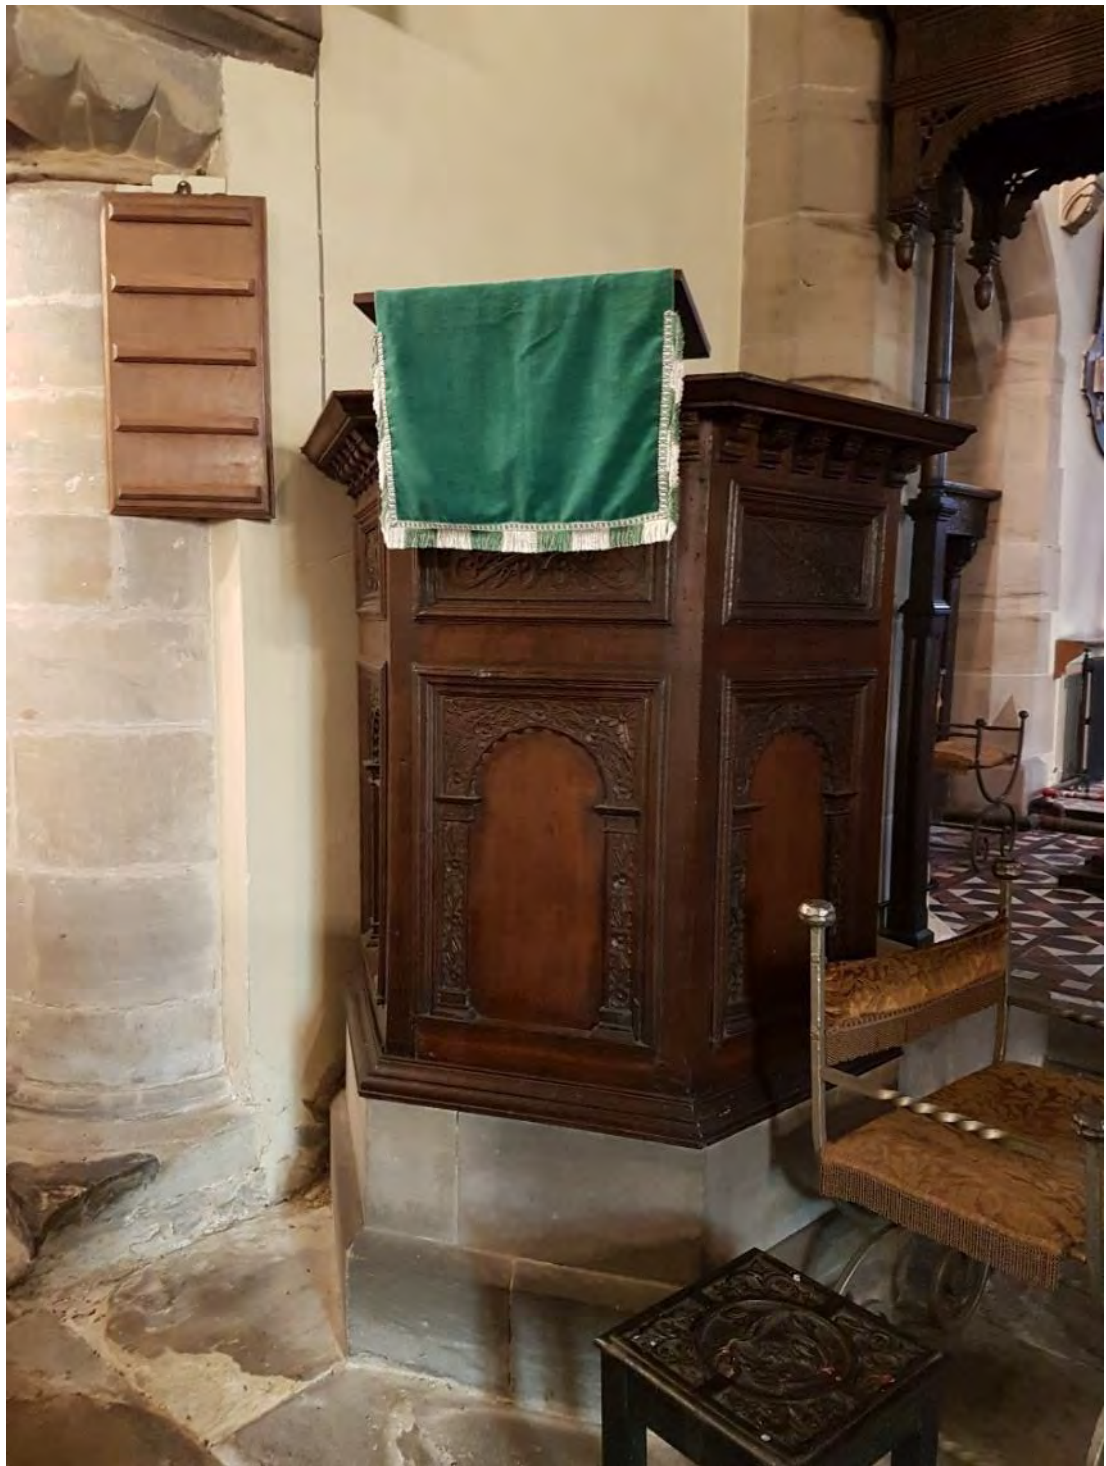
Figure 153: The extant pulpit at the north-eastern corner of the nave, showing the 1637 pulpit to reused and set onto an 1862-3 sandstone base (Source: Author 2019).

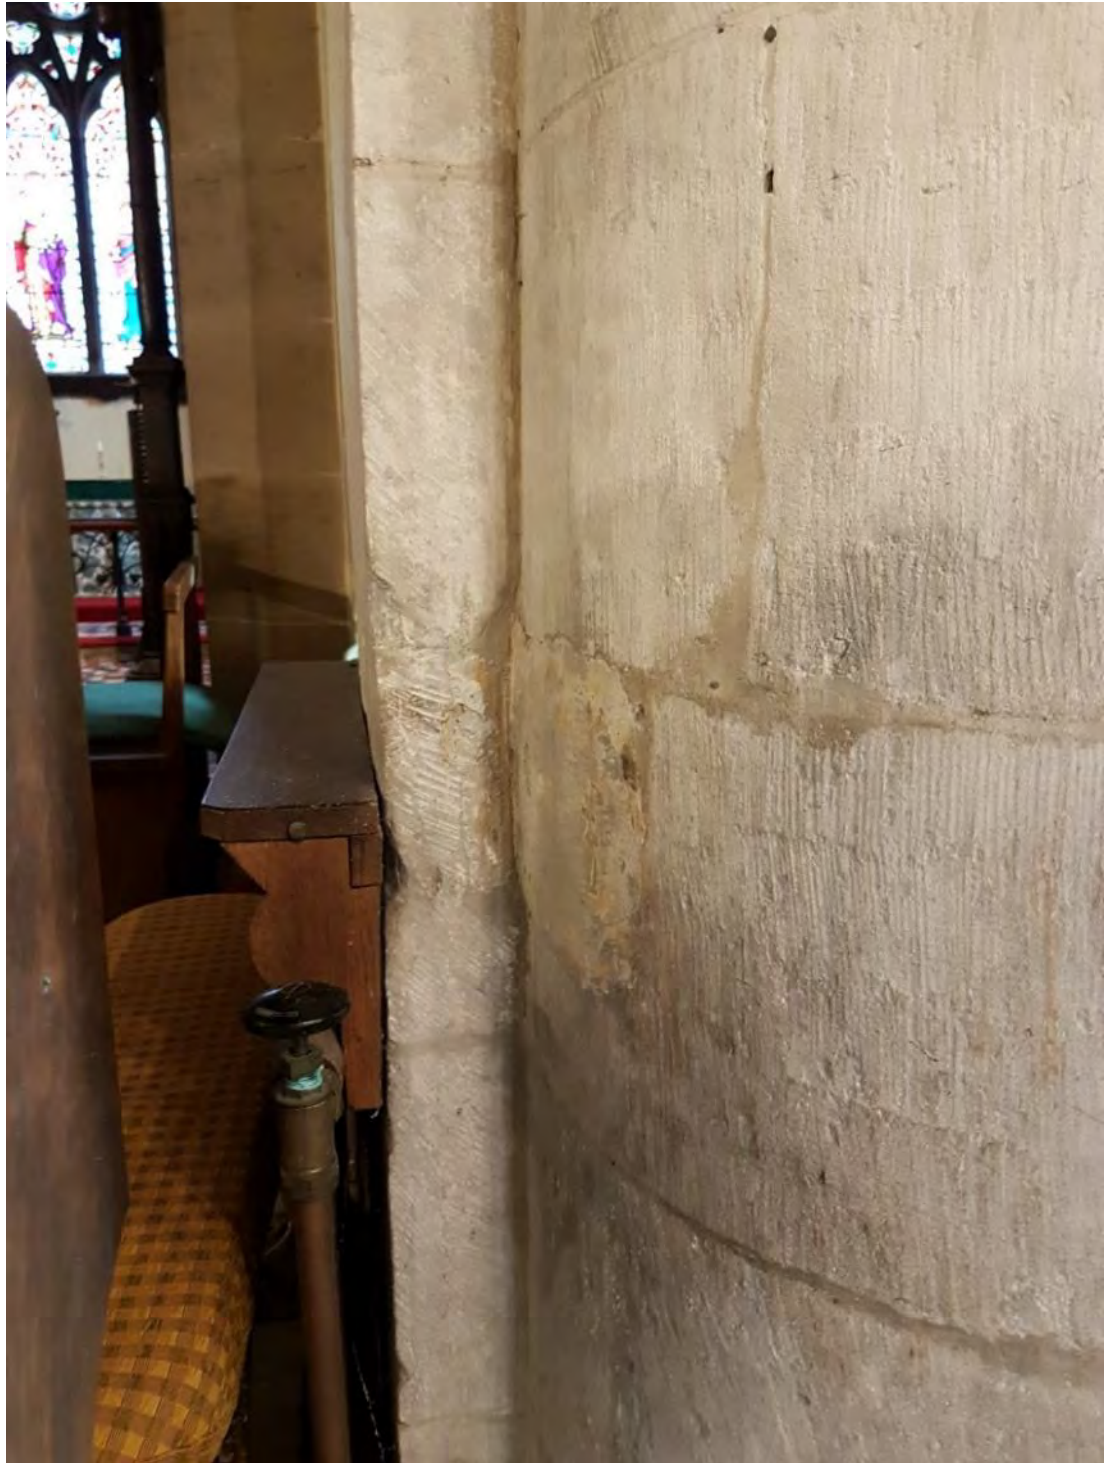
Figure 154: Repair from fixing of box pews to eastern column of southern arcade (Source: Author 2019).

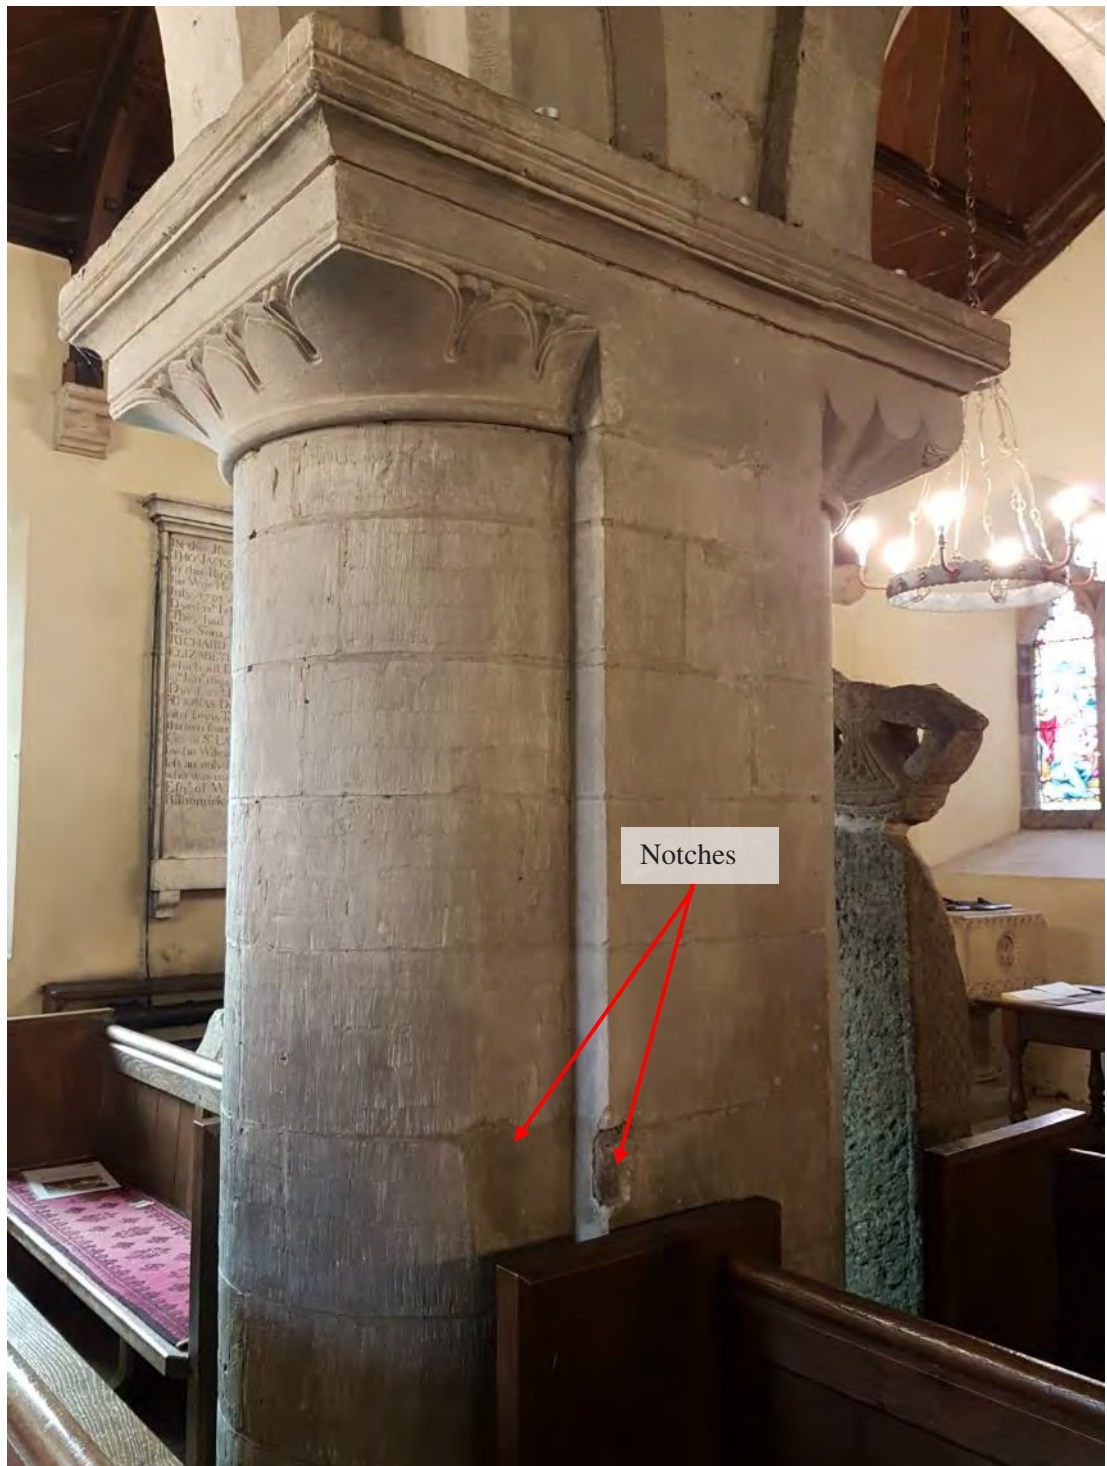
Figure 156: The central pillar of the southern arcade, showing the repaired notches, possibly a result of the installation of the box pews (Source: Author 2019).

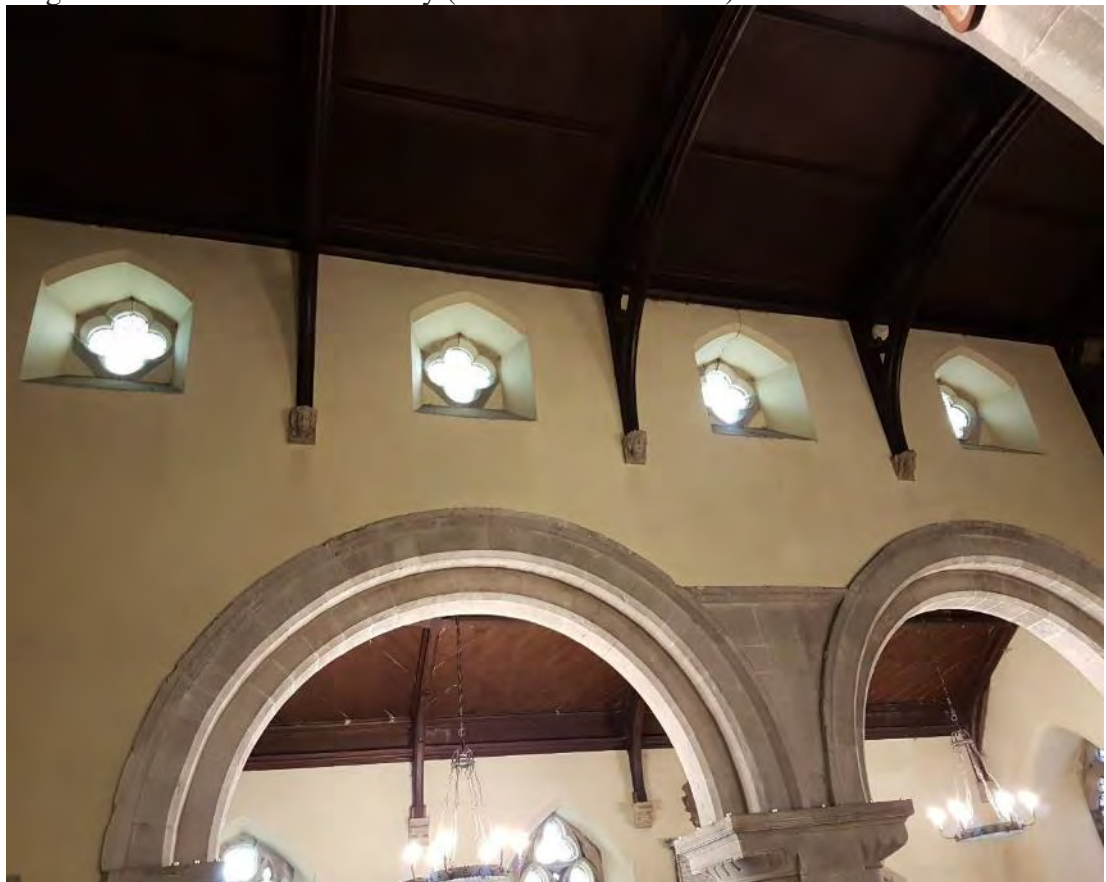
Figure 162: The reused C15 corbels along the north wall of the 1862-3 clerestory, decorated with family crests and human heads. The corbels have been reused at a lower height than for the C15 clerestory (Source: Author 2019).

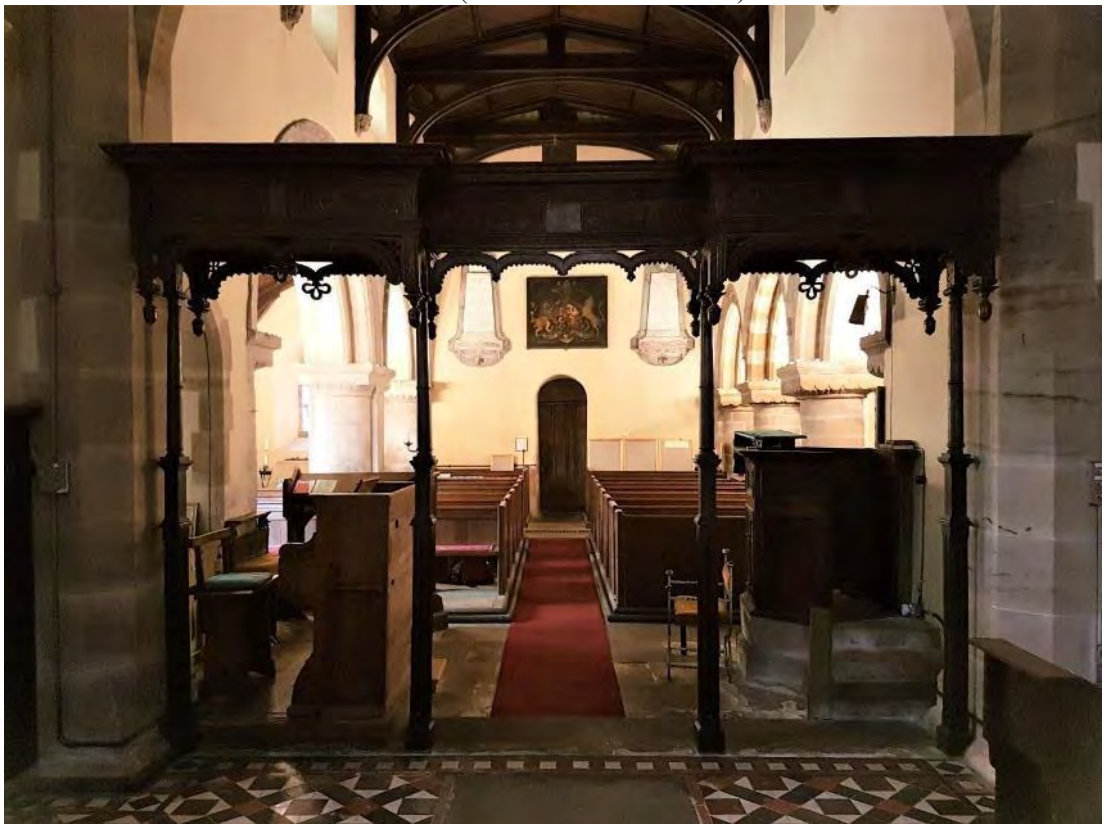
Figure 177: The western side of the 1637 oak chancel screen from the nave, showing a head with a dated recessed central bay and a floriated frieze below a moulded cornice and dentils, resting on four turned and moulded shafts, with hanging brandished decoration with trefoils and acorns (Source: Author 2019).

Sources demonstrate that the extant 1637 three-bayed square-framed oak chancel screen was located underneath the square-headed chancel arch in the Post-Medieval church, forming a visually permeable, but symbolic, barrier between the nave and chancel (Figure 142, Figure 167 and Figure 177; Eastmead 1824, 187; The York Herald 1863, 7). The oak chancel screen comprises a decorative head with a recessed central bay resting on four turned and moulded shafts separating the bays (Figure 177-Figure 178). The head of the chancel screen is decorated with a floriated frieze below a moulded cornice and dentils, with hanging brandished decoration with trefoils and acorns (Figure 177-Figure 178). Prior to the restoration, the chancel screen had two timber panels in the southern bay, and likely, in the northern bay (Figure 142). Though the simple style of the panels indicates an eighteenth-century date, it is possible that details may have been omitted in the drawing, and that they were original to the 1637 chancel screen (Figure 142). These panels are likely to have been the height of the lower mouldings around the shafts, though there may have been additional decoration or panelling between the two mouldings (Figure 177-Figure 178). Although the extant chancel screen appears to be shorter than shown in the drawing from 1861, the height is likely to be an oversight made by the artist, as the chancel screen shows no signs of foreshortening (Figure 142, Figure 177-Figure 178).

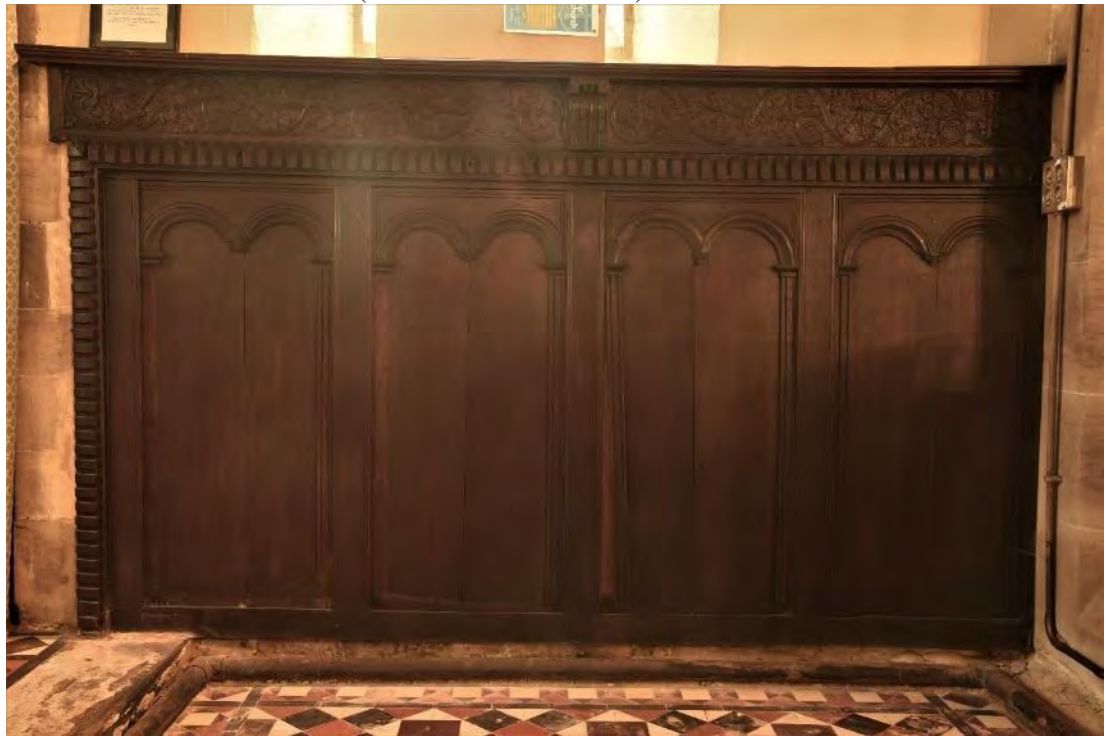
Figure 179: The extant part of the reused seventeenth-century timber reredos along the eastern wall of the chancel (Source: Author 2019).

Documentary sources demonstrate that the Post-Medieval chancel was lined with timber panelling (Figure 142; Eastmead 1824, 187; The York Herald 1863, 7). The pictorial source for the panelling in situ shows that it covered the chancel walls to a height approximately level with the chancel screen but below the eastern window (Figure 142). The panelling on the southern elevation appears to comprise a continuous frieze and cornice above panelling, with a gap in the centre for the Norman door (Figure 142). The panelling on the eastern elevation is indistinguishable and is not visible on the northern elevation (Figure 142). From the visual analysis of the extant church (Chapter 4), seventeenth-century timber panelling has been reused along the eastern wall of the chancel (Figure 179), in the western bay of the chancel along the south wall (Figure 180), along the western and southern sides of the vestry (Figure 181, Figure 182, Figure 183 and Figure 184), in the north aisle as a chair (Figure 185) and in the tower (Figure 186). The majority of these screens and panelling display evidence of reuse, such as foreshortening, asymmetry, unused joints and missing elements (Figure 179-Figure 186).

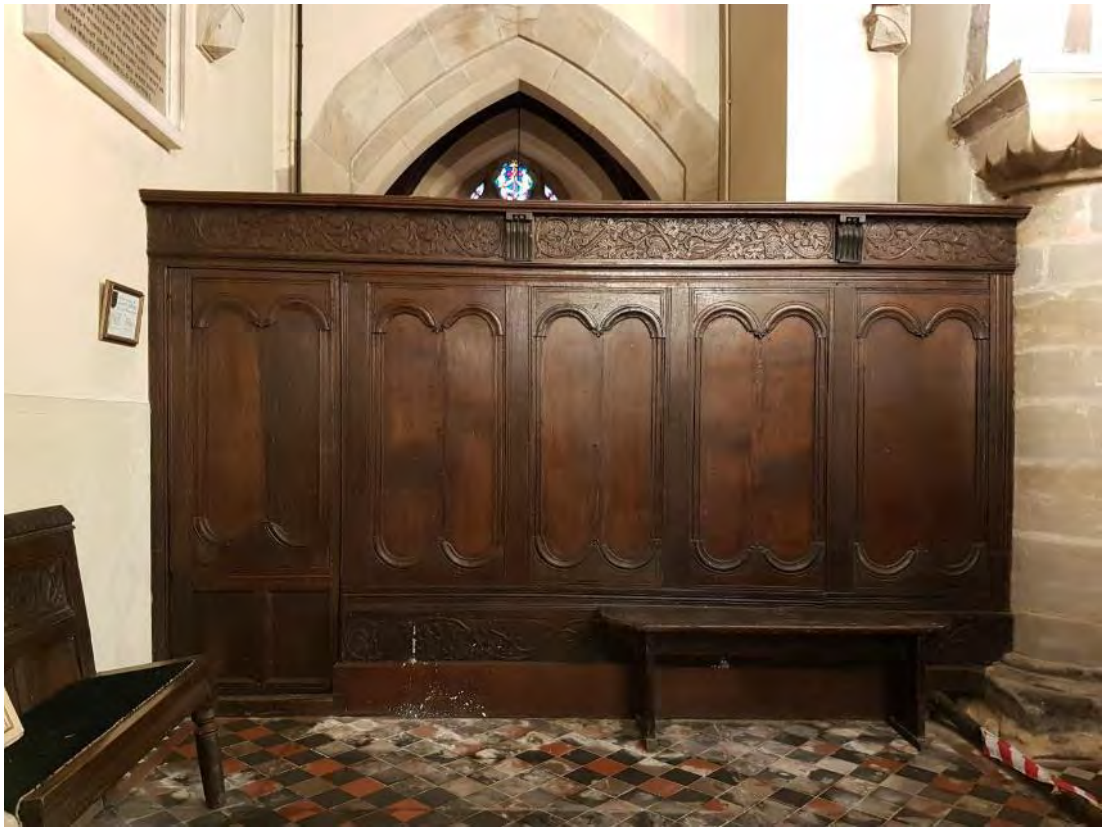
Figure 180: The altered and reused seventeenth-century screen in the western bay of the chancel, along the south wall (Source: Author 2019).

The matching floriated friezes, moulded triglyphs and moulded cornice on multiple screens, indicate that they were carved contemporaneously and were part of the entablature for the same decorative panelling (Figure 180-Figure 184). The entablature would have run along the top of the chancel panelling, as shown in the 1861 drawing (Figure 142). The double-arched components of the panelling appear contemporaneous with the friezes and are likely to have run along the chancel walls below the entablature, with a dentilated stringcourse between them, as well as perhaps running along the side, as is apparent on the panelling along the south wall of the chancel and the chair (Figure 180 and Figure 185). It is likely that the base exhibited the floriated frieze and skirting visible in the western vestry screen (Figure 181). The panelling along the Post-Medieval chancel would have been taller than existing, demonstrated by pictorial evidence and physical evidence of foreshortening (Figure 142, Figure 180 to Figure 185). The panelling currently along the eastern wall of the chancel comprises only a horizontal component decorated with dentils and brandished hanging projections (Figure 179), matching the chancel screen. This panelling is likely to have comprised the top of the seventeenth-century reredos in the Post-Medieval period. The human-headed timber shafts of the southern screen of the vestry, as well as its central panel with a decorative round-headed arch, are likely to have comprised part of this reredos (Figure 184). The screen between the vestry and chancel is an amalgamation of different timber elements and was not originally intended for this position, as the frieze has been cut at the ends to fit, the bottom of the frieze shows evidence of earlier fixing points and the base has been constructed from mismatched pieces of timber (Figure 184).

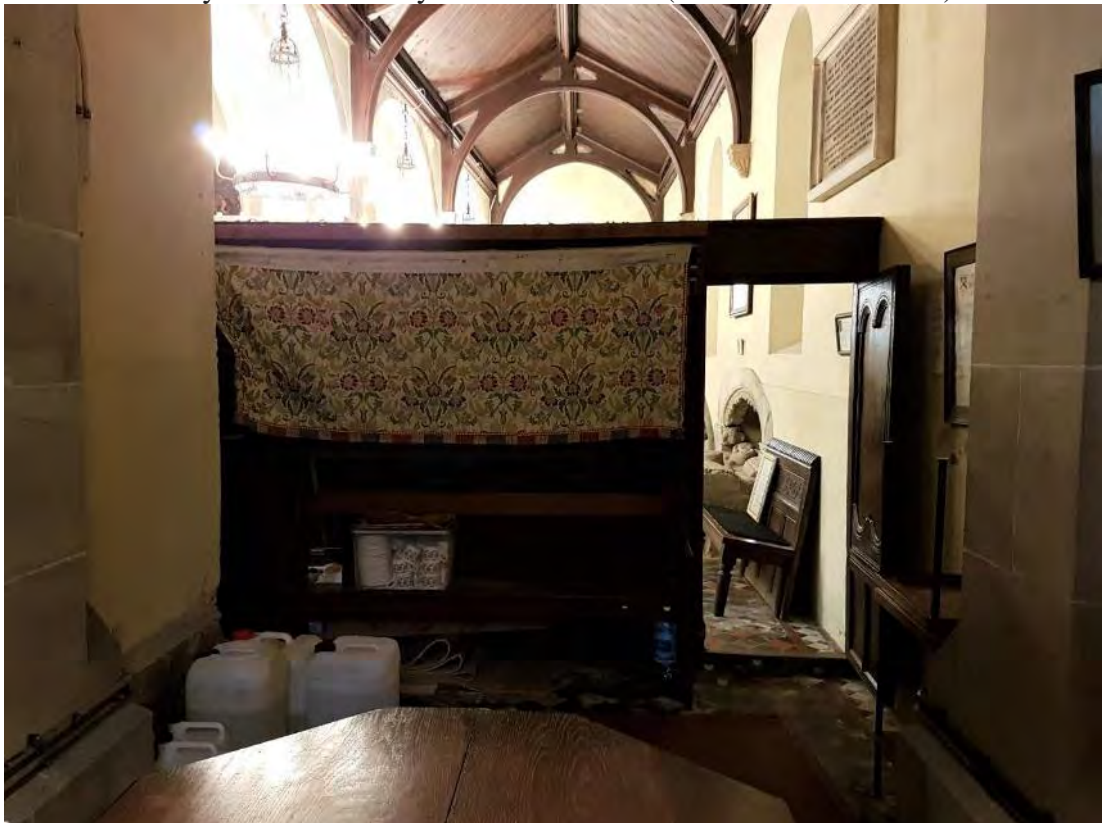
Figure 181: The front of the reused seventeenth-century screen running between the eastern nave bay and chancel bay of the north aisle (Source: Author 2019).

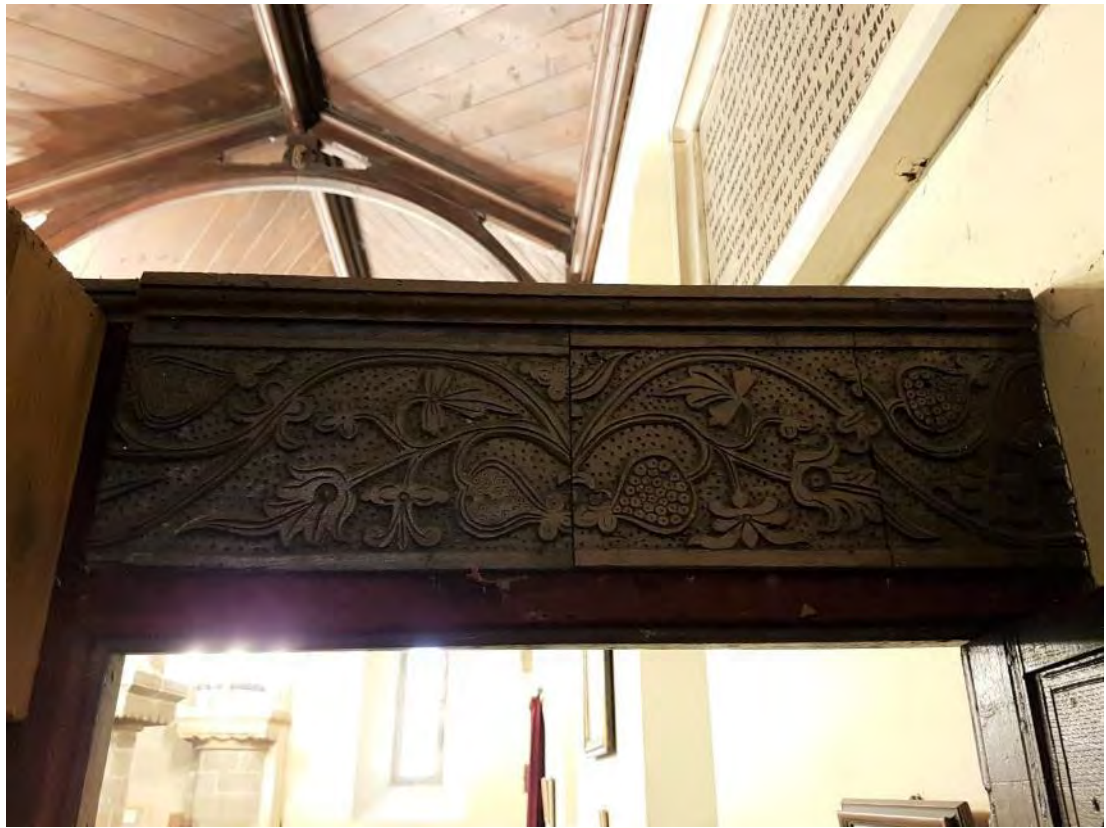
Figure 182: The back of the reused seventeenth-century screen running between the eastern nave bay and chancel bay of the north aisle, taken from the vestry (Source: Author 2019).
