# **NOT ALL THOSE WHO WANDER ARE LOST:**

## **Reconstructing the Post-Medieval Phase of Stonegrave Minster using a Buildings Archaeology Approach**

**MA in the Archaeology of Buildings**

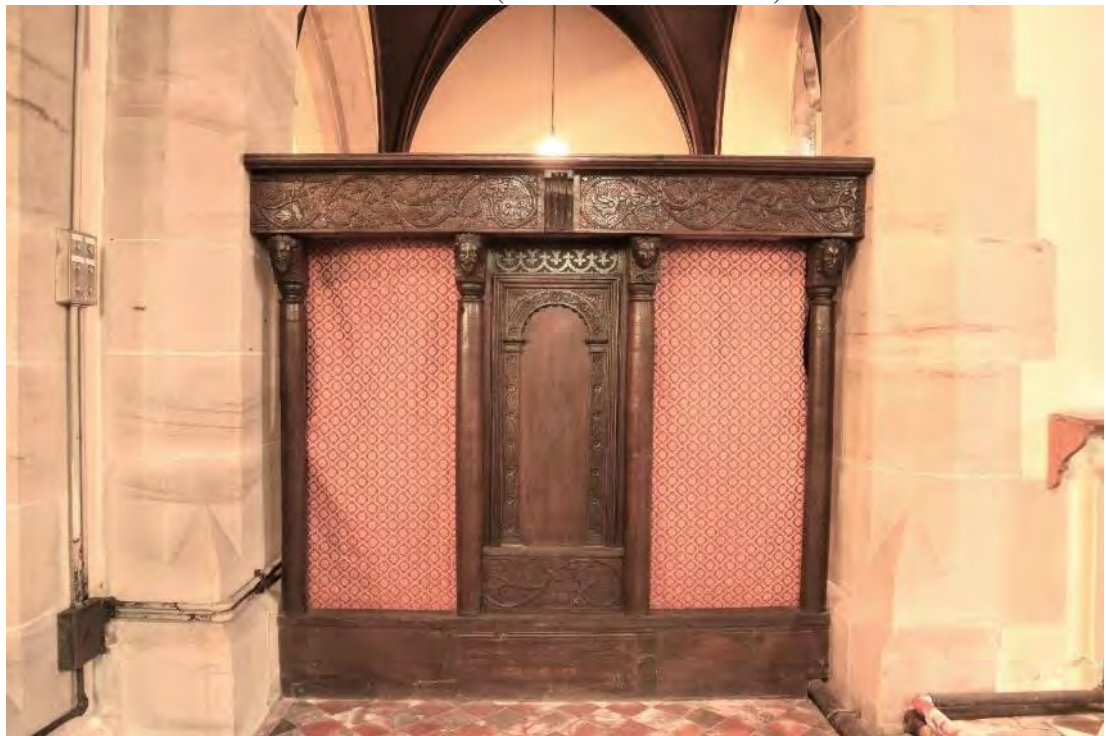
Figure 183: The back of the reused seventeenth-century screen running between the eastern nave bay and chancel bay of the north aisle, taken from the vestry, showing the reused floriated frieze above the door (Source: Author 2019).

The matching floriated friezes, moulded triglyphs and moulded cornice on multiple screens, indicate that they were carved contemporaneously and were part of the entablature for the same decorative panelling (Figure 180-Figure 184). The entablature would have run along the top of the chancel panelling, as shown in the 1861 drawing (Figure 142). The double-arched components of the panelling appear contemporaneous with the friezes and are likely to have run along the chancel walls below the entablature, with a dentilated stringcourse between them, as well as perhaps running along the side, as is apparent on the panelling along the south wall of the chancel and the chair (Figure 180 and Figure 185). It is likely that the base exhibited the floriated frieze and skirting visible in the western vestry screen (Figure 181). The panelling along the Post-Medieval chancel would have been taller than existing, demonstrated by pictorial evidence and physical evidence of foreshortening (Figure 142, Figure 180 to Figure 185). The panelling currently along the eastern wall of the chancel comprises only a horizontal component decorated with dentils and brandished hanging projections (Figure 179), matching the chancel screen. This panelling is likely to have comprised the top of the seventeenth-century reredos in the Post-Medieval period. The human-headed timber shafts of the southern screen of the vestry, as well as its central panel with a decorative round-headed arch, are likely to have comprised part of this reredos (Figure 184). The screen between the vestry and chancel is an amalgamation of different timber elements and was not originally intended for this position, as the frieze has been cut at the ends to fit, the bottom of the frieze shows evidence of earlier fixing points and the base has been constructed from mismatched pieces of timber (Figure 184).

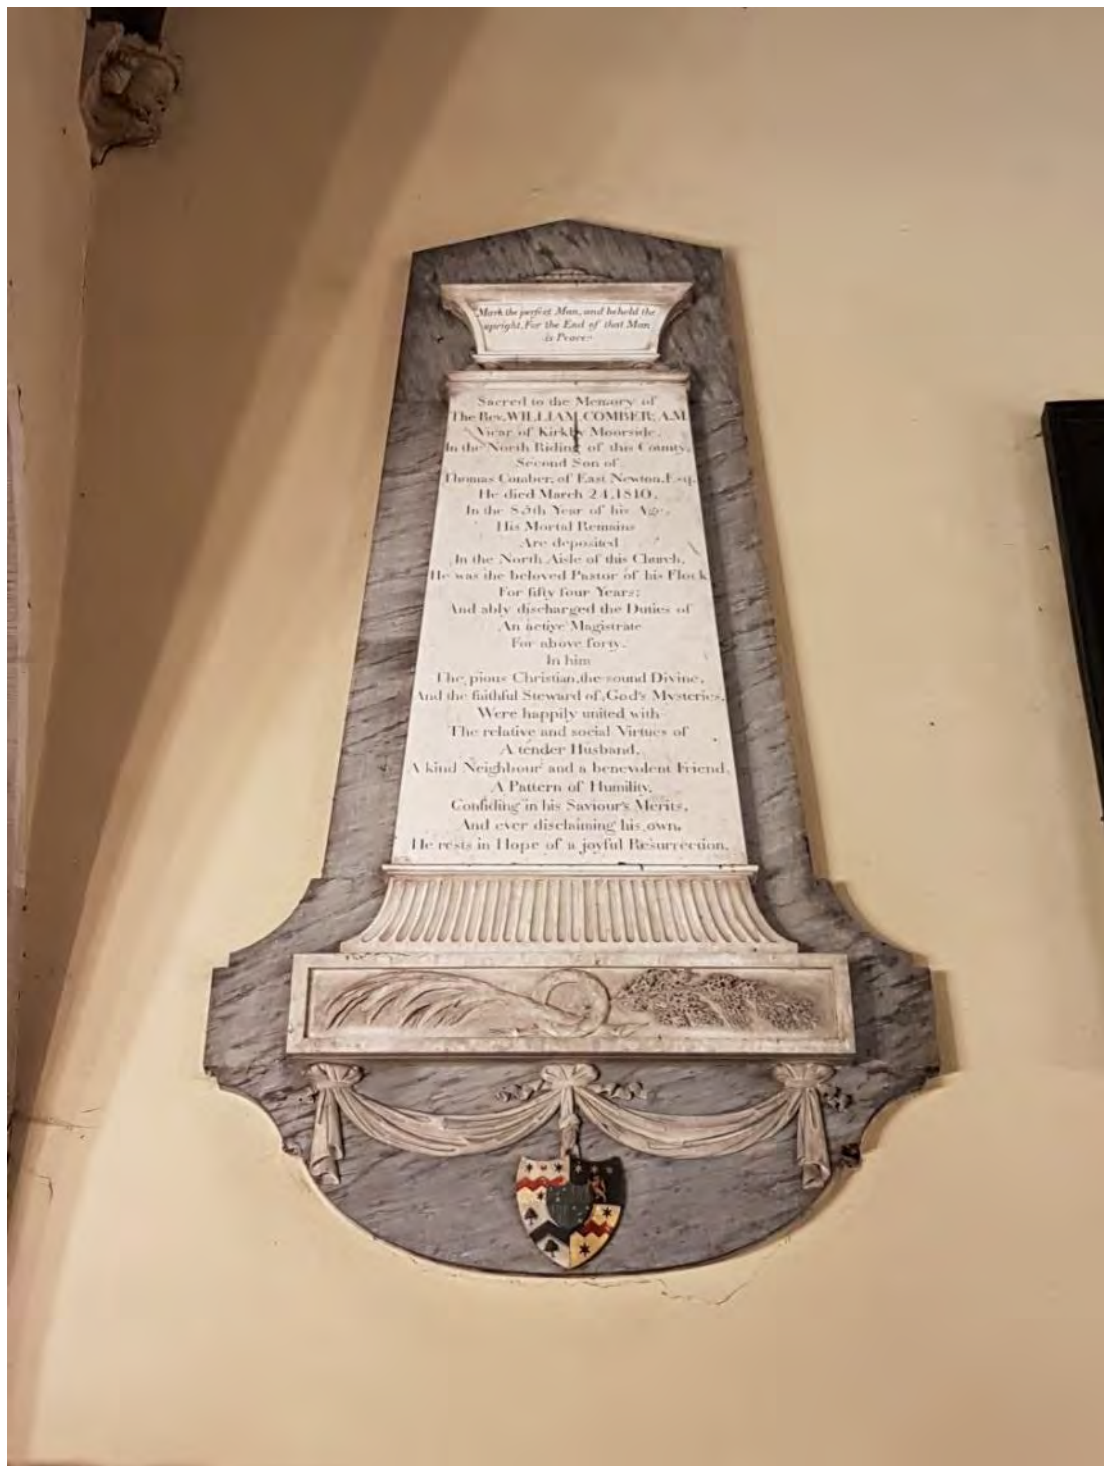
Figure 189: The late eighteenth- or early nineteenth-century wall-mounted memorial tablet to Thomas Comber (d. 1763), father of William Comber, previously and currently located on the north wall of the chancel (Source: Author 2019).

The chancel contained a number of memorials, some of which remain. Eastmead (1824, 188) noted the presence of Thomas Comber's memorial on the north wall, which is a late eighteenth- or early nineteenth-century mural tablet currently on the north wall of the extant chancel (Figure 189). Eastmead (1824, 188-9) further notes that the memorials to Rev. William Comber (d.1810) and 'his wife Dorothy Comber' (d.1807), which were 'similar in size, and corresponding in...sculptural decorations' were located together on the southern wall of the chancel. These early nineteenth-century memorials are currently fixed to the western wall of the nave (Figure 190-Figure 191; Chapter 4). It is likely that these monuments were located above the timber panelling (Figure 142). Eastmead (1824, 189) locates the black marble gravestone to Dean Thomas Comber (d.1699) in the eastern end of the chancel, but is now in the western bay (Figure 187). Dean Thomas Comber's mother, Mary Burton, (d.1672) was buried on one side of this memorial, while his wife, Alice (d.1720), and son, Thomas (d.1702), were buried together on the other (Eastmead 1824, 189-90). The corresponding bronzes now fixed to nineteenth-century marble backing and flanking the eastern wall of the chancel were formerly fixed to grave-slabs in the flooring (Figure 192-Figure 193). Additionally, Eastmead (1824, 189) noted the presence of a 'triangular shaped stone' with an 'illegible' inscription located near the 'the altar rails'. Eastmead (1824, 189) presumed it was the monument for a 'former rector', but as the stone is no longer extant, this cannot be confirmed.

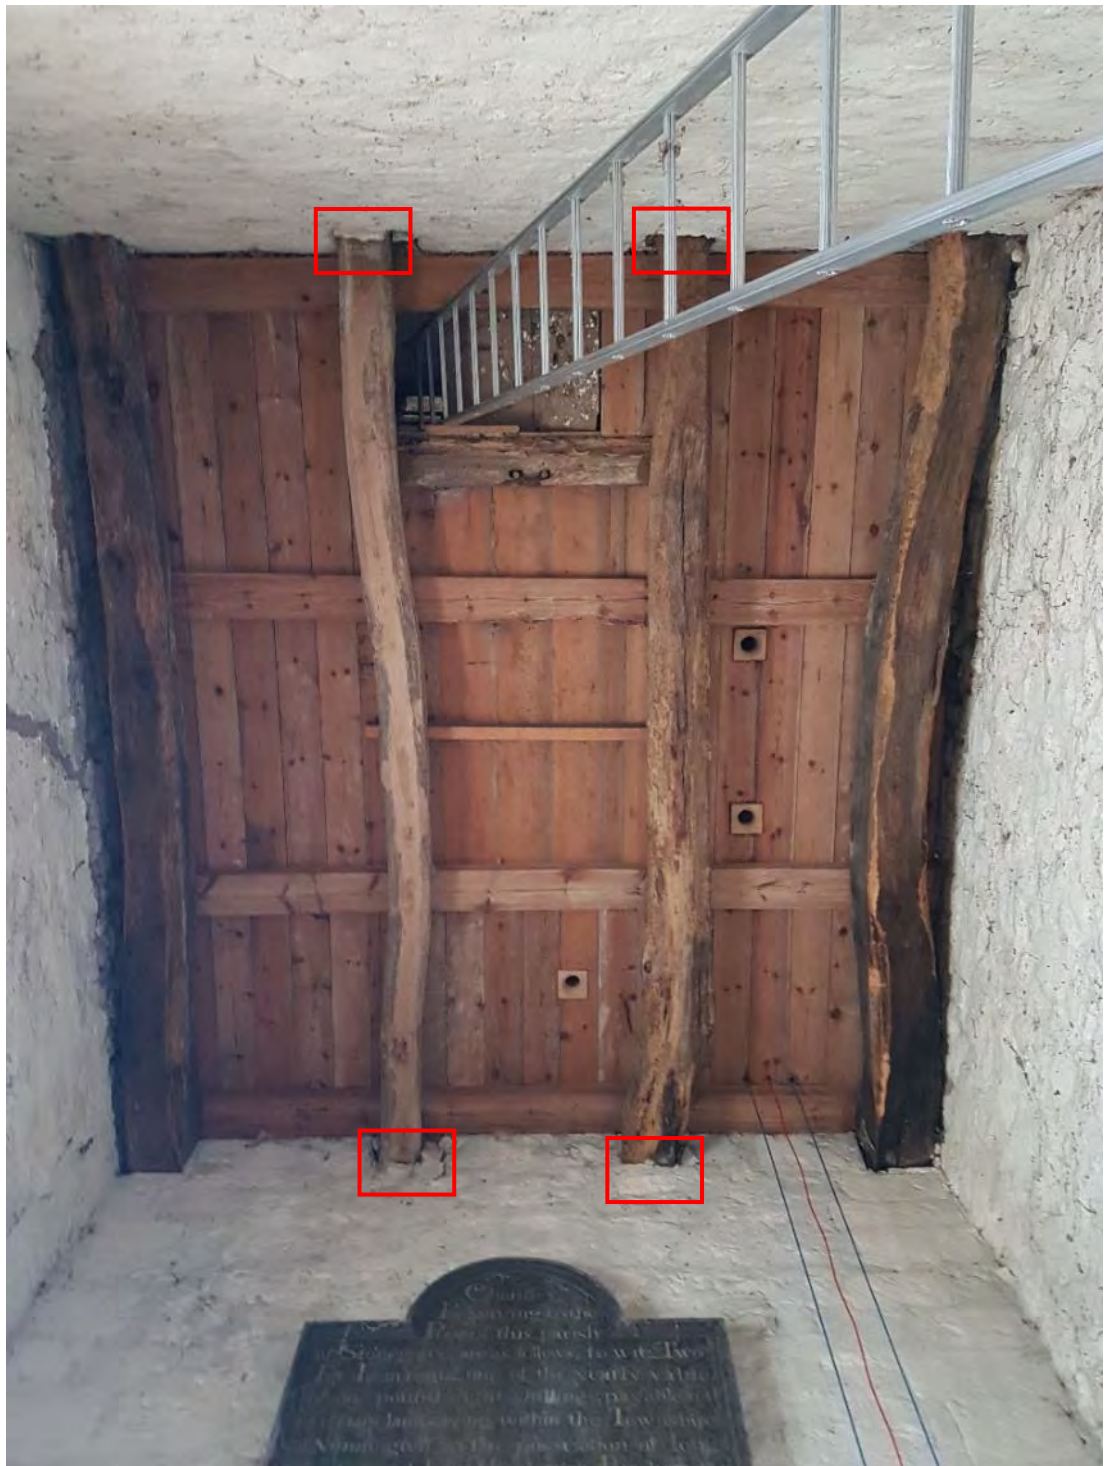
Figure 196: The exposed ceiling of the first stage of the tower, showing the built-up areas of stonework around the central beams outlined in red (Source: Author 2019).

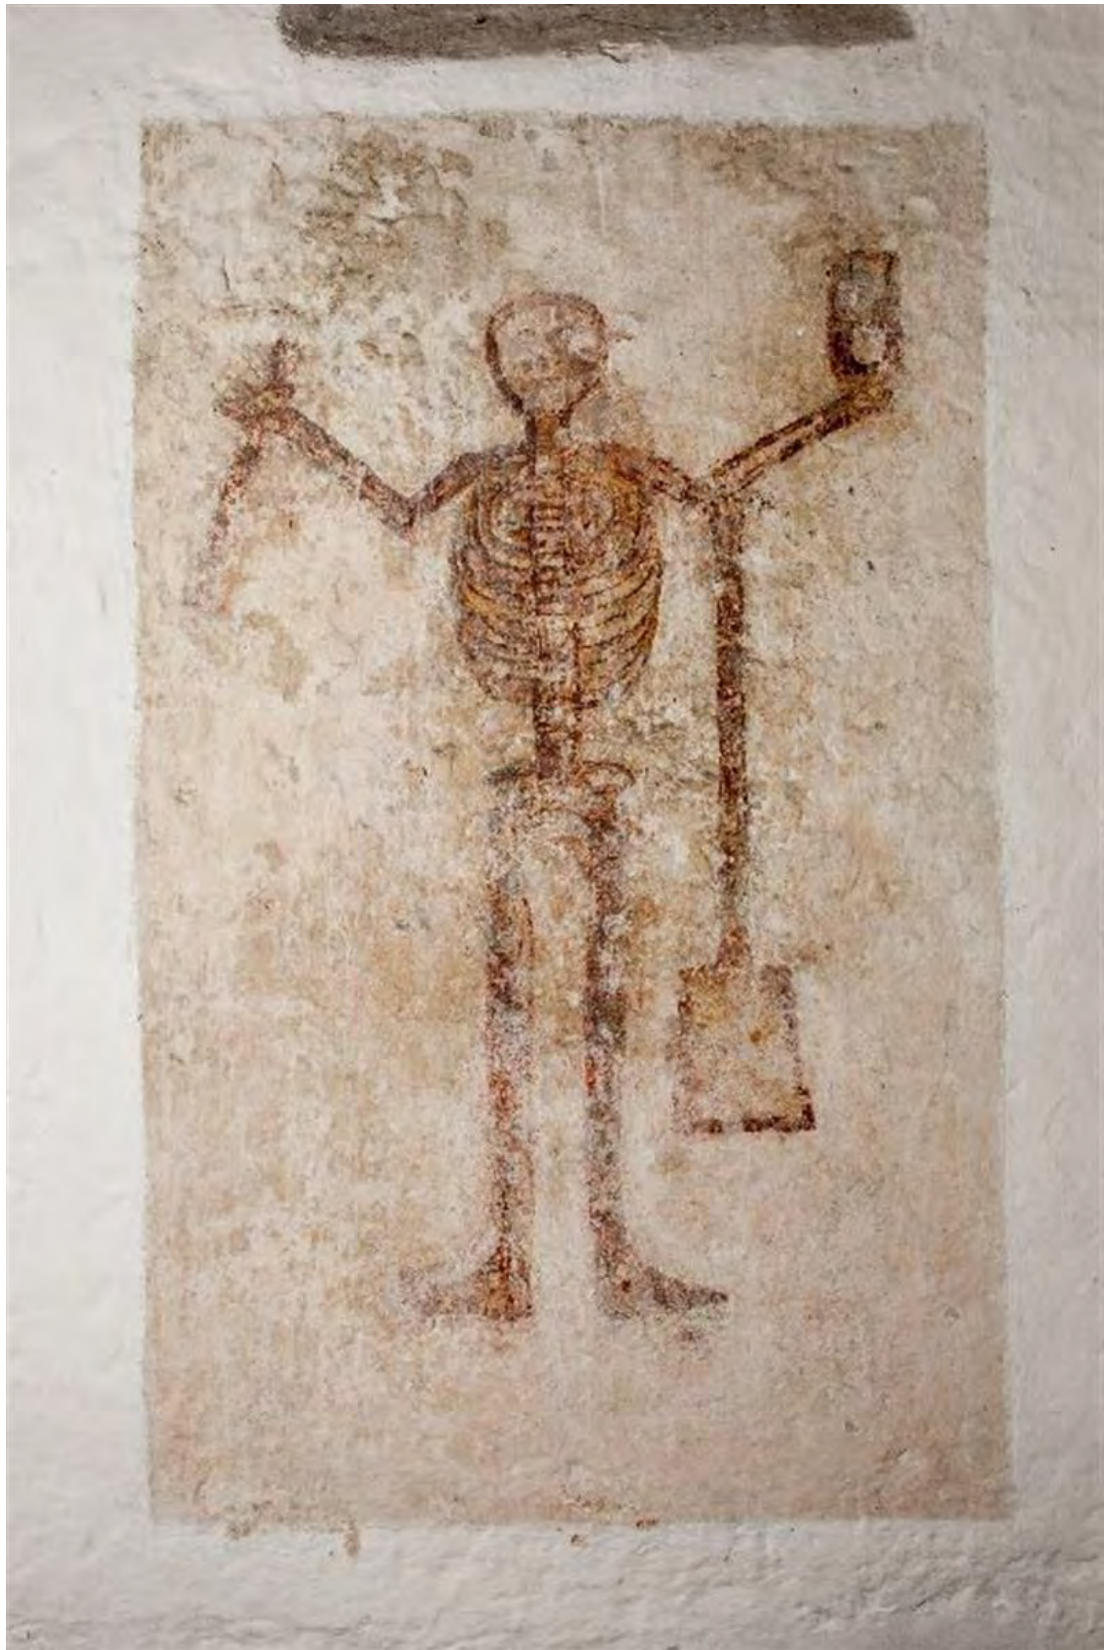
Figure 202: Photograph of the nave at St Ishow's Church, Partrishow, showing the scriptural texts and coat of arms (Source: Wright 2012a).

Only 4% of pre-Victorian churches in England partially retain their Post-Medieval paint scheme, with only 9% of these churches located in the North (Newham 2015). Evidence of Stonegrave's Post-Medieval painting scheme, which may be extant beneath the existing plaster and paint, is therefore rare. Paintings of scriptural texts, though relatively common in the Post-Medieval period (Newham 2015), have few unaltered survivors due to the popularity of whitewashing or plaster scraping during Victorian restoration (Brandwood 1990, 73). The 'time and death' painting is rare, as the only other extant versions are at: Westborough, Lincolnshire; Yaxley, Huntingdonshire; Llangar, Denbighshire; and Patrishrow, Powys (Field and Smith 2014, 269). The most similar version to Stonegrave's painting appears to be at St Ishow's Church, Patrishrow, Powys, which also displays painted Post-Medieval scriptural texts and a coat of arms (Figure 202

and Figure 203). However, even such churches as Powys have experienced alterations and repair since the Post-Medieval period (Figure 202; RCAHMW 2007).

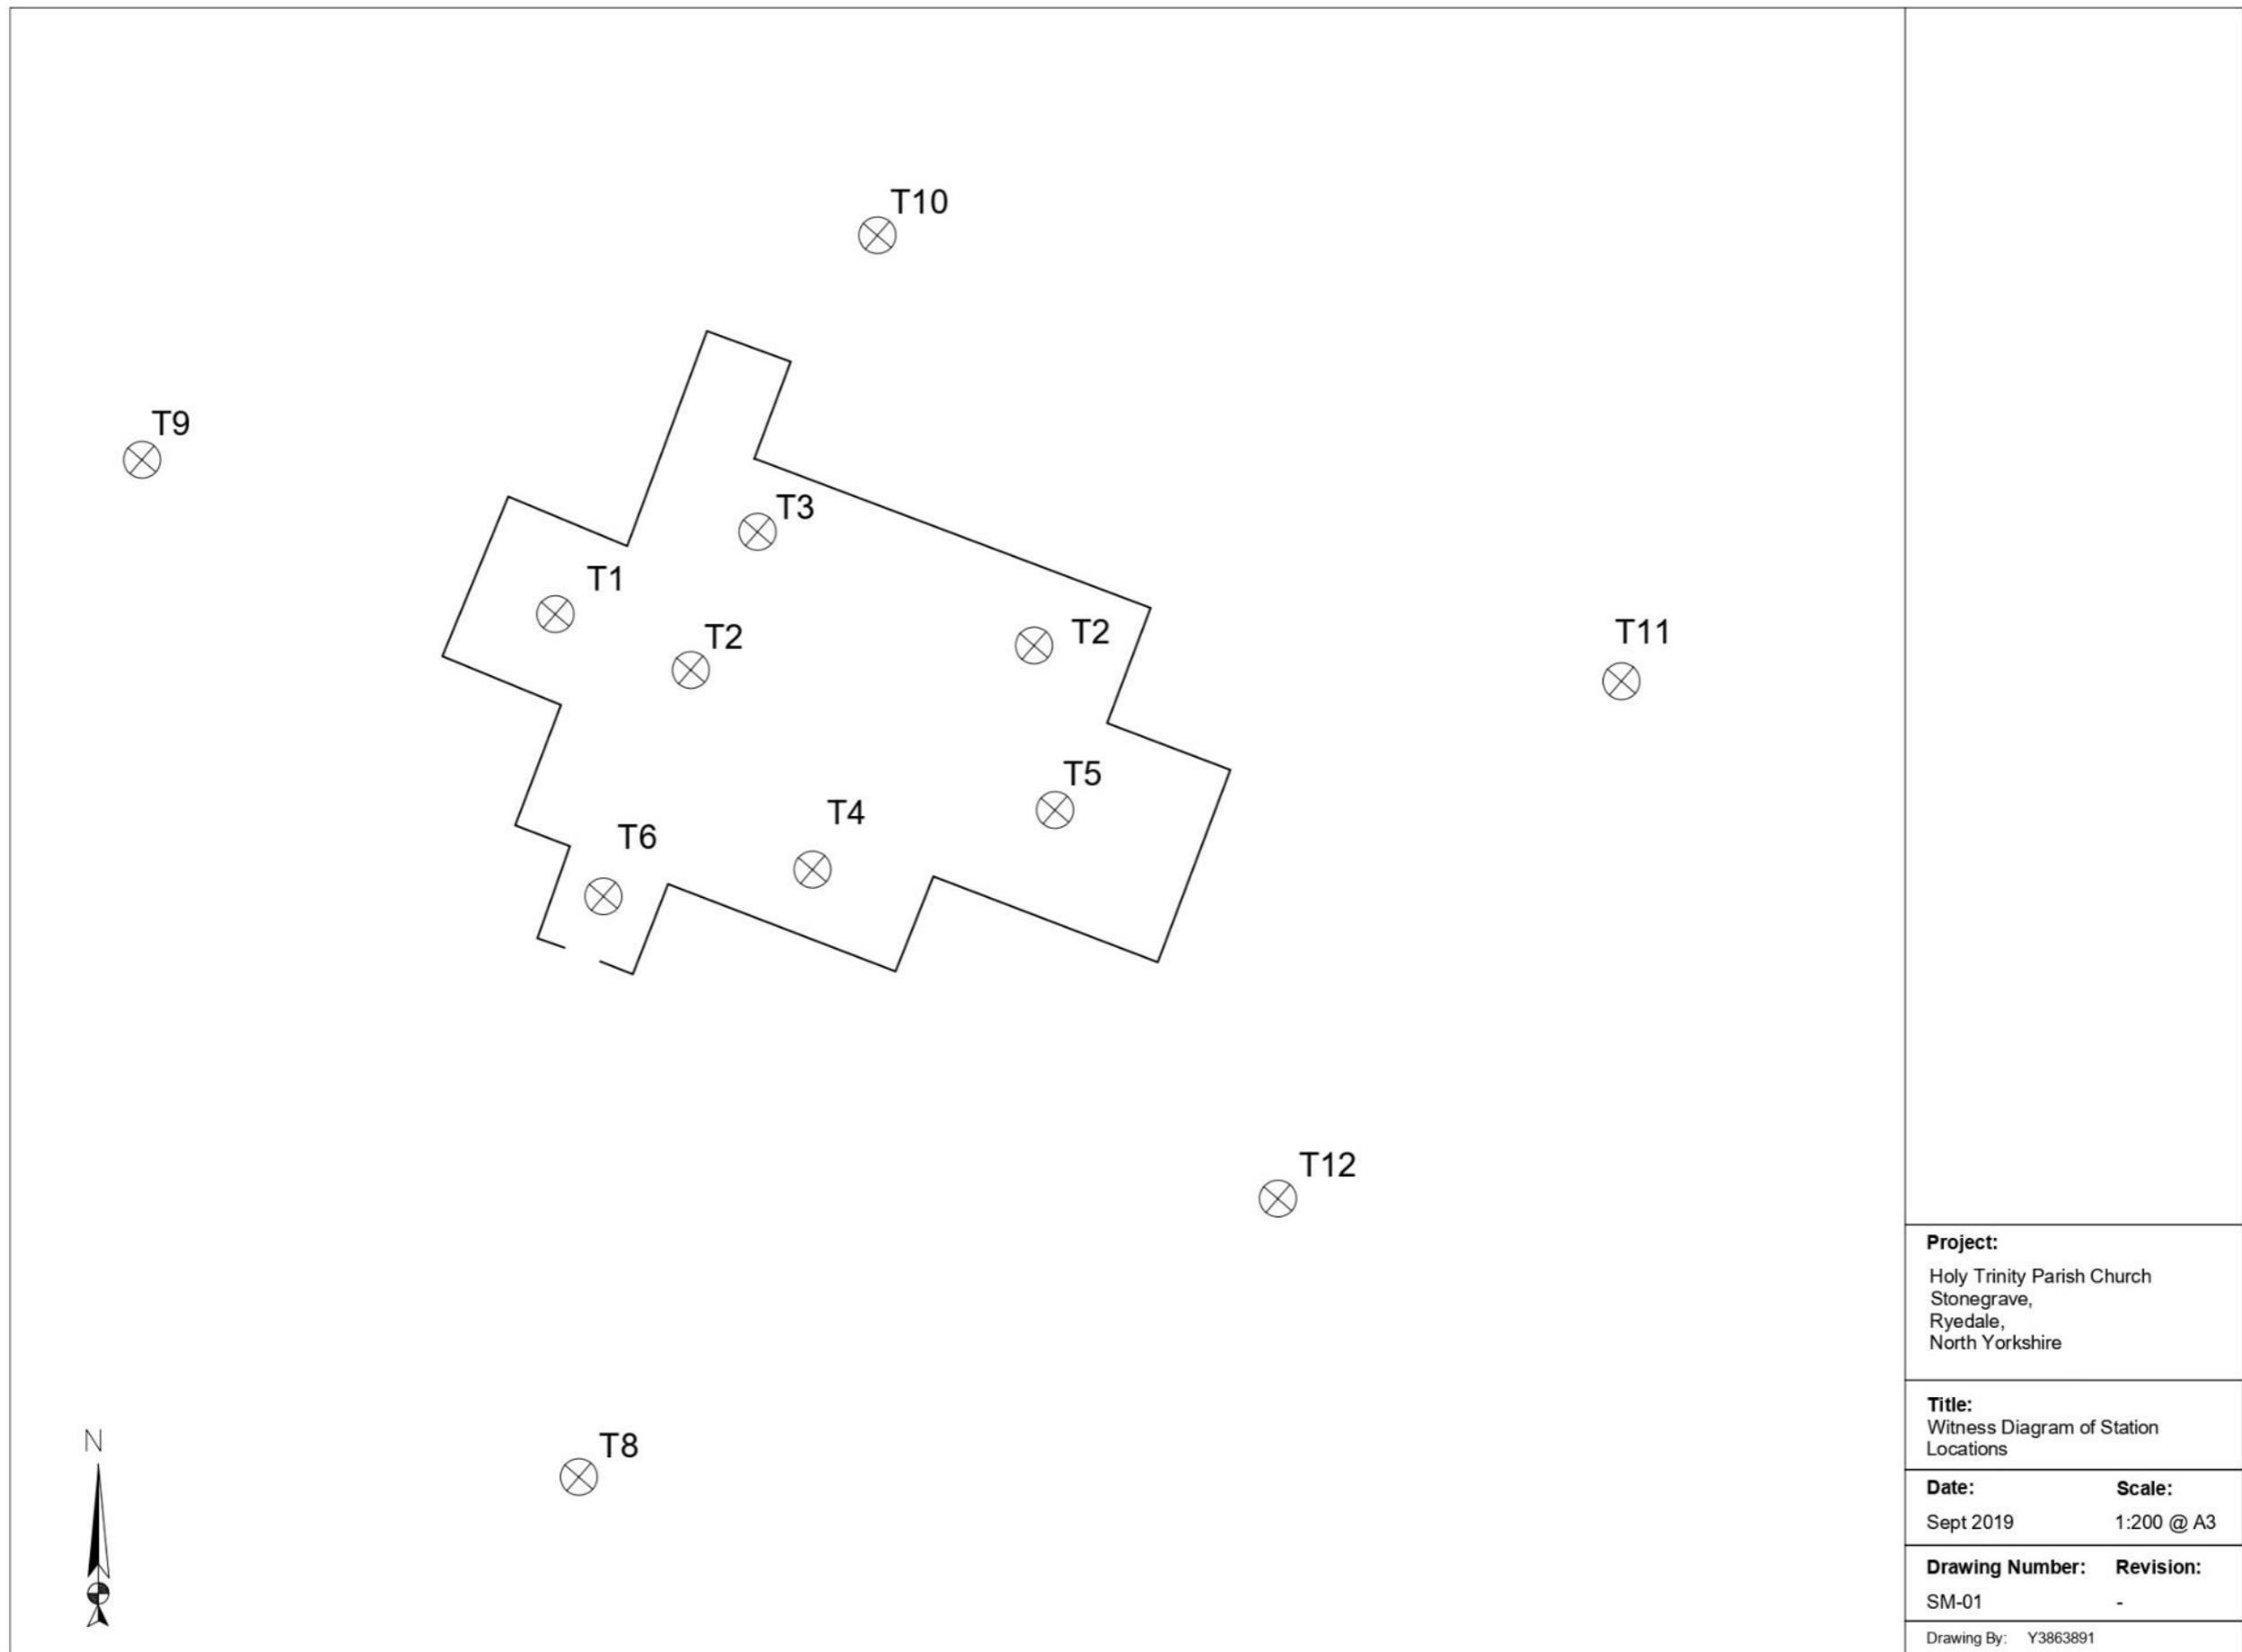
Plan 1: Witness diagram of Station Locations at Stonegrave Minster (Source: Author 2019).
